Device	SAF-C161JI-32RF, SAK-C161JI-32RF, SAF-C161JC-32RF, SAF-C161JC-32RF, SAF-C161CS-32RF, SAF-C161CS-32RF
Marking/Step	Step (E)ES-AB, AB
Package	P-TQFP-128-2

This Errata Sheet describes the deviations from the current user documentation.

Current Documentation

- C161CS/JC/JI-32R/-L Data Sheet, V3.0, Jan. 2001
- C161CS/JC/JI-32R/-L User's Manual, V3.0, Feb. 2001
- Instruction Set Manual: User's Manual, V2.0, Mar. 2001

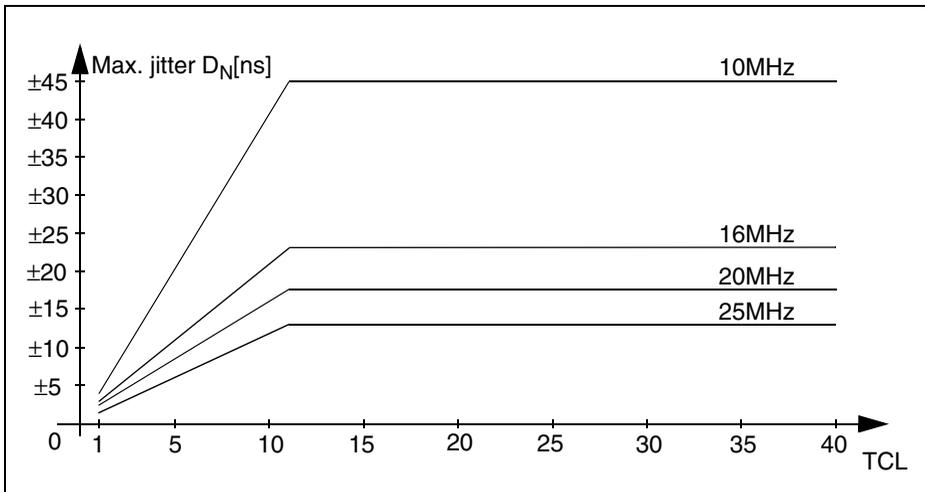
PLL.3.1 Increased PLL Jitter caused by external Access**Problem description:**

The value of the additional jitter is not a fixed one but it depends on the kind of activity on the external bus or output pins. The additional jitter increases with the number of output/bus pins which are switched at the same time to a new voltage level because the problem is caused by noise on the on-chip power supply.

This approximated formula is valid for $1 \leq N \leq 12$ and $10 \text{ MHz} \leq f_{\text{CPU}} \leq 25 \text{ MHz}$.

For all accumulated periods longer than 12 TCL the $N=12$ value can be used; see figure below.

In case that the additional jitter causes problems in the system which cannot be relaxed with software adapted timing parameters, then direct drive or prescaler mode can be used. If the maximum frequency of the on-chip oscillator (16 MHz) is not sufficient then an external clock generator can be used.

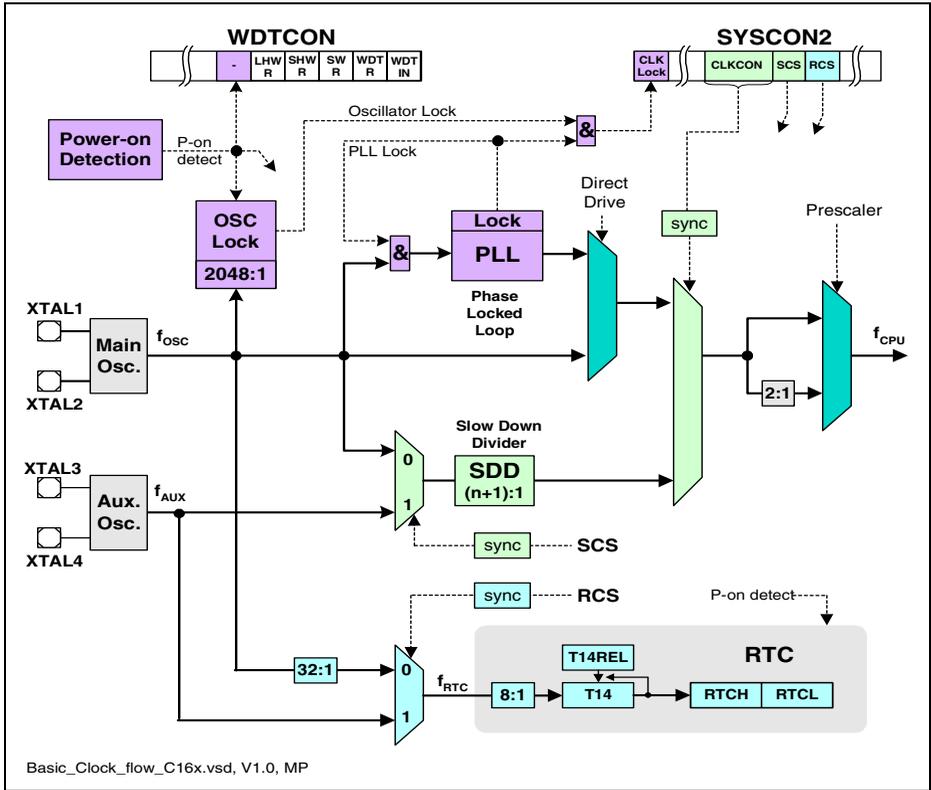
Figure 1 C16x Clock Configuration

During power-on or during a power off/on sequence it is possible that the internal clock configuration of the power management is not set to a defined state. An undefined state of the power management clock configuration can cause different kinds of malfunctions in the system. The below described malfunction does not always occur but can appear sporadically.

Root cause of the Problem:

If the conditions to get a defined clock configuration at power-on are not fulfilled then it is possible that the internal power-on detection unit does not detect power-on. Whether power-on was detected or not can be checked with WDTCON.5. If power-on was detected then $\text{WDTCON.5} = 1$ else $\text{WDTCON.5} = 0$. The function of bit WDTCON.5 is implemented for evaluation purposes and is not guaranteed.

If power-on was not detected by the on-chip power-on detection unit then this can cause a malfunction of the internal oscillator lock detect unit. In that case the internal oscillator lock signal is not set after 2048 XTAL1 clock periods.

Consider the conditions to get a defined clock configuration at power-on.
