Device	SAF-C161JI-32RF, SAK-C161JI-32RF, SAF-C161JC-32RF, SAF-C161JC-32RF, SAF-C161CS-32RF, SAF-C161CS-32RF
Marking/Step	Step (E)ES-AB, AB
Package	P-TQFP-128-2

This Errata Sheet describes the deviations from the current user documentation.

1 History List/Change Summary

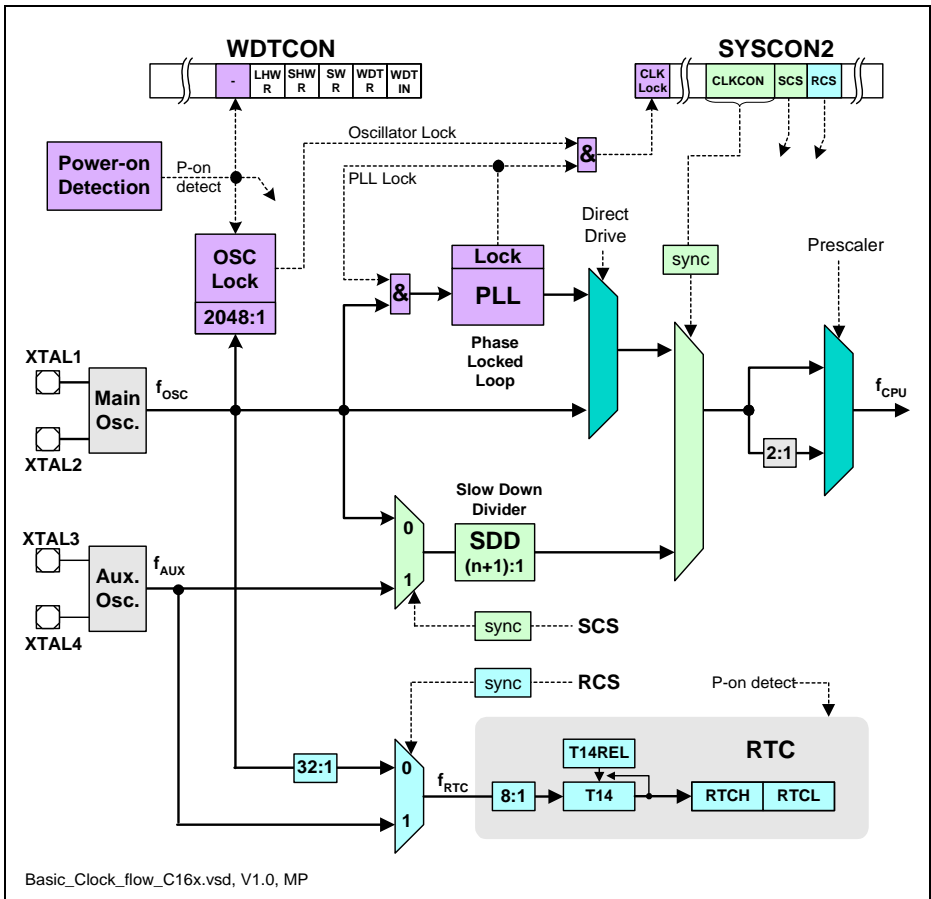
Figure 2 C161CS/JC/JI-32RF Clock Configuration

During power-on or during a power off/on sequence it is possible that the internal clock configuration of the power management is not set to a defined state. An undefined state of the power management clock configuration can cause different kinds of malfunctions in the system. The below described malfunction does not always occur but can appear sporadically.

When the power-on detection fails during power-on because of not considering the necessary conditions, the register bits SCS, RCS and the RTC registers are undefined. Further the oscillator lock signal is not set.

When the power-on detection fails during power-on because of not considering the necessary conditions, the register bits SCS, RCS and the RTC registers are undefined.

Consider the conditions to get a defined clock configuration at power-on.

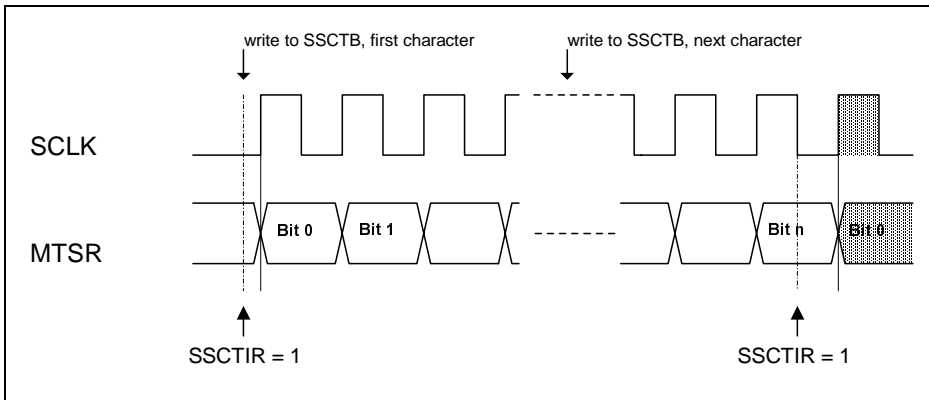
Figure 3 SSCTB Timing

- When SSCTB has been written while the transmit shift register was empty (and the SSC is enabled), flag SSCTIR is set to '1' directly after completion of the write operation, independent of the selected baud rate. When the transmit shift register is not empty when SSCTB was written, SSCTIR is set to '1' after the last latching edge of SCLK (= 1/2 bit time before the first shifting edge of the next character). See also e.g. C167CR User's Manual V3.1, p. 12-5.

The following diagram shows these relations in an example for a data transfer in master mode with SSCPO = 0 and SSCPH = 0. It is assumed that the transmit shift register is empty at the time the first character is written to SSCTB:

Typically, in interrupt driven systems, no problems are expected from the modified timing of flag SSCTIR. However, when flag SSCTIR is polled by software in combination with other flags which are set/cleared at the end or at the beginning of a transfer (e.g. SSCBSY), the modified timing may have an effect.

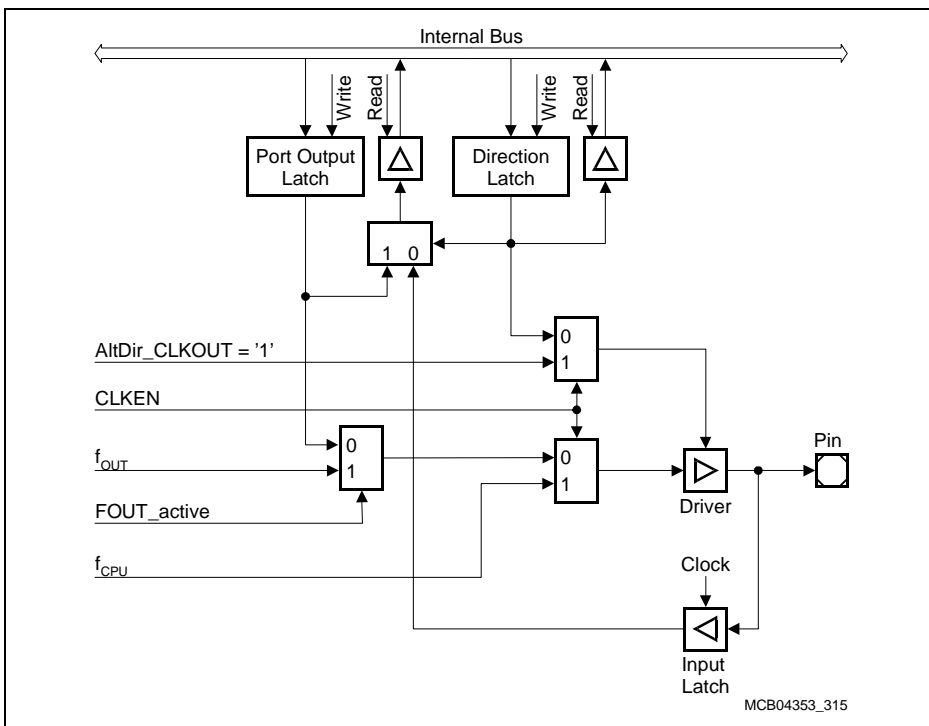
PORT.D3 P3.15 and Frequency Output Signal Path

To enable the frequency output signal f_{OUT} bit CLKEN in register SYSCON must be cleared (before EINIT) and f_{OUT} must be enabled in register FOCON. In contrast to signal CLKOUT the direction latch has to be set by software to enable f_{OUT} .
