Device	SAF-C161JI-32RF, SAK-C161JI-32RF, SAF-C161JC-32RF, SAK-C161JC-32RF, SAF-C161CS-32RF, SAK-C161CS-32RF
Marking/Step	Step (E)ES-CA, CA
Package	P-TQFP-128-2

This Errata Sheet describes the deviations from the current user documentation.

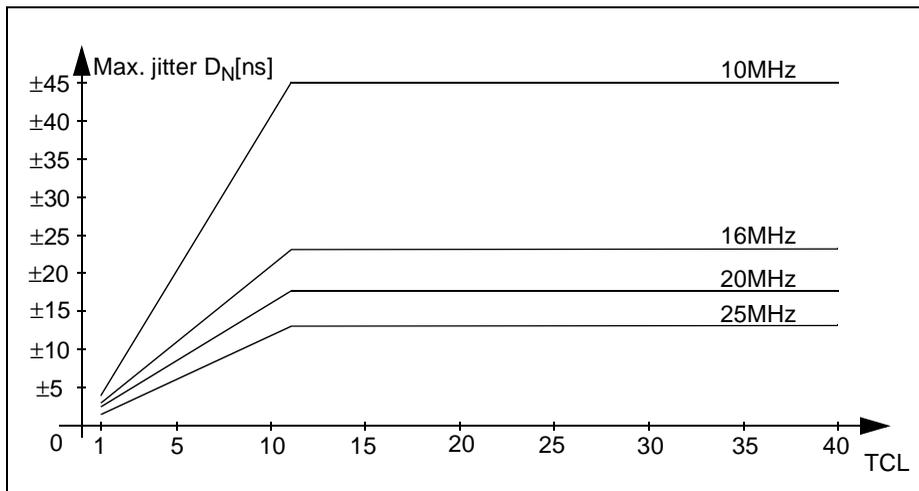
Figure 1 Additional Jitter

The value of the additional jitter is not a fixed one but it depends on the kind of activity on the external bus or output pins. The additional jitter increases with the number of output/bus pins which are switched at the same time to a new voltage level because the problem is caused by noise on the on-chip power supply.

This approximated formula is valid for $1 \leq N \leq 12$ and $10 \text{ MHz} \leq f_{\text{CPU}} \leq 25 \text{ MHz}$.

For all accumulated periods longer than 12 TCL the $N=12$ value can be used; see figure below.

In case that the additional jitter causes problems in the system which cannot be relaxed with software adapted timing parameters, then direct drive or prescaler mode can be used. If the maximum frequency of the on-chip oscillator (16 MHz) is not sufficient then an external clock generator can be used.

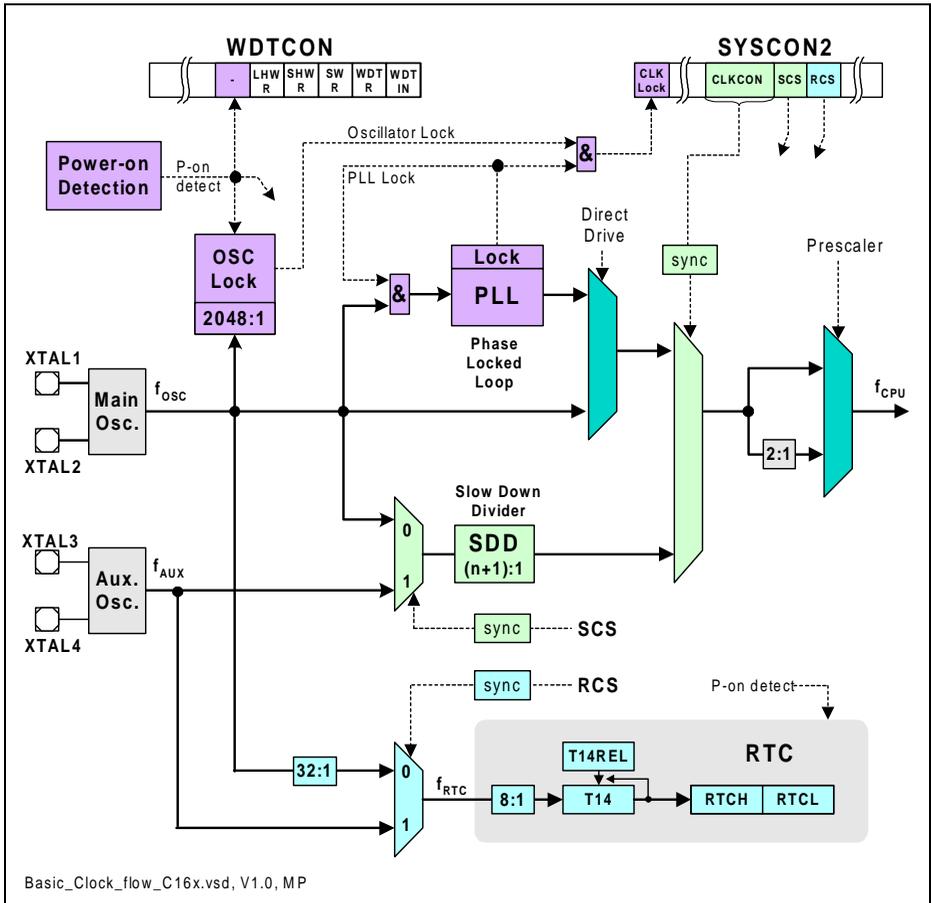
Figure 2 C161JI/JC/CS-32RF Clock Configuration

During power-on or during a power off/on sequence it is possible that the internal clock configuration of the power management is not set to a defined state. An undefined state of the power management clock configuration can cause different kinds of malfunctions in the system. The below described malfunction does not always occur but can appear sporadically.

If power-on was not detected by the on-chip power-on detection unit then this can cause a malfunction of the internal oscillator lock detect unit. In that case the internal oscillator lock signal is not set after 2048 XTAL1 clock periods.

Consider the conditions to get a defined clock configuration at power-on.

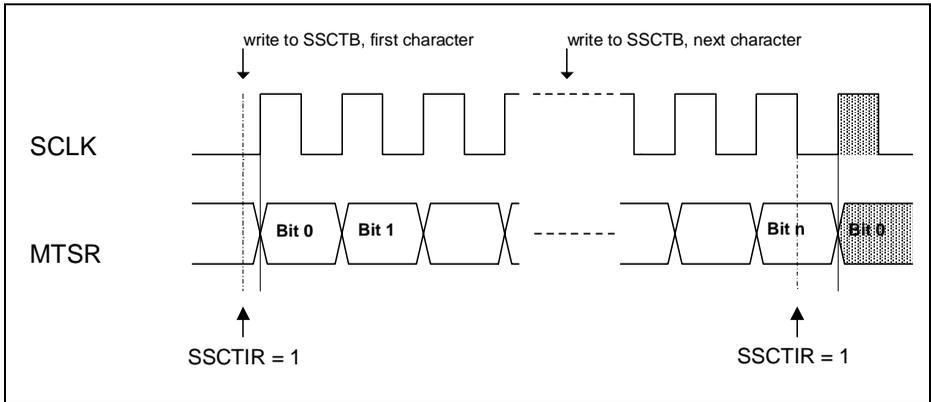
Figure 3 SSCTB Timing

When SSCTB has been written while the transmit shift register was empty (and the SSC is enabled), flag SSCTIR is set to '1' directly after completion of the write operation, independent of the selected baud rate. When the transmit shift register is not empty when SSCTB was written, SSCTIR is set to '1' after the last latching edge of SCLK (= 1/2 bit time before the first shifting edge of the next character). See also e.g. C167CR User's Manual V3.1, p. 12-5.

Typically, in interrupt driven systems, no problems are expected from the modified timing of flag SSCTIR. However, when flag SSCTIR is polled by software in combination with other flags which are set/cleared at the end or at the beginning of a transfer (e.g. SSCBSY), the modified timing may have an effect.

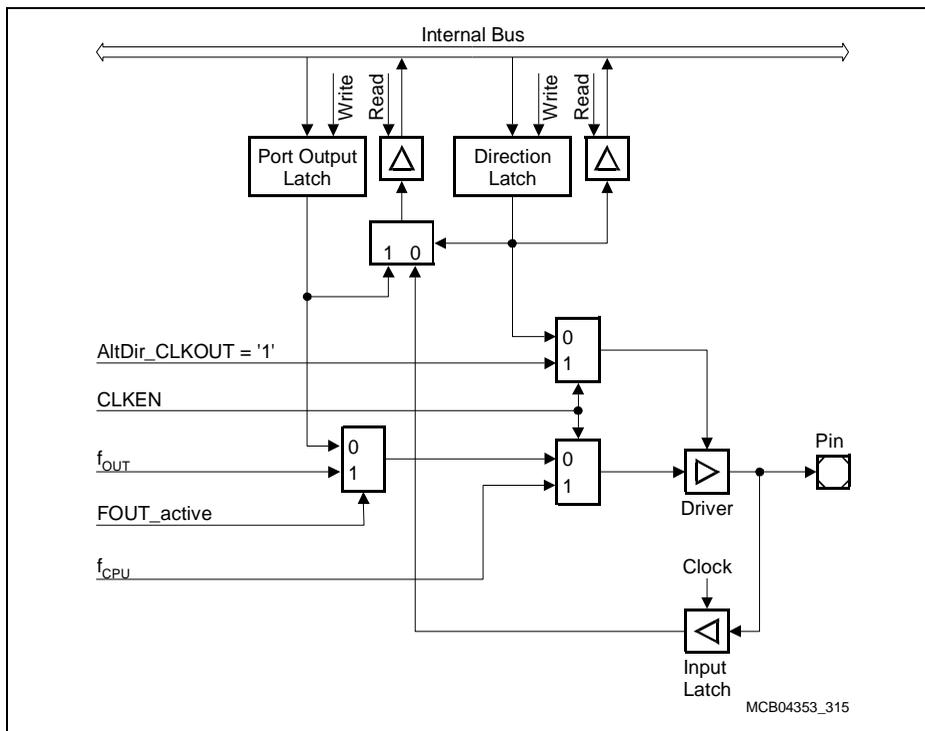
PORT.D3 P3.15 and Frequency Output Signal Path

To enable the frequency output signal f_{OUT} bit CLKEN in register SYSCON must be cleared (before EINIT) and f_{OUT} must be enabled in register FOCON. In contrast to signal CLKOUT the direction latch has to be set by software to enable f_{OUT} .
