Errata Sheet

March 30, 2001 / Release 1.0

Device: **SAB-C161K-LM**
 SAF-C161K-LM

Stepping Code / Marking: **ES-HA, HA**

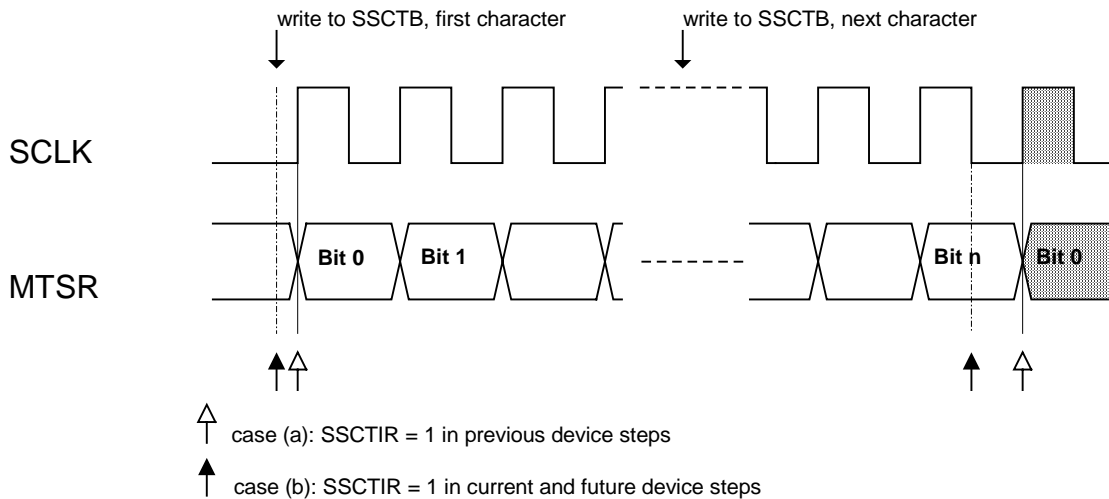
6. Timing of flag SSCTIR (SSC Transmit Interrupt Request)

- (a) before step **FA** (internal stepping F11) of the **C161K**, flag SSCTIR is set to '1' synchronous to the shift clock SCLK 1/2 bit time before the first latching edge (= first shifting clock edge when SSCPH = 0). When SSCTB is written while the shift register is empty, the maximum delay between the time SSCTB has been written and flag SSCTIR=1 is up to 1/2 bit time.

- (b) beginning with step **FA** (internal stepping F12) of the **C161K**, when SSCTB has been written while the transmit shift register was empty (and the SSC is enabled), flag SSCTIR is set to '1' directly after completion of the write operation, independent of the selected baud rate. When the transmit shift register is not empty when SSCTB was written, SSCTIR is set to '1' after the last latching edge of SCLK (= 1/2 bit time before the first shifting edge of the next character). See also e.g. C167CR User's Manual V3.1, p. 12-5.

The following diagram shows these relations in an example for a data transfer in master mode with SSCPO = 0 and SSCPH = 0. It is assumed that the transmit shift register is empty at the time the first character is written to SSCTB:

Typically, in interrupt driven systems, no problems are expected from the modified timing of flag SSCTIR. However, when flag SSCTIR is polled by software in combination with other flags which are set/cleared at the end or at the beginning of a transfer (e.g. SSCBSY), the modified timing may have an effect.

In order to achieve a defined and systematic behavior with all device steps, the SSC receive interrupt, which is generated at the end of a character transmission, may be used instead of the SSC transmit interrupt.
