Errata Sheet

August 8, 2003 / Release 1.6

Device:	SAB-C161PI-LM, -L25M SAF-C161PI-LM, -L25M SAB-C161PI-LM3V SAF-C161PI-LM3V SAB-C161PI-LF, -L25F SAF-C161PI-LF, -L25F SAB-C161PI-LF3V SAF-C161PI-LF3V
Stepping Code / Marking:	ES-AA, AA ES-BA-H, BA-H
Package:	P-MQFP-100-2, P-TQFP-100-1

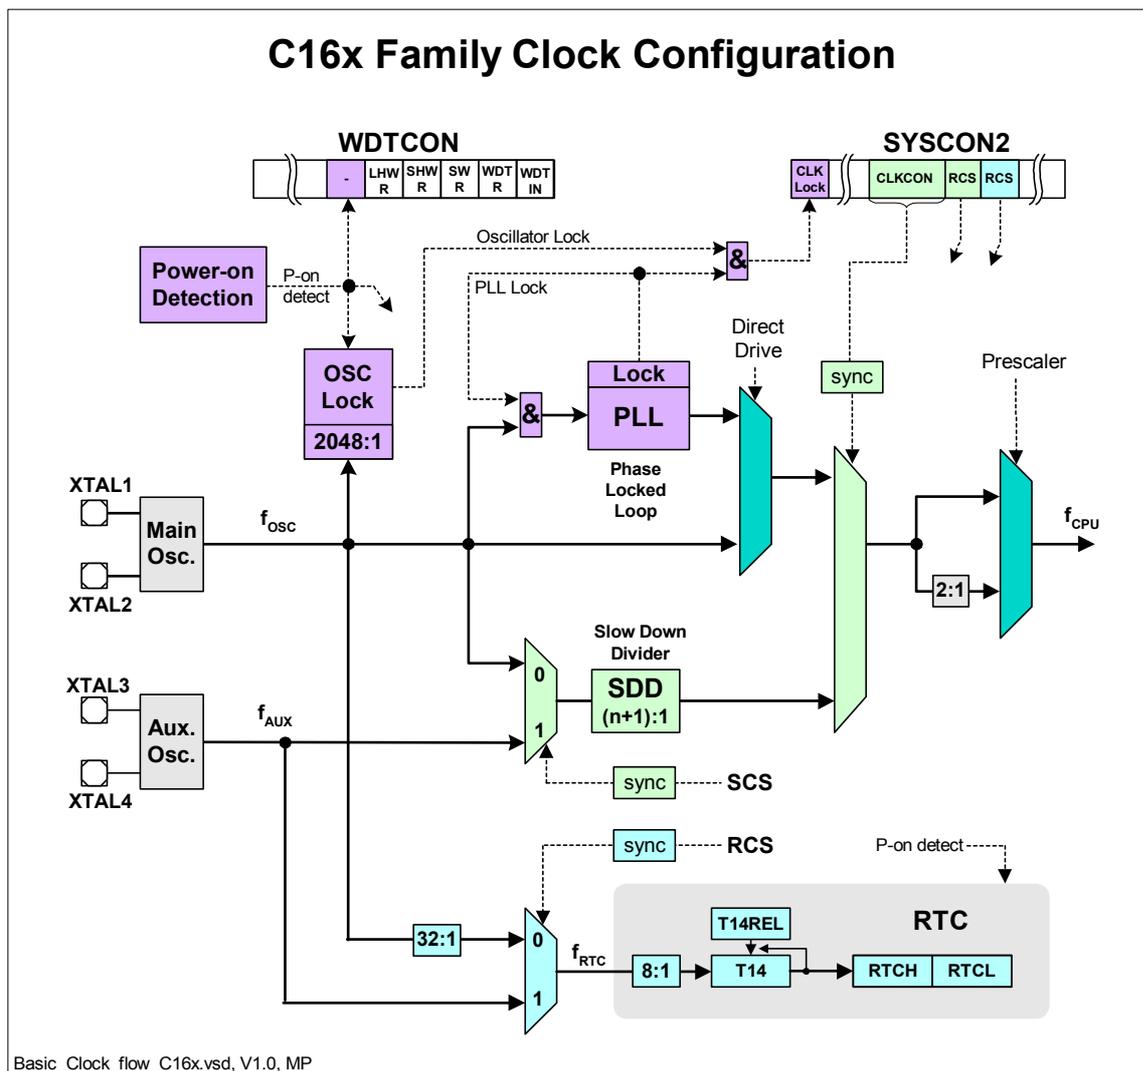
Case 4: NO Clock @ XTAL1 and Power-on Detection FAIL

Note: The C161PI includes no auxiliary oscillator. Bits SCS and RCS are set to zero.

Workaround:

Consider the conditions to get a defined clock configuration at power-on.

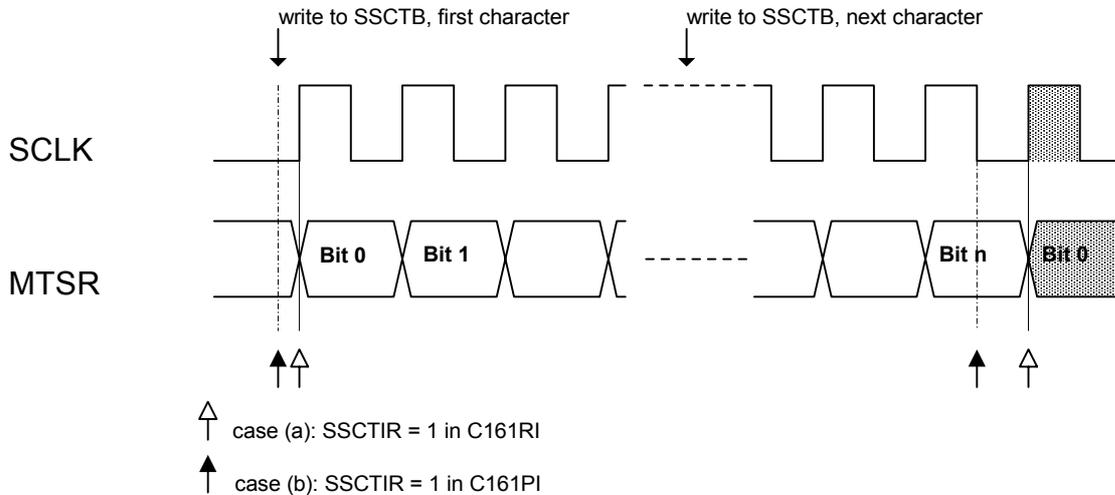
- in the **C161RI**, flag SSCTIR is set to '1' synchronous to the shift clock SCLK 1/2 bit time before the first latching edge (= first shifting clock edge when SSCPH = 0). When SSCTB is written while the shift register is empty, the maximum delay between the time SSCTB has been written and flag SSCTIR=1 is up to 1/2 bit time.
- in the **C161PI**, when SSCTB has been written while the transmit shift register was empty (and the SSC is enabled), flag SSCTIR is set to '1' directly after completion of the write operation, independent of the selected baud rate. When the transmit shift register is not empty when SSCTB was written, SSCTIR is set to '1' after the last latching edge of SCLK (= 1/2 bit time before the first shifting edge of the next character). See also e.g. C167CR User's Manual V3.1, p. 12-5.

Typically, in interrupt driven systems, no problems are expected from the modified timing of flag SSCTIR. However, when flag SSCTIR is polled by software in combination with other flags which are set/cleared at the end or at the beginning of a transfer (e.g. SSCBSY), the modified timing may have an effect.

Another situation where a different system behaviour may be noticed is the case when only one character is transferred by the PEC into the transmit buffer register SSCTB. In this case, 2 interrupt requests from SSCTIR are expected: the 'PEC COUNT = 0' interrupt, and the 'SSCTB empty' interrupt.
