Errata Sheet

August 8, 2003 / Release 1.0

Device: SAB-C161PI-LM, -L25M
SAF-C161PI-LM, -L25M
SAB-C161PI-LM3V
SAF-C161PI-LM3V

Stepping Code / Marking: ES-CA, CA

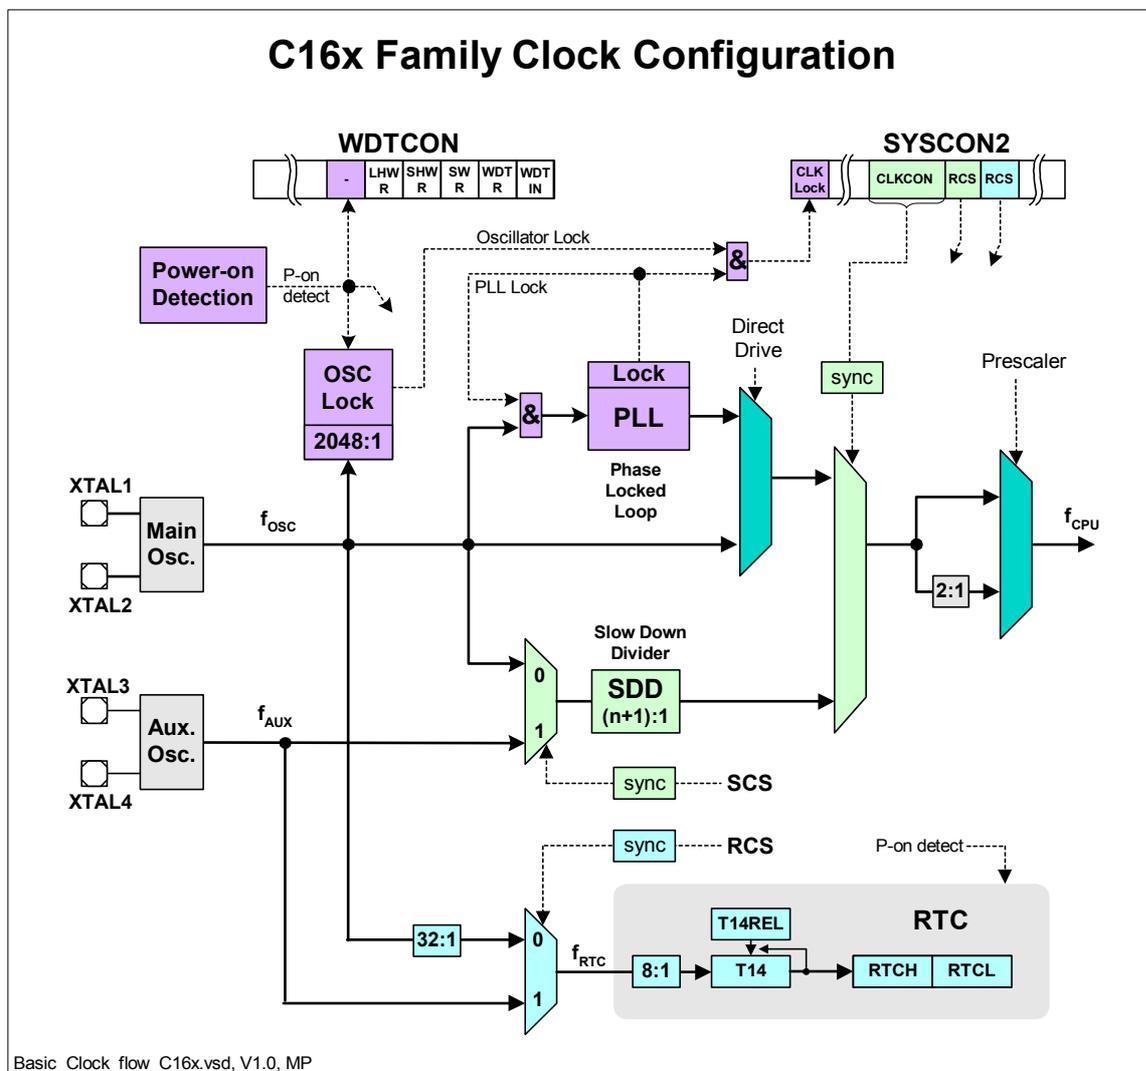
Case 3: Clock @ XTAL1 and Power-on Detection FAIL

When the power-on detection fails during power-on because of not considering the necessary conditions, the register bit CLKLOCK and the RTC registers are undefined. Further the oscillator lock signal is not set.

When the system is running in direct drive or PLL clock mode, it is possible to switch the clock path to SDD mode via software. But it is NOT possible to switch back to the clock path of direct drive or PLL clock mode (basic clock) because the switch back mechanism will wait for the oscillator lock signal.

Case 4: NO Clock @ XTAL1 and Power-on Detection FAIL

If the system gets no clock at XTAL1 during power-on and the power-on detection fails then the following settings can be found:

- The real time clock registers are undefined (T14, T14REL, RTCH, RTCL).
- The slow down divider (SDD) may be selected as f_{CPU} clock source (no oscillator watchdog function possible). In that case the system will stop.

Workarounds:

- Consider the conditions to get a defined clock configuration at power-on
- In systems where direct drive or prescaler mode is used it is possible to set the SDD to factor one or two and to stay in SDD mode (no oscillator watchdog function possible).

Workaround:

Consider the conditions to get a defined clock configuration at power-on.

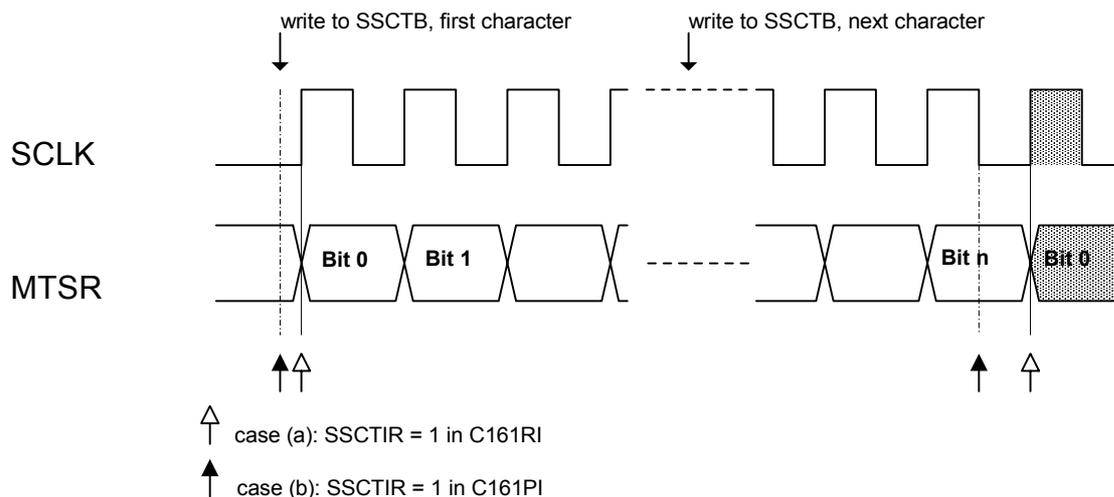
- in the **C161RI**, flag SSCTIR is set to '1' synchronous to the shift clock SCLK 1/2 bit time before the first latching edge (= first shifting clock edge when SSCPH = 0). When SSCTB is written while the shift register is empty, the maximum delay between the time SSCTB has been written and flag SSCTIR=1 is up to 1/2 bit time.
- in the **C161PI**, when SSCTB has been written while the transmit shift register was empty (and the SSC is enabled), flag SSCTIR is set to '1' directly after completion of the write operation, independent of the selected baud rate. When the transmit shift register is not empty when SSCTB was written, SSCTIR is set to '1' after the last latching edge of SCLK (= 1/2 bit time before the first shifting edge of the next character). See also e.g. C167CR User's Manual V3.1, p. 12-5.

The following diagram shows these relations in an example for a data transfer in master mode with SSCPO = 0 and SSCPH = 0. It is assumed that the transmit shift register is empty at the time the first character is written to SSCTB:

Typically, in interrupt driven systems, no problems are expected from the modified timing of flag SSCTIR. However, when flag SSCTIR is polled by software in combination with other flags which are set/cleared at the end or at the beginning of a transfer (e.g. SSCBSY), the modified timing may have an effect.
