Device **C161S-L25M, -LM3V**
Marking/Step **(E)ES-AA, AA**
Package **P-MQFP-80**

This Errata Sheet describes the deviations from the current user documentation. The module oriented classification and numbering system uses an ascending sequence over several derivatives, including already solved deviations. So gaps inside this enumeration can occur.

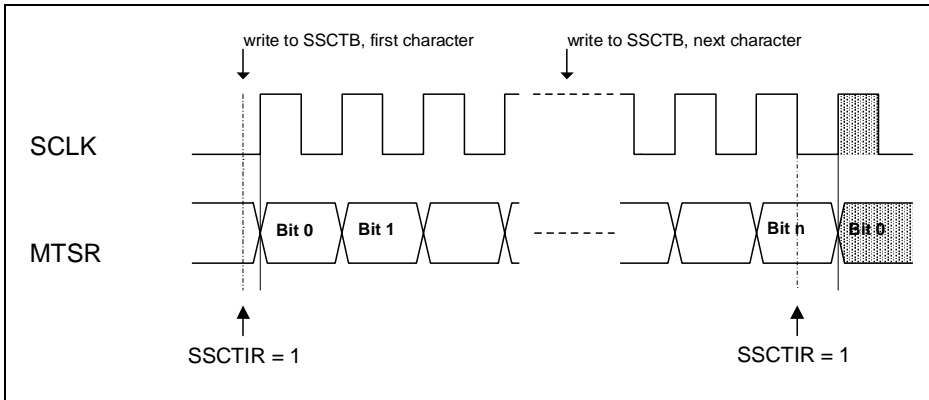
Figure 1 SSCTB Timing

When SSCTB has been written while the transmit shift register was empty (and the SSC is enabled), flag SSCTIR is set to '1' directly after completion of the write operation, independent of the selected baud rate. When the transmit shift register is not empty when SSCTB was written, SSCTIR is set to '1' after the last latching edge of SCLK (= 1/2 bit time before the first shifting edge of the next character). See also e.g. C167CR User's Manual V3.1, p. 12-5.

The following diagram shows these relations in an example for a data transfer in master mode with SSCPO = 0 and SSCPH = 0. It is assumed that the transmit shift register is empty at the time the first character is written to SSCTB:

Typically, in interrupt driven systems, no problems are expected from the modified timing of flag SSCTIR. However, when flag SSCTIR is polled by software in combination with other flags which are set/cleared at the end or at the beginning of a transfer (e.g. SSCBSY), the modified timing may have an effect.
