Device	C164CI-8E
Marking/Step	Step ES-CA, CA
Package	C-MQFP, P-MQFP-80

This Errata Sheet describes the deviations from the current user documentation.

# 1 History List/Change Summary

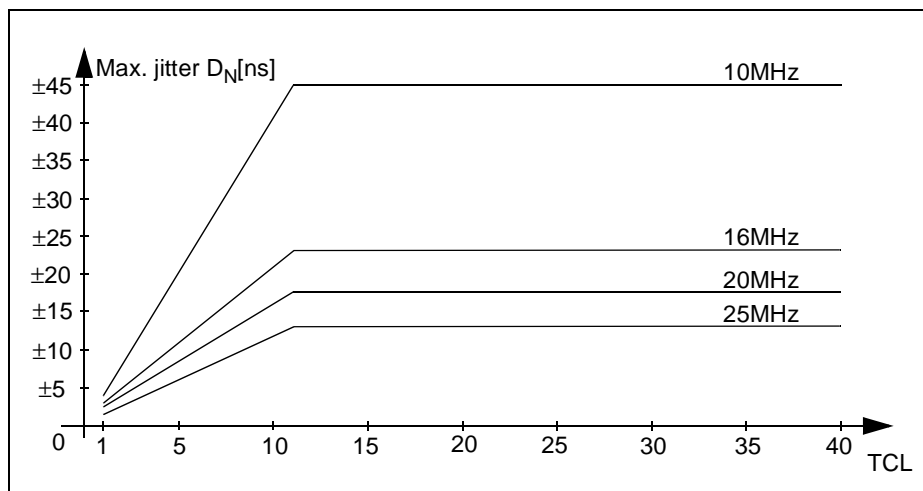
**Figure 1 Additional Jitter**

**PLL.3.1 Increased PLL Jitter caused by external Access****Problem description:**

The value of the additional jitter is not a fixed one but it depends on the kind of activity on the external bus or output pins. The additional jitter increases with the number of output/bus pins which are switched at the same time to a new voltage level because the problem is caused by noise on the on-chip power supply.

This approximated formula is valid for  $1 \leq N \leq 12$  and  $10 \text{ MHz} \leq f_{\text{CPU}} \leq 25 \text{ MHz}$ .

For all accumulated periods longer than 12 TCL the  $N=12$  value can be used; see figure below.

In case that the additional jitter causes problems in the system which cannot be relaxed with software adapted timing parameters, then direct drive or prescaler mode can be used. If the maximum frequency of the on-chip oscillator (16 MHz) is not sufficient then an external clock generator can be used.

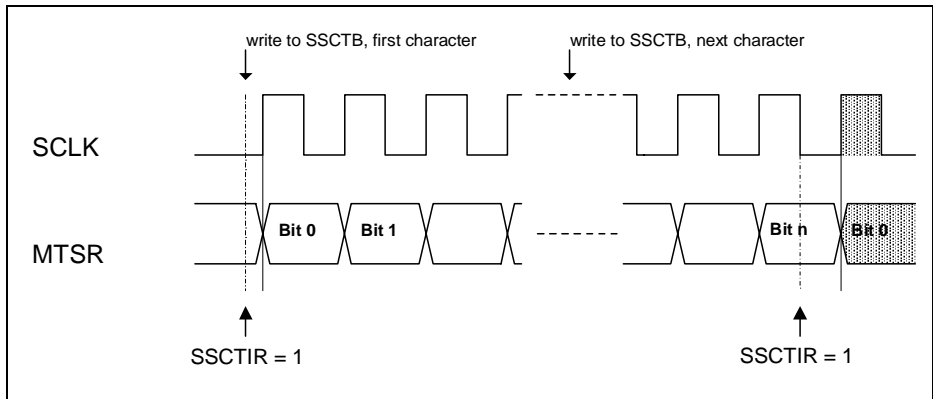
**Figure 2 SSCTB Timing**

When SSCTB has been written while the transmit shift register was empty (and the SSC is enabled), flag SSCTIR is set to '1' directly after completion of the write operation, independent of the selected baud rate. When the transmit shift register is not empty when SSCTB was written, SSCTIR is set to '1' after the last latching edge of SCLK (= 1/2 bit time before the first shifting edge of the next character). See also e.g. C167CR User's Manual V3.1, p. 12-5.

The following diagram shows these relations in an example for a data transfer in master mode with SSCPO = 0 and SSCPH = 0. It is assumed that the transmit shift register is empty at the time the first character is written to SSCTB:

Typically, in interrupt driven systems, no problems are expected from the modified timing of flag SSCTIR. However, when flag SSCTIR is polled by software in combination with other flags which are set/cleared at the end or at the beginning of a transfer (e.g. SSCBSY), the modified timing may have an effect.
