Device **C164CI-8E**
Marking/Step **Step ES-CB, CB**
Package **C-MQFP, P-MQFP-80**

This Errata Sheet describes the deviations from the current user documentation.

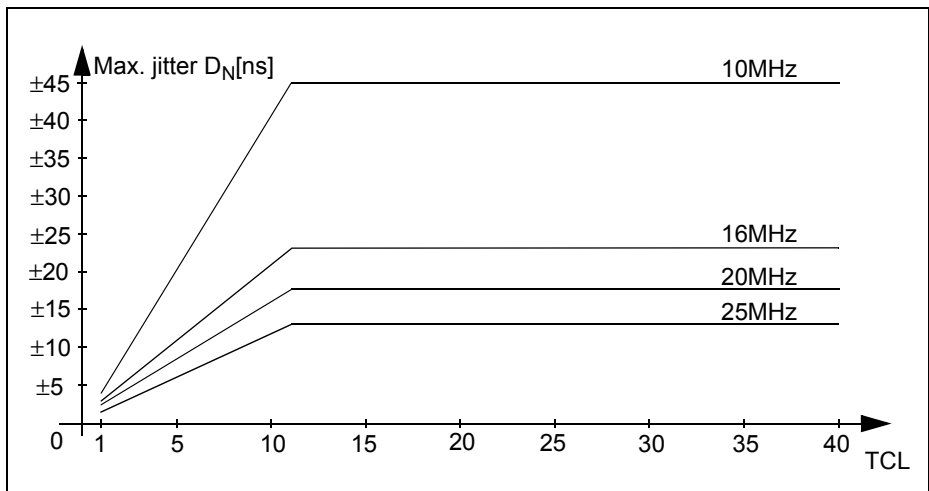
Figure 1 Additional Jitter

The value of the additional jitter is not a fixed one but it depends on the kind of activity on the external bus or output pins. The additional jitter increases with the number of output/bus pins which are switched at the same time to a new voltage level because the problem is caused by noise on the on-chip power supply.

This approximated formula is valid for $1 \leq N \leq 12$ and $10 \text{ MHz} \leq f_{\text{CPU}} \leq 25 \text{ MHz}$.

For all accumulated periods longer than 12 TCL the $N=12$ value can be used; see figure below.

In case that the additional jitter causes problems in the system which cannot be relaxed with software adapted timing parameters, then direct drive or prescaler mode can be used. If the maximum frequency of the on-chip oscillator (16 MHz) is not sufficient then an external clock generator can be used.
