Device **C164CI-8E**
Marking/Step **Step ES-DA, DA**
Package **C-MQFP, P-MQFP-80**

This Errata Sheet describes the deviations from the current user documentation. The module oriented classification and numbering system uses an ascending sequence over several derivatives, including already solved deviations. So gaps inside this enumeration can occur.

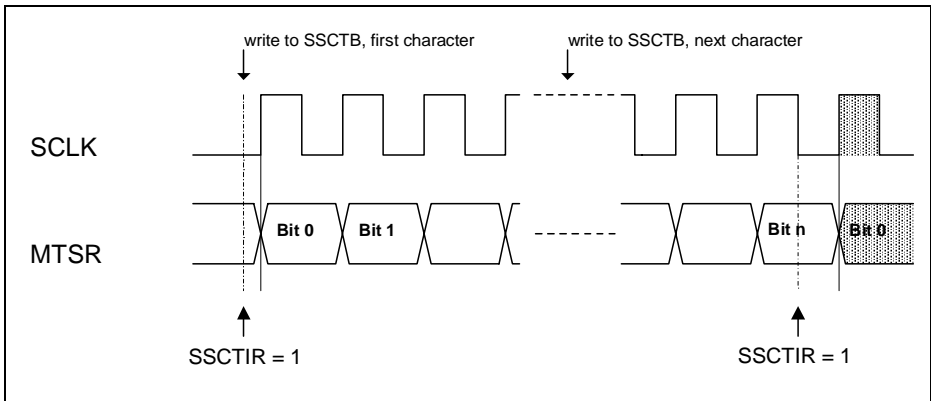
Figure 2 SSCTB Timing

When SSCTB has been written while the transmit shift register was empty (and the SSC is enabled), flag SSCTIR is set to '1' directly after completion of the write operation, independent of the selected baud rate. When the transmit shift register is not empty when SSCTB was written, SSCTIR is set to '1' after the last latching edge of SCLK (= 1/2 bit time before the first shifting edge of the next character). See also e.g. C167CR User's Manual V3.1, p. 12-5.

The following diagram shows these relations in an example for a data transfer in master mode with SSCPO = 0 and SSCPH = 0. It is assumed that the transmit shift register is empty at the time the first character is written to SSCTB:

Typically, in interrupt driven systems, no problems are expected from the modified timing of flag SSCTIR. However, when flag SSCTIR is polled by software in combination with other flags which are set/cleared at the end or at the beginning of a transfer (e.g. SSCBSY), the modified timing may have an effect.

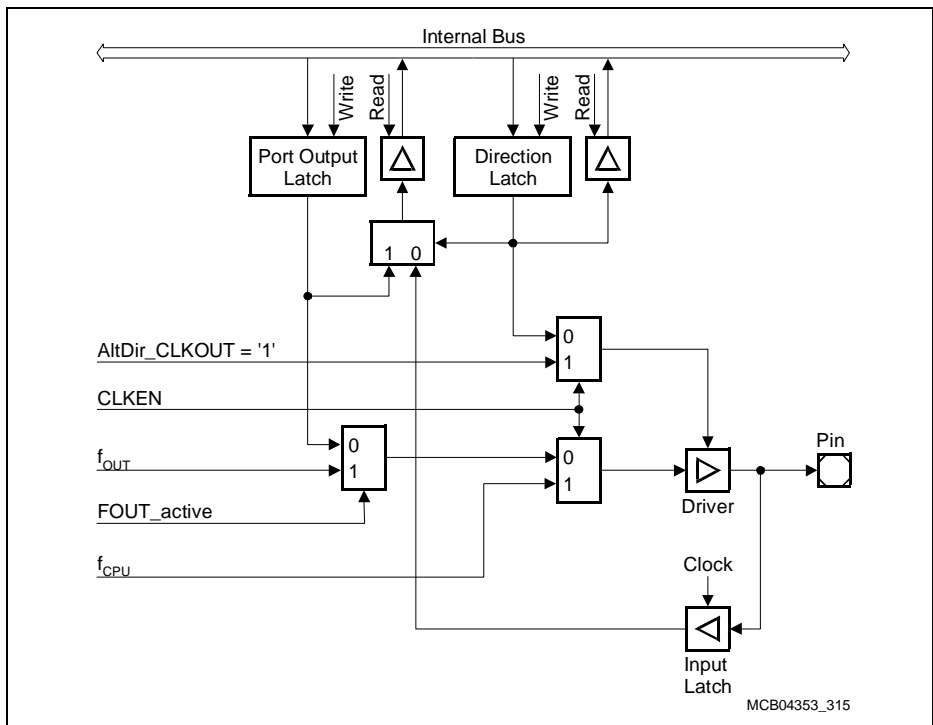
PORT.D3 P3.15 and Frequency Output Signal Path

To enable the frequency output signal f_{OUT} bit CLKEN in register SYSCON must be cleared (before EINIT) and f_{OUT} must be enabled in register FOCON. In contrast to signal CLKOUT the direction latch has to be set by software to enable f_{OUT} .
