Device	C164CI-8E
Marking/Step	Step ES-DB, DB
Package	P-MQFP-80

This Errata Sheet describes the deviations from the current user documentation.

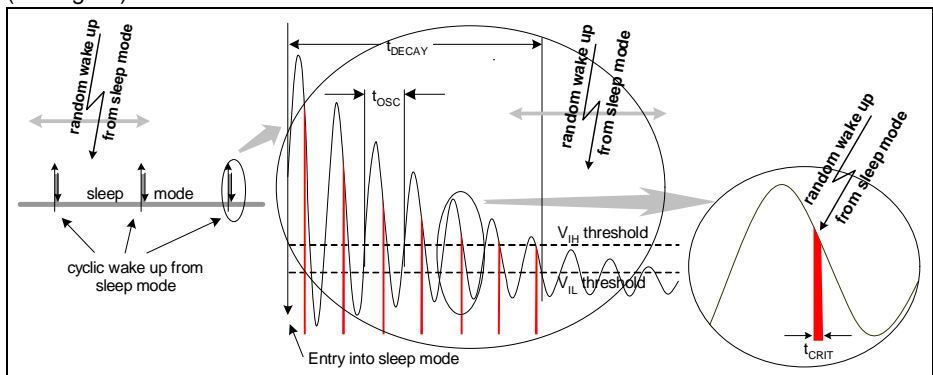
Figure 1 Critical Event

Due to a synchronization problem, the device may not correctly wake up from sleep mode if an asynchronous external wake up trigger occurs already in the oscillator decay time, i.e. in a particular time window before the device has actually entered sleep mode (see figure)

2. the IDLE instruction to enter sleep mode has been executed, i.e. the main oscillator is in the oscillator decay time (typically ~ 160 µs decay time for a 16 MHz crystal, ~ 2 µs for a 16 MHz ceramic resonator)
3. the external wake up trigger signal (fast external interrupt or signal on pin $\overline{\text{NMI}}$) coincides with the critical time window (t_{CRIT}) of each oscillator cycle during the decay time of the clock signal at pin XTAL1 (critical times shown in red in figure)

The problem occurs only in the decay time of the main oscillator and in a very small window around the clock edge at XTAL1 (t_{CRIT} is about 5 ps wide).

- Select RTC on in sleep mode (SYSCON1.SLEEPCON = 01_B).
For devices with auxiliary oscillator (e.g. C161CS), select main oscillator as clock source (SYSCON2.RCS = 0).
- Avoid a wake up during the main oscillator decay time

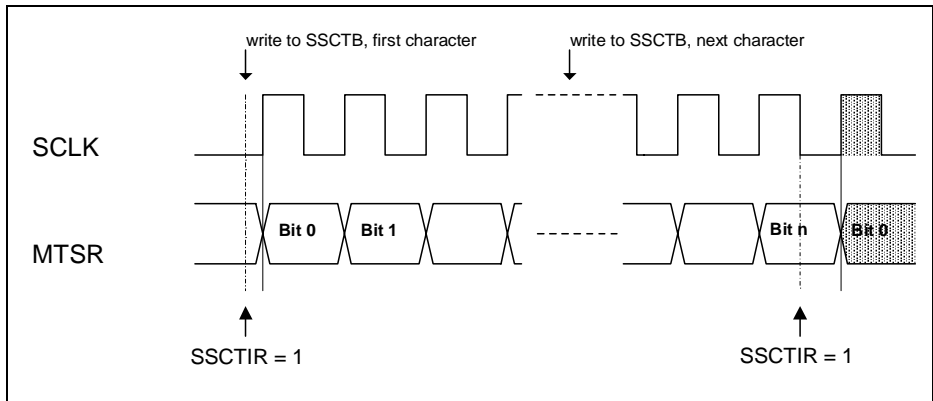
Figure 2 SSCTB Timing

When SSCTB has been written while the transmit shift register was empty (and the SSC is enabled), flag SSCTIR is set to '1' directly after completion of the write operation, independent of the selected baud rate. When the transmit shift register is not empty when SSCTB was written, SSCTIR is set to '1' after the last latching edge of SCLK (= 1/2 bit time before the first shifting edge of the next character). See also e.g. C167CR User's Manual V3.1, p. 12-5.

Typically, in interrupt driven systems, no problems are expected from the modified timing of flag SSCTIR. However, when flag SSCTIR is polled by software in combination with other flags which are set/cleared at the end or at the beginning of a transfer (e.g. SSCBSY), the modified timing may have an effect.

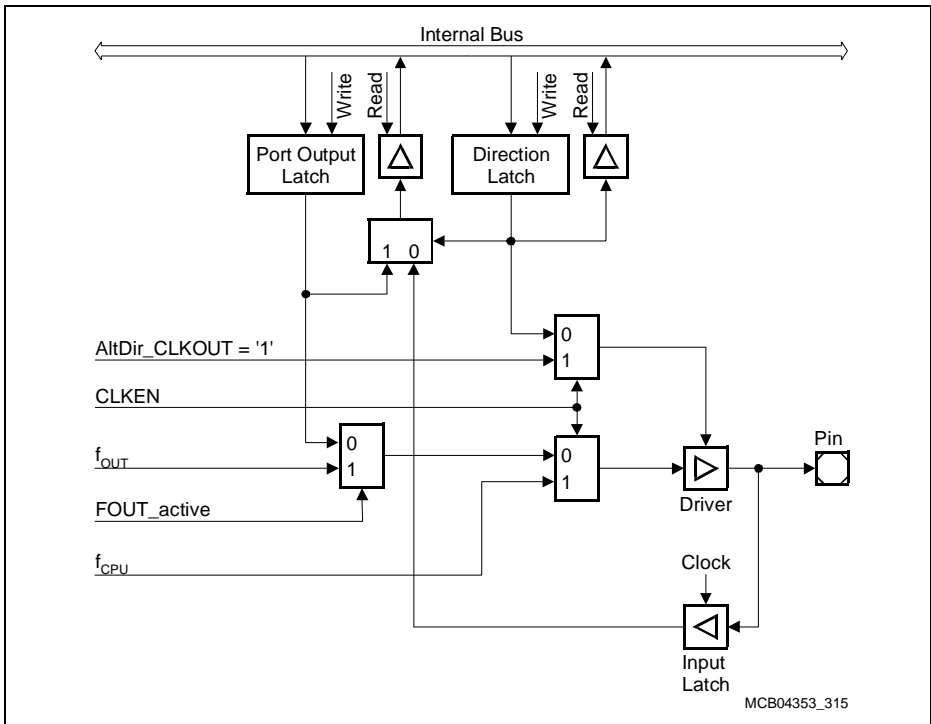
To enable the frequency output signal f_{OUT} bit CLKEN in register SYSCON must be cleared (before EINIT) and f_{OUT} must be enabled in register FOCON. In contrast to signal CLKOUT the direction latch has to be set by software to enable f_{OUT} .
