Device **C164CI-8EM, C164CI-8E25M**
Marking/Step **Step ES-DB, DB**
Package **P-MQFP-80**

This Errata Sheet describes the deviations from the current user documentation.

Current Documentation

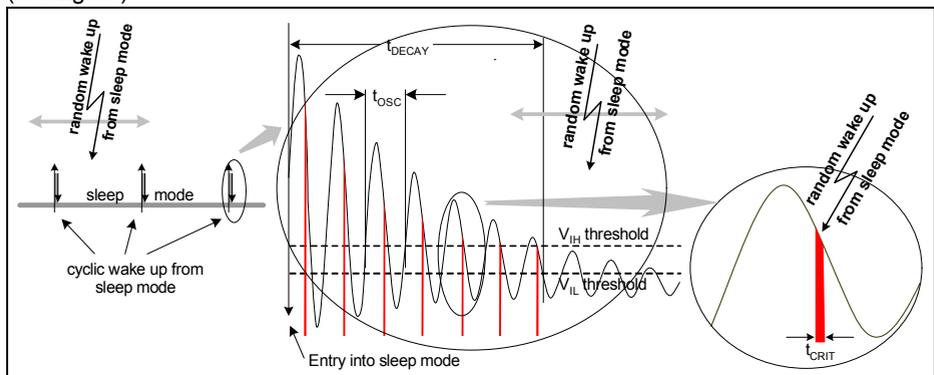
Figure 1 Critical Event

Due to a synchronization problem, the device may not correctly wake up from sleep mode if an asynchronous external wake up trigger occurs already in the oscillator decay time, i.e. in a particular time window before the device has actually entered sleep mode (see figure)

3. the external wake up trigger signal (fast external interrupt or signal on pin $\overline{\text{NMI}}$) coincides with the critical time window (t_{CRIT}) of each oscillator cycle during the decay time of the clock signal at pin XTAL1 (critical times shown in red in figure)

The problem occurs only in the decay time of the main oscillator and in a very small window around the clock edge at XTAL1 (t_{CRIT} is about 5 ps wide).

- Select RTC on in sleep mode (SYSCON1.SLEEPCON = 01_B).
For devices with auxiliary oscillator (e.g. C161CS), select main oscillator as clock source (SYSCON2.RCS = 0).
- Avoid a wake up during the main oscillator decay time

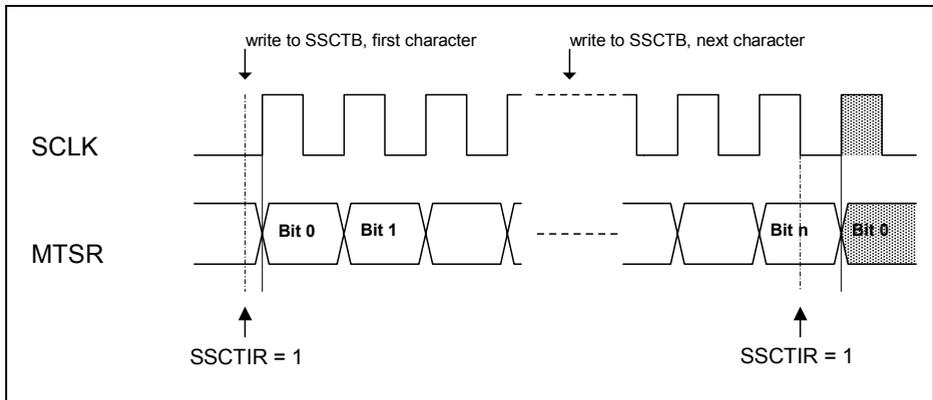
Figure 2 SSCTB Timing

When SSCTB has been written while the transmit shift register was empty (and the SSC is enabled), flag SSCTIR is set to '1' directly after completion of the write operation, independent of the selected baud rate. When the transmit shift register is not empty when SSCTB was written, SSCTIR is set to '1' after the last latching edge of SCLK (= 1/2 bit time before the first shifting edge of the next character). See also e.g. C167CR User's Manual V3.1, p. 12-5.

Typically, in interrupt driven systems, no problems are expected from the modified timing of flag SSCTIR. However, when flag SSCTIR is polled by software in combination with other flags which are set/cleared at the end or at the beginning of a transfer (e.g. SSCBSY), the modified timing may have an effect.

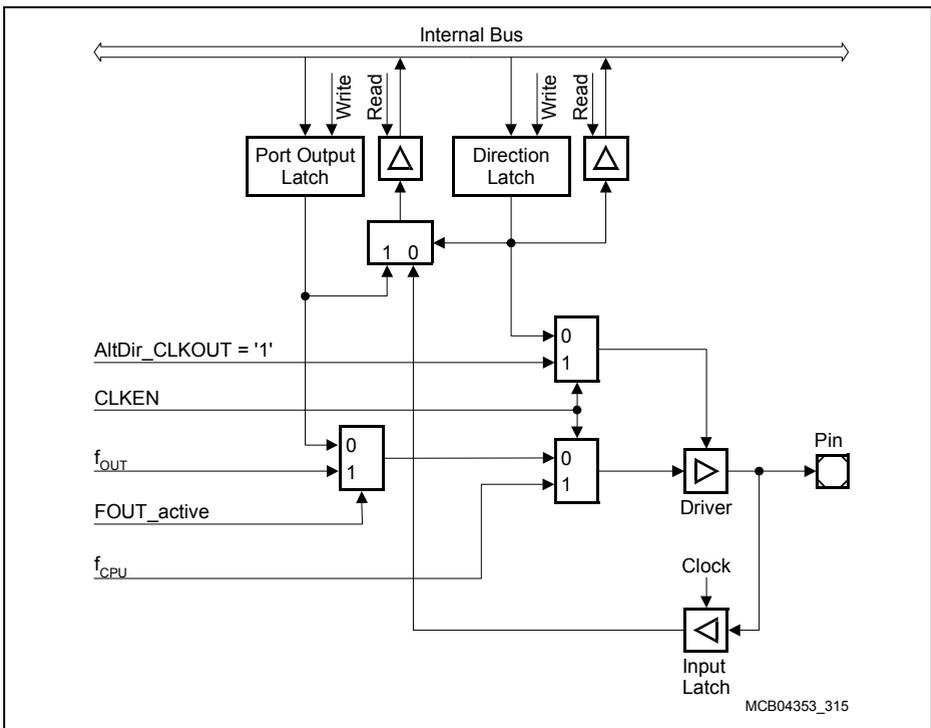
PORT.D3 P3.15 and Frequency Output Signal Path

To enable the frequency output signal f_{OUT} bit CLKEN in register SYSCON must be cleared (before EINIT) and f_{OUT} must be enabled in register FOCON. In contrast to signal CLKOUT the direction latch has to be set by software to enable f_{OUT} .
