<b>Device</b>	<b>C164CI-8R, C164SI-8R, C164CL-8R, C164SL-8R, C164xy-L</b>
<b>Marking/Step</b>	<b>(E)ES-AC, AC</b>
<b>Package</b>	<b>P-MQFP-80-1 (C-MQFP-80: EES-AC only)</b>

This Errata Sheet describes the deviations from the current user documentation. The module oriented classification and numbering system uses an ascending sequence over several derivatives, including already solved deviations. So gaps inside this enumeration can occur.

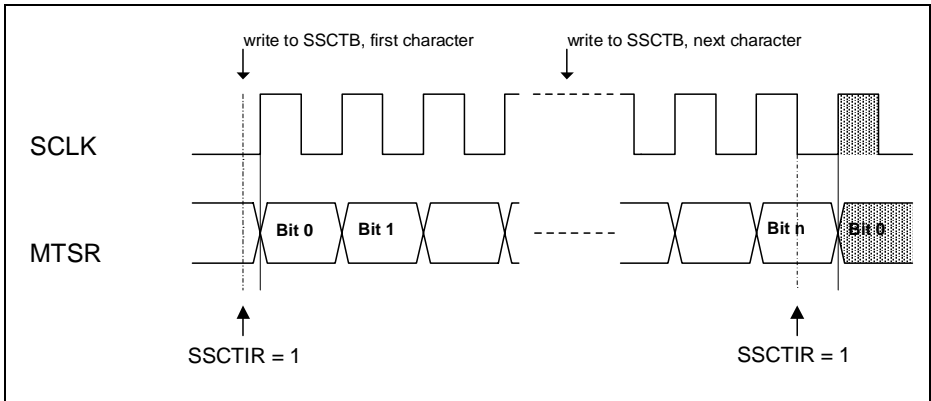
**Figure 1 SSCTB Timing**

When SSCTB has been written while the transmit shift register was empty (and the SSC is enabled), flag SSCTIR is set to '1' directly after completion of the write operation, independent of the selected baud rate. When the transmit shift register is not empty when SSCTB was written, SSCTIR is set to '1' after the last latching edge of SCLK (= 1/2 bit time before the first shifting edge of the next character). See also e.g. C167CR User's Manual V3.1, p. 12-5.

The following diagram shows these relations in an example for a data transfer in master mode with SSCPO = 0 and SSCPH = 0. It is assumed that the transmit shift register is empty at the time the first character is written to SSCTB:

Typically, in interrupt driven systems, no problems are expected from the modified timing of flag SSCTIR. However, when flag SSCTIR is polled by software in combination with other flags which are set/cleared at the end or at the beginning of a transfer (e.g. SSCBSY), the modified timing may have an effect.
