Device	C164CI-8R, C164SI-8R, C164CL-8R, C164SL-8R, C164xy-L
Marking/Step	(E)ES-CA, CA, CA+
Package	P-MQFP-80

This Errata Sheet describes the deviations from the current user documentation.

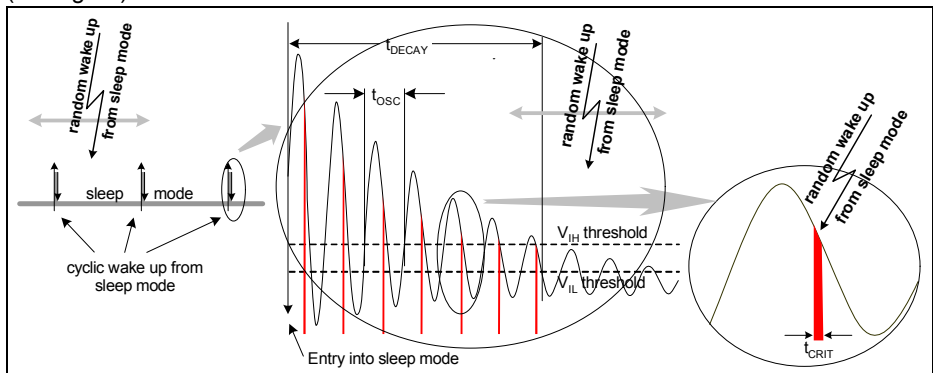
Figure 1 Critical Event

Due to a synchronization problem, the device may not correctly wake up from sleep mode if an asynchronous external wake up trigger occurs already in the oscillator decay time, i.e. in a particular time window before the device has actually entered sleep mode (see figure)

3. the external wake up trigger signal (fast external interrupt or signal on pin $\overline{\text{NMI}}$) coincides with the critical time window (t_{CRIT}) of each oscillator cycle during the decay time of the clock signal at pin XTAL1 (critical times shown in red in figure)

The problem occurs only in the decay time of the main oscillator and in a very small window around the clock edge at XTAL1 (t_{CRIT} is about 5 ps wide).

- Select RTC on in sleep mode (SYSCON1.SLEEPCON = 01_B).
For devices with auxiliary oscillator (e.g. C161CS), select main oscillator as clock source (SYSCON2.RCS = 0).
- Avoid a wake up during the main oscillator decay time

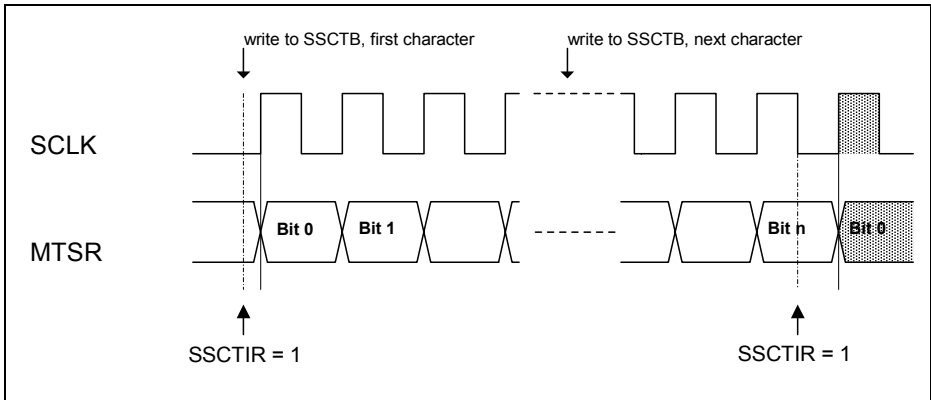
Figure 2 SSCTB Timing

When SSCTB has been written while the transmit shift register was empty (and the SSC is enabled), flag SSCTIR is set to '1' directly after completion of the write operation, independent of the selected baud rate. When the transmit shift register is not empty when SSCTB was written, SSCTIR is set to '1' after the last latching edge of SCLK (= 1/2 bit time before the first shifting edge of the next character). See also e.g. C167CR User's Manual V3.1, p. 12-5.

Typically, in interrupt driven systems, no problems are expected from the modified timing of flag SSCTIR. However, when flag SSCTIR is polled by software in combination with other flags which are set/cleared at the end or at the beginning of a transfer (e.g. SSCBSY), the modified timing may have an effect.
