Errata Sheet

October 16, 2001 / Release 1.5

Device: **SAK-C167CS-LM**
 SAK-C167CS-4RM

Stepping Code / Marking: **ES-AB, AB**

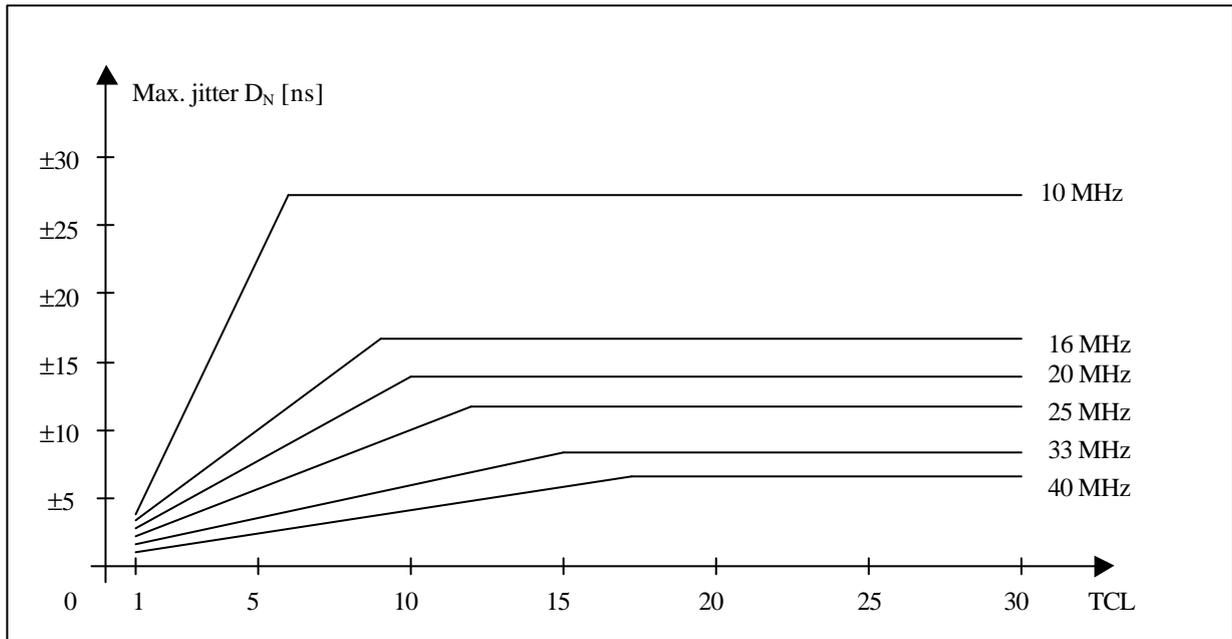
PLL.3.4: Increased PLL Jitter caused by external Access

The value of the additional jitter is not a fixed one but it depends on the kind of activity on the external bus or output pins. The additional jitter increases with the number of output/bus pins which are switched at the same time to a new voltage level because the problem is caused by noise on the on-chip power supply.

Were N = number of consecutive TCL, f_{CPU} = CPU frequency in MHz and $T_m = f_{\text{CPU}} * 0.35 + 2.5$. This approximated formula is valid for a CPU frequency $10 \text{ MHz} \leq f_{\text{CPU}} \leq 40 \text{ MHz}$ with the conditions:

$$T_m = f_{\text{CPU}} * 0.35 + 2.5 \quad \text{for } N \leq T_m$$

$$T_m = N \quad \text{for } N > T_m$$

Workaround:

In the case that the additional jitter causes problems in the system which cannot be relaxed with software adapted timing parameters the following workarounds are possible:
