# Errata Sheet

July 7, 2003 / Release 1.2

<b>Device:</b>	<b>SAK-C167CS-LM SAK-C167CS-L33M SAK-C167CS-L40M SAK-C167CS-4RM SAK-C167CS-4R33M SAK-C167CS-4R40M</b>
<b>Stepping Code / Marking:</b>	<b>ES-BA, BA, BA 6</b>
<b>Package:</b>	<b>P-MQFP-144-1, P-MQFP-144-6 (BA 6)</b>

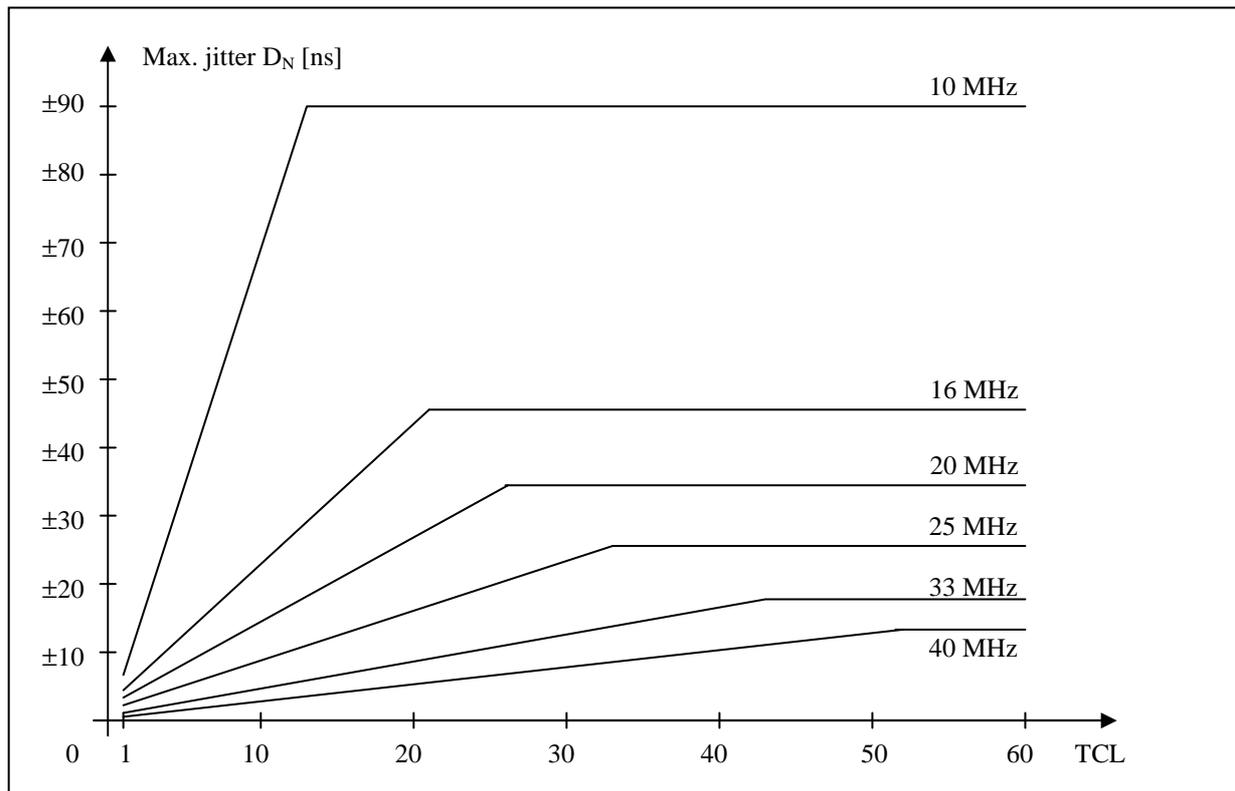
### PLL.3.3: Increased PLL Jitter caused by external Access

The value of the additional jitter is not a fixed one but it depends on the kind of activity on the external bus or output pins. The additional jitter increases with the number of output/bus pins which are switched at the same time to a new voltage level because the problem is caused by noise on the on-chip power supply.

This approximated formula is valid for a CPU frequency  $10 \text{ MHz} \leq f_{\text{CPU}} \leq 40 \text{ MHz}$  with the conditions:

$$\begin{aligned} T_m &= f_{\text{CPU}} * 1.3 && \text{for } N \leq T_m \\ T_m &= N && \text{for } N > T_m \end{aligned}$$

### Workaround:

In the case that the additional jitter causes problems in the system which cannot be relaxed with software adapted timing parameters the following workarounds are possible:
