Errata Sheet

March 31, 2003 / Release 1.3

Device:	SAK-C167CR-L(33)M, SAF-C167CR-L(33)M, SAB-C167CR-L(33)M SAK-C167CR-4R(33)M, SAF-C167CR-4R(33)M, SAB-C167CR-4R(33)M SAK-C167CR-16R(33)M, SAF-C167CR-16R(33)M, SAB-C167CR-16R(33)M SAK-C167SR-L(33)M
Stepping Code / Marking:	ES-GA, GA, GA-T, GA-T 6 ES-JA
Package:	P-MQFP-144-1, P-MQFP-144-6 (GA-T 6)

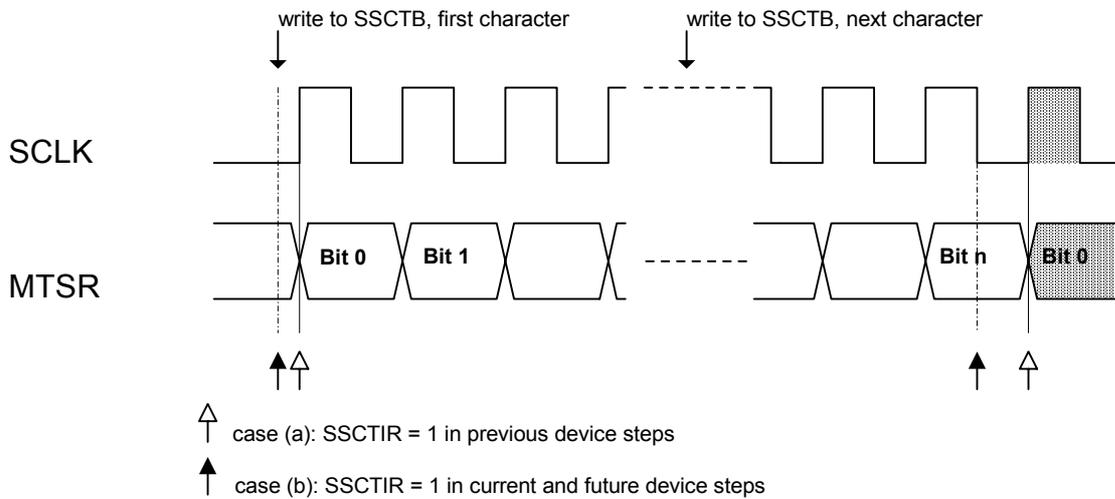
- before step **FA**, flag SSCTIR is set to '1' synchronous to the shift clock SCLK 1/2 bit time before the first latching edge (= first shifting clock edge when SSCPH = 0). When SSCTB is written while the shift register is empty, the maximum delay between the time SSCTB has been written and flag SSCTIR=1 is up to 1/2 bit time.
- beginning with step **FA**, when SSCTB has been written while the transmit shift register was empty (and the SSC is enabled), flag SSCTIR is set to '1' directly after completion of the write operation, independent of the selected baud rate. When the transmit shift register is not empty when SSCTB was written, SSCTIR is set to '1' after the last latching edge of SCLK (= 1/2 bit time before the first shifting edge of the next character). See also e.g. C167CR User's Manual V3.1, p. 12-5.

The following diagram shows these relations in an example for a data transfer in master mode with SSCPO = 0 and SSCPH = 0. It is assumed that the transmit shift register is empty at the time the first character is written to SSCTB:

Typically, in interrupt driven systems, no problems are expected from the modified timing of flag SSCTIR. However, when flag SSCTIR is polled by software in combination with other flags which are set/cleared at the end or at the beginning of a transfer (e.g. SSCBSY), the modified timing may have an effect.
