Device TC36x
Marking/Step (E)ES-AA, AA
Package see Data Sheet

10298AERRA

This Errata Sheet describes the deviations from the current user documentation.

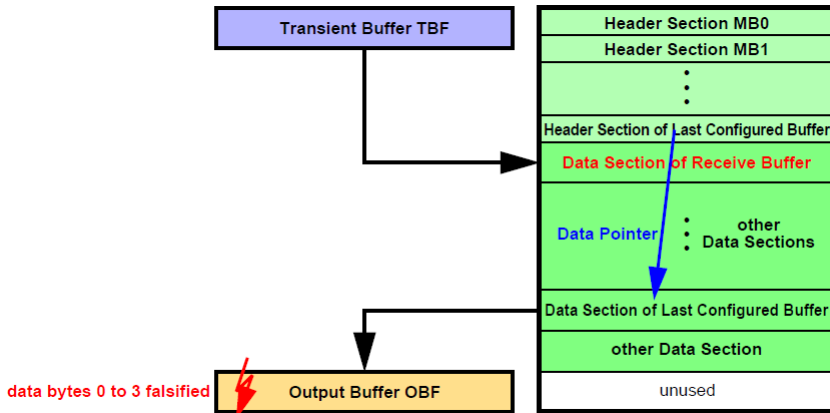
Figure 2 Message buffer transfer from Message RAM to OBF

When the message buffer has its payload configured to maximum length (**PLC** = 127), the OBF word on address 00h (payload data bytes 0 to 3) is overwritten with unexpected data at the end of the transfer.

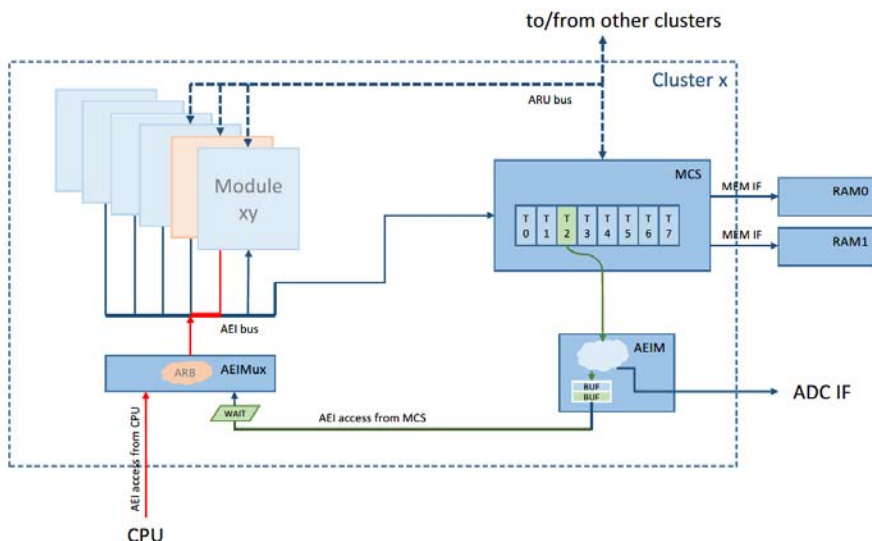
Figure 6 MCS AEI master access path

Figure 6 shows an uncritical traffic situation. Here an access of a MCS thread to the AEI bus (green access path) is temporary delayed due to an ongoing AEI bus access from the CPU (red access path). The MCS access to the AEI bus will be safely buffered at the AEIM (green buffer). As soon as the CPU access to the AEI bus completes, the buffered AEI bus access from MCS will be executed.

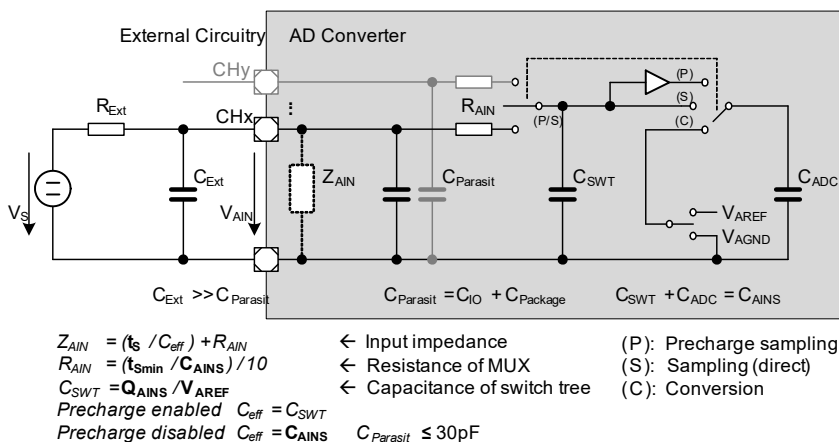
Figure 9 Equivalent Circuitry for Analog Inputs

Figure “Equivalent Circuitry for Analog Inputs” will be modified in future revisions of the Data Sheet, including the term $C_{Parasit} \leq 30 \text{ pF}$, as shown in the following figure:

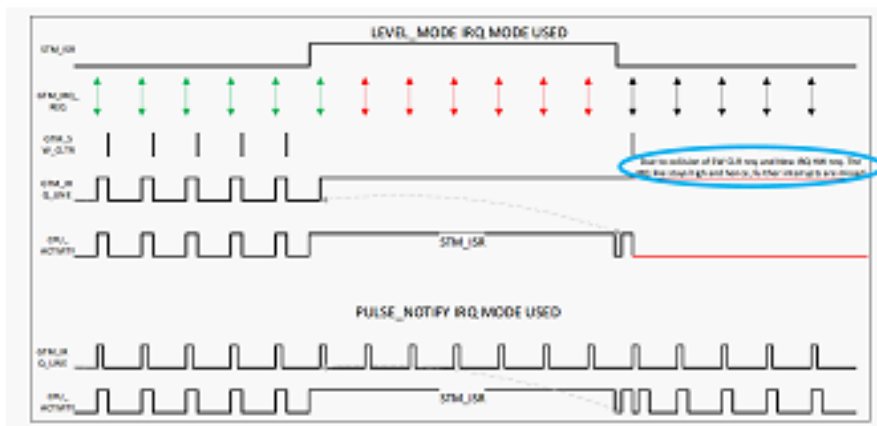
Figure 10 Interrupt Level vs. Pulse-Notify mode - Corner Case Example

Hence, in Level Mode, in some scenarios where another interrupt request is generated by GTM while the ISR handle also requests a SW clear, then, as the interrupt event is dominant over the clear event (for simultaneous interrupt and clear events), GTM_IRQ_XXX is not cleared and remains high. As a consequence, the IR observes no transition on GTM_IRQ_XX. Thus, any forthcoming interrupt events in this scenario are lost as there is no chance to release the CPU IRQ when a collision happens as shown in Figure below.

If Pulse-Notify mode is selected, every internal trigger will be forwarded to the IR, irrespective of the time of occurrence and the clear event, as the pulse-notify leads to set and reset of GTM_IRQ_XXX as compared to only setting of the GTM_IRQ_XXX line in Level mode.

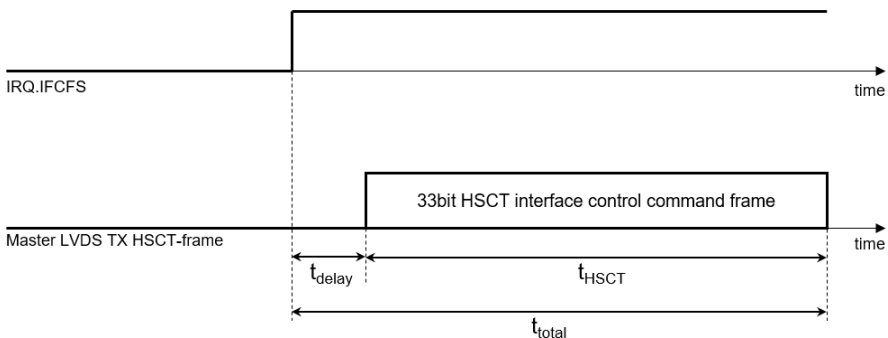
Figure 12 Timing of LVDS TX interface command sending in relation to IRQ.IFCFS

the user might falsely assume that also the actual sending on the LVDS TX port has already occurred once the IRQ.IFCFS flag is set, which is not true.

Instead the timing shown in **Figure 12** applies.
