# AURIX™ TC36x errata sheet

Marking/Step: (E)ES-AA, AA

## About this document

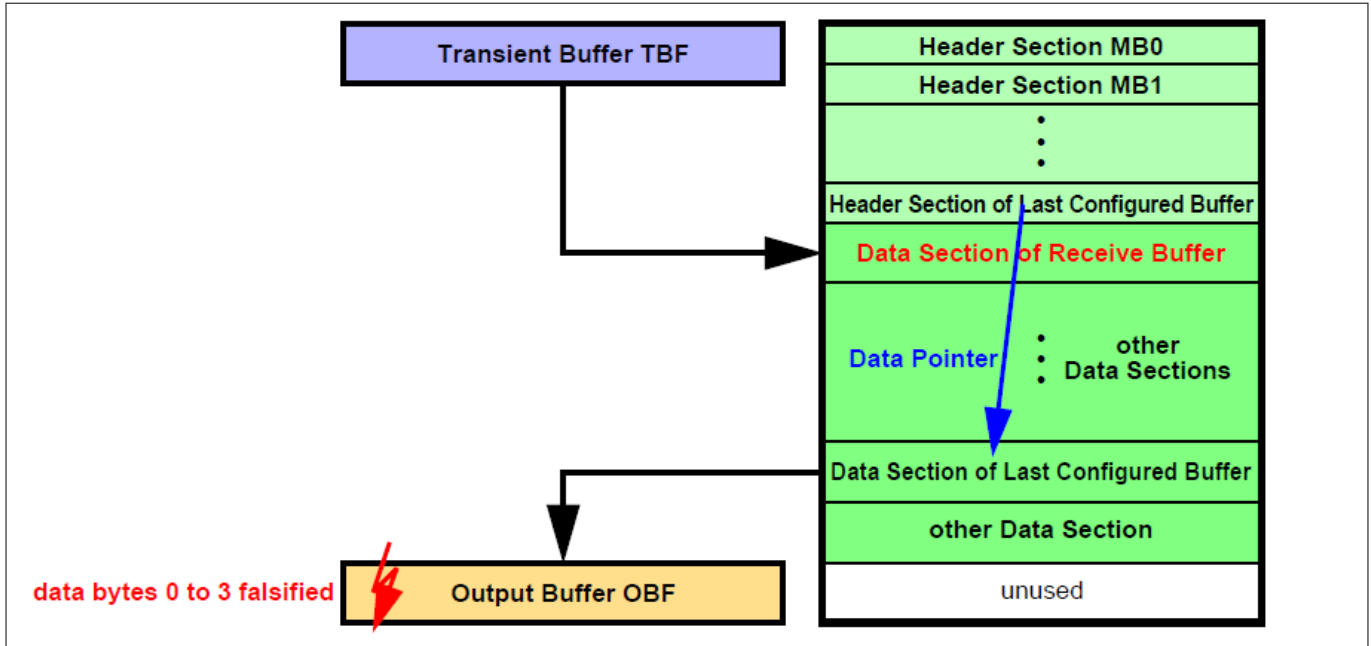
**Figure 1** Message buffer transfer from Message RAM to OBF

When the message buffer has its payload configured to maximum length (`PLC = 127`), the OBF word on address `00h` (payload data bytes 0 to 3) is overwritten with unexpected data at the end of the transfer.

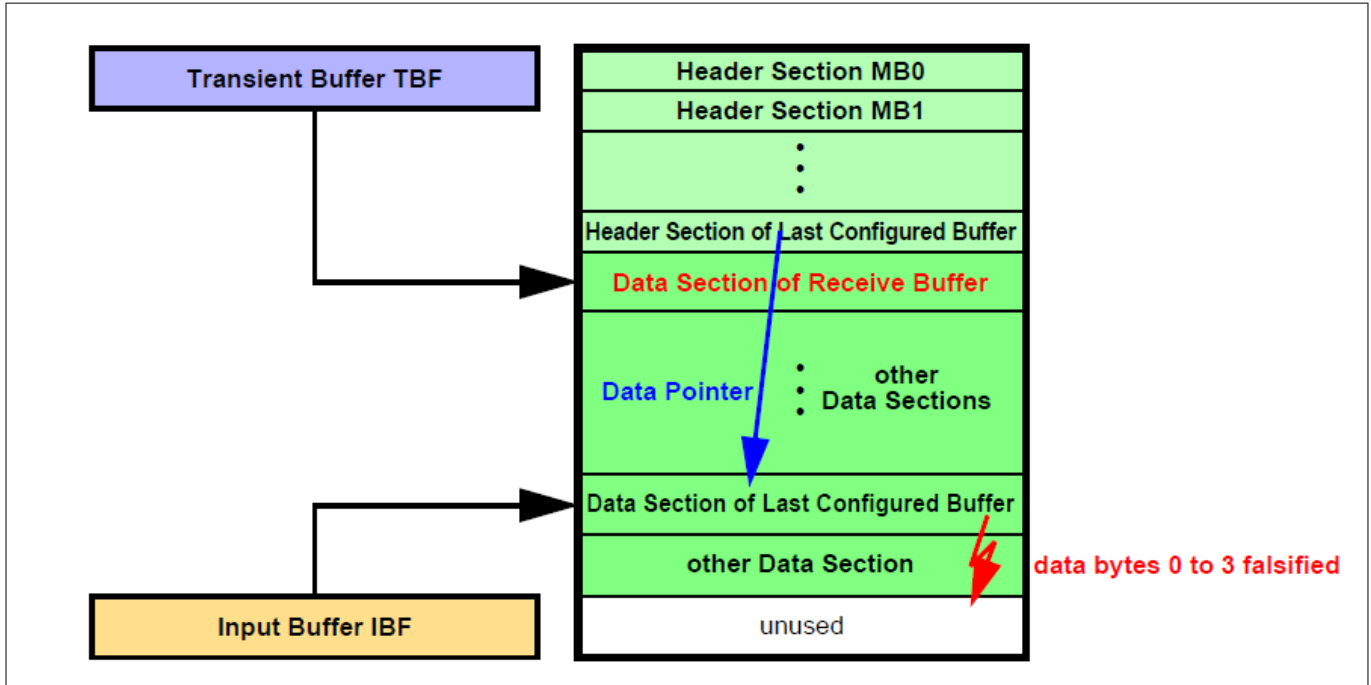
**Figure 2** Message buffer transfer from IBF to Message RAM

After the Data Section of the selected message buffer in the Message RAM has been written, one additional write access overwrites the following word in the Message RAM which might be the first word of the next Data Section.

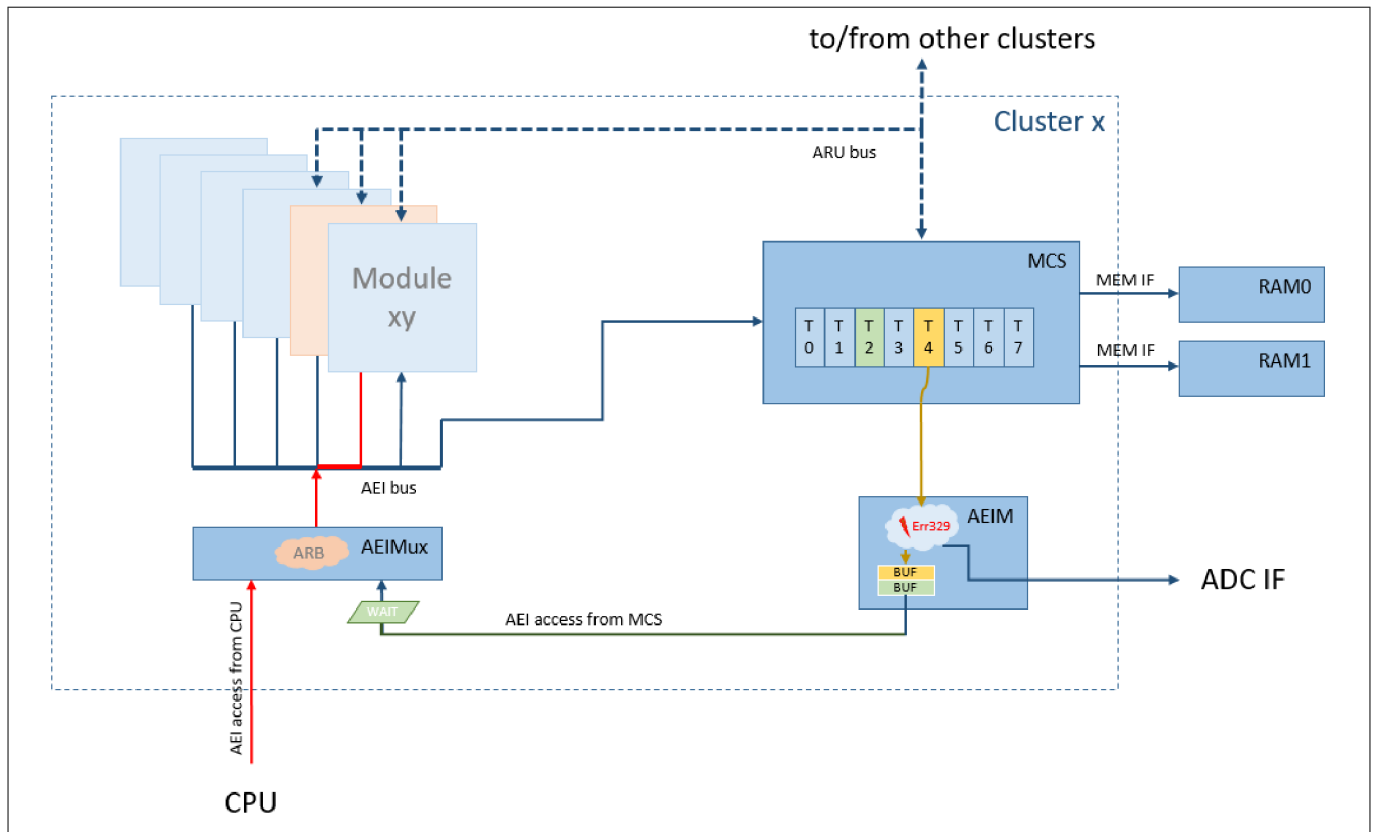
**Figure 6 Critical MCS AEI master scenario**

In [Figure 6](#), a potential risk for the occurrence of problem GTM\_AI.329 is illustrated. Here the first buffer of the AEIM (green) is still waiting for the access to the AEI bus while a second AEI bus access from MCS arrives at the AEIM (yellow access path). Under certain, but for the user unpredictable timing conditions, this second AEI bus access arriving at the AEIM can trigger the misbehavior described in problem GTM\_AI.329.

The workarounds described in the 'Workaround' section will ensure that not more than one AEIM buffer will be filled and therefore the occurrence of problem GTM\_AI.329 is avoided. All workarounds have been tested and proven correct.

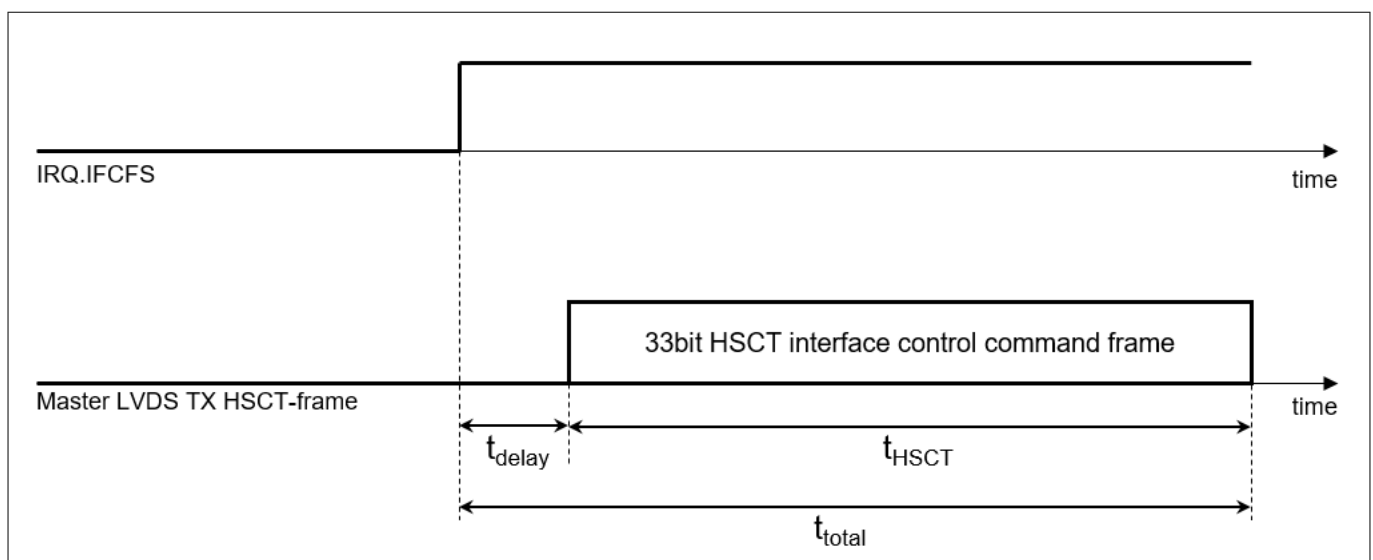
**Figure 13 Timing of LVDS TX interface command sending in relation to IRQ.IFCFS**

the user might falsely assume that also the actual sending on the LVDS TX port has already occurred once the IRQ.IFCFS flag is set, which is not true.

Instead the timing shown in the following figure applies.

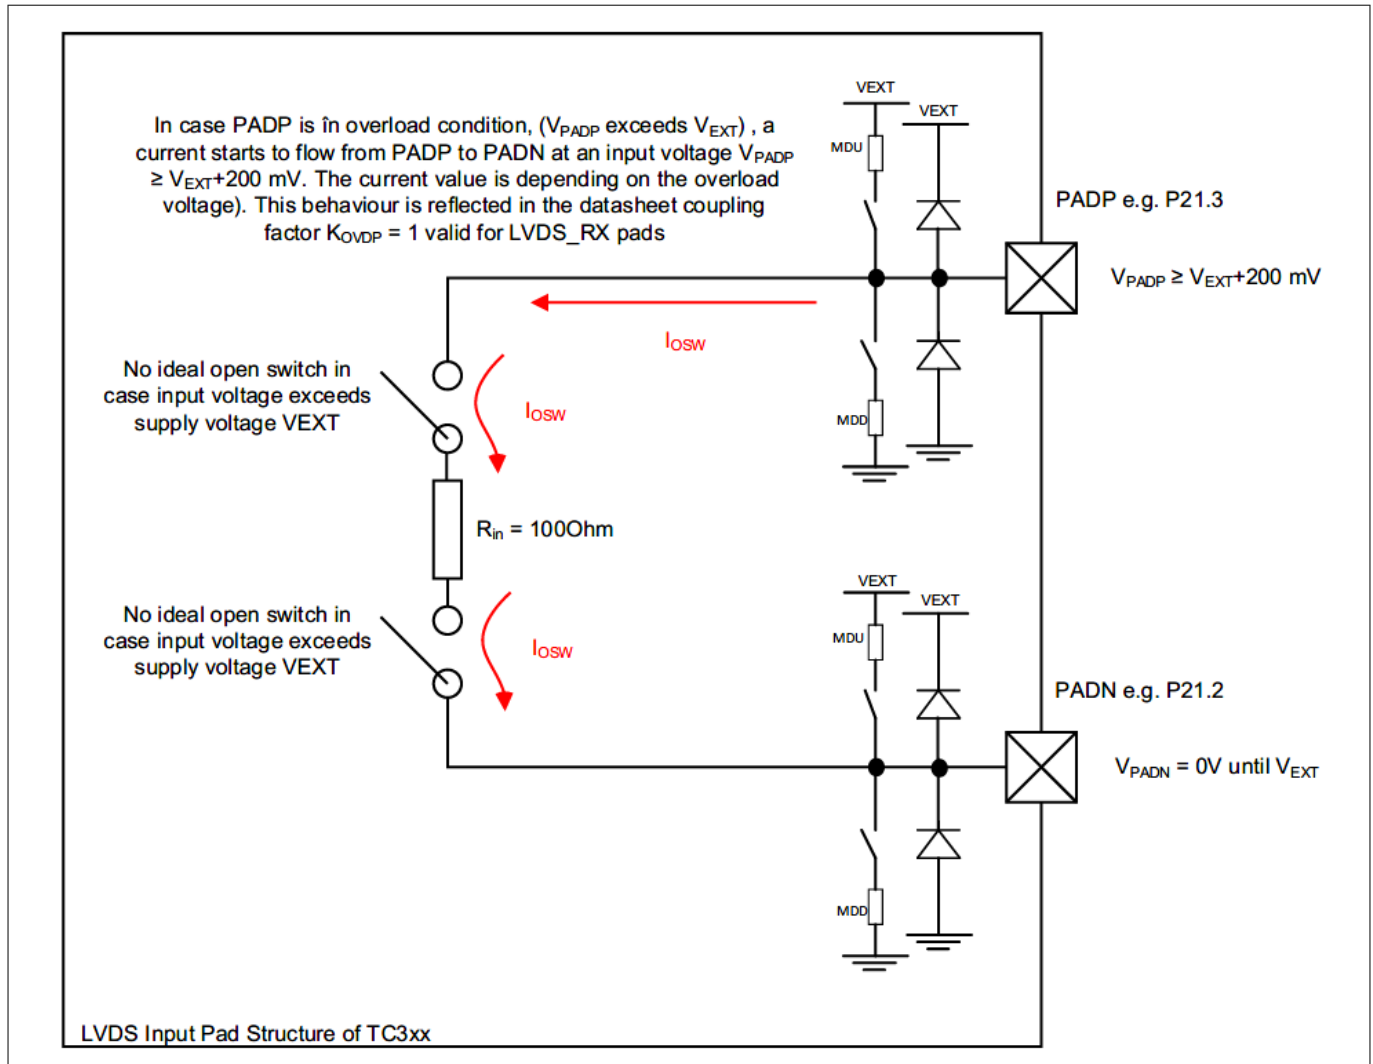
Figure 17 Positive overload on P-pad of a LVDS RX pin pair (both used as inputs)

The overload current  $I_{OSW}$  through the non-ideal open switch significantly increases when  $V_{PADP} \geq V_{EXT} + 200 \text{ mV}$ .

**Note:** In general, the effect will also occur if the N-pad is used as output, or for a negative overload condition on either the P-pad or the N-pad.
