Device TC37xEXT
Marking/Step (E)ES-AB, AB
Package see Data Sheet

10297AERRA

This Errata Sheet describes the deviations from the current user documentation.

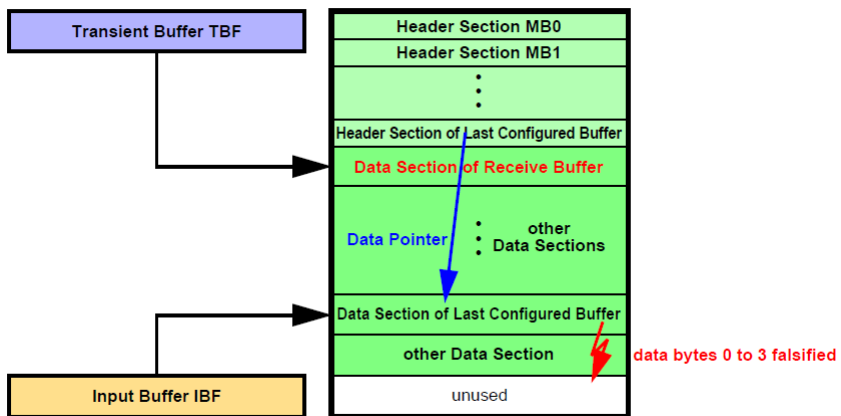
Figure 3 Message buffer transfer from IBF to Message RAM

After the Data Section of the selected message buffer in the Message RAM has been written, one additional write access overwrites the following word in the Message RAM which might be the first word of the next Data Section.

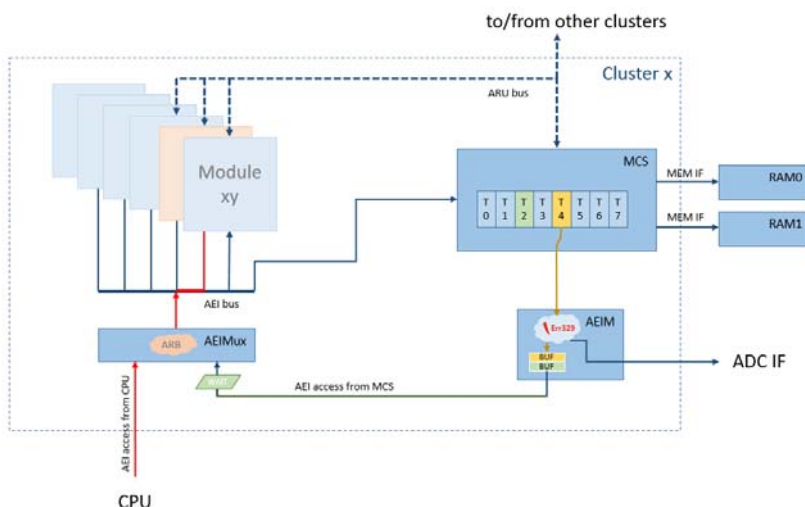
Figure 7 Critical MCS AEI master scenario

In [Figure 7](#), a potential risk for the occurrence of problem GTM_AI.329 is illustrated. Here the first buffer of the AEIM (green) is still waiting for the access to the AEI bus while a second AEI bus access from MCS arrives at the AEIM (yellow access path). Under certain, but for the user unpredictable timing conditions, this second AEI bus access arriving at the AEIM can trigger the misbehavior described in problem GTM_AI.329.

The workarounds described in the following section will ensure that not more than one AEIM buffer will be filled and therefore the occurrence of problem GTM_AI.329 is avoided. All workarounds have been tested and proven correct.

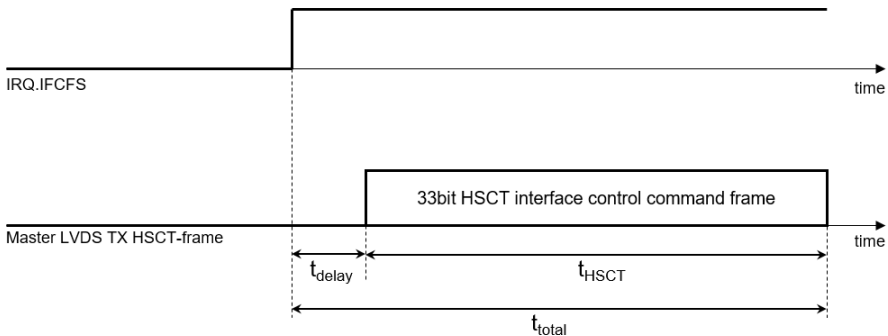
Figure 12 Timing of LVDS TX interface command sending in relation to IRQ.IFCFS

the user might falsely assume that also the actual sending on the LVDS TX port has already occurred once the IRQ.IFCFS flag is set, which is not true.

Instead the timing shown in **Figure 12** applies.

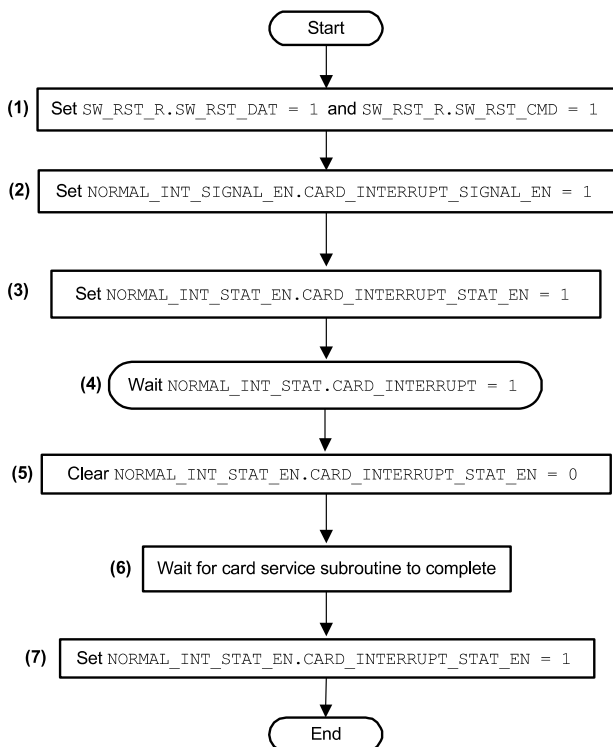
Figure 13 SDIO Card Interrupt Sequence

Figure “SDIO Card Interrupt Sequence” in the SDMMC chapter of the current version of the TC3xx User’s Manual is wrong. The correct sequence is shown in the following **Figure 13**.
