Device TC37x
Marking/Step (E)ES-AA, AA
Package see Data Sheet

10296AERRA

This Errata Sheet describes the deviations from the current user documentation.

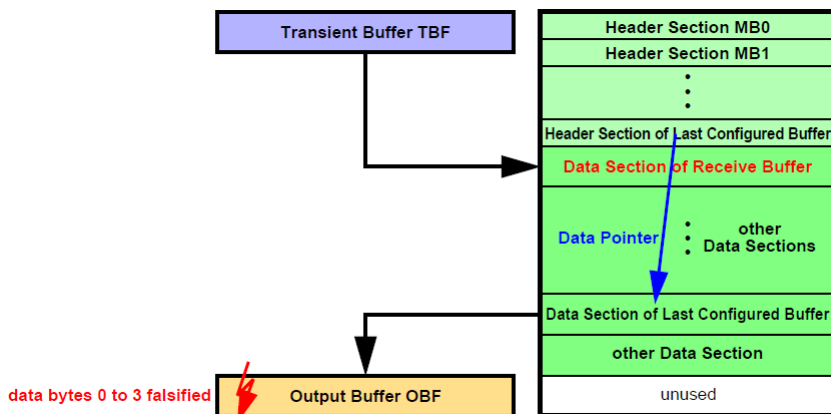
Figure 2 Message buffer transfer from Message RAM to OBF

When the message buffer has its payload configured to maximum length (**PLC** = 127), the OBF word on address 00h (payload data bytes 0 to 3) is overwritten with unexpected data at the end of the transfer.

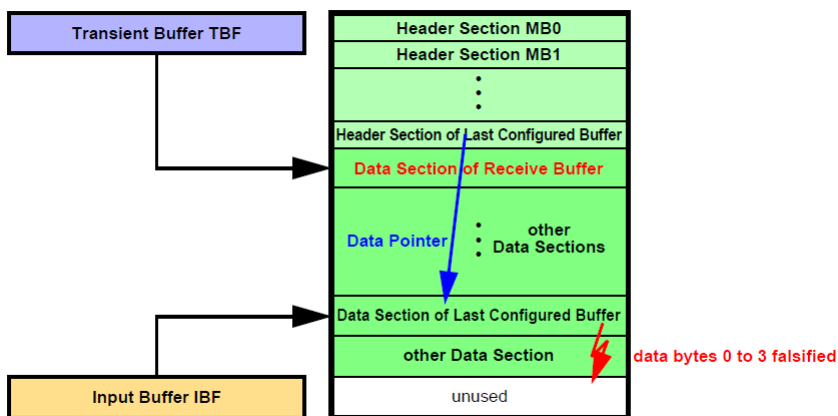
Figure 3 Message buffer transfer from IBF to Message RAM

After the Data Section of the selected message buffer in the Message RAM has been written, one additional write access overwrites the following word in the Message RAM which might be the first word of the next Data Section.

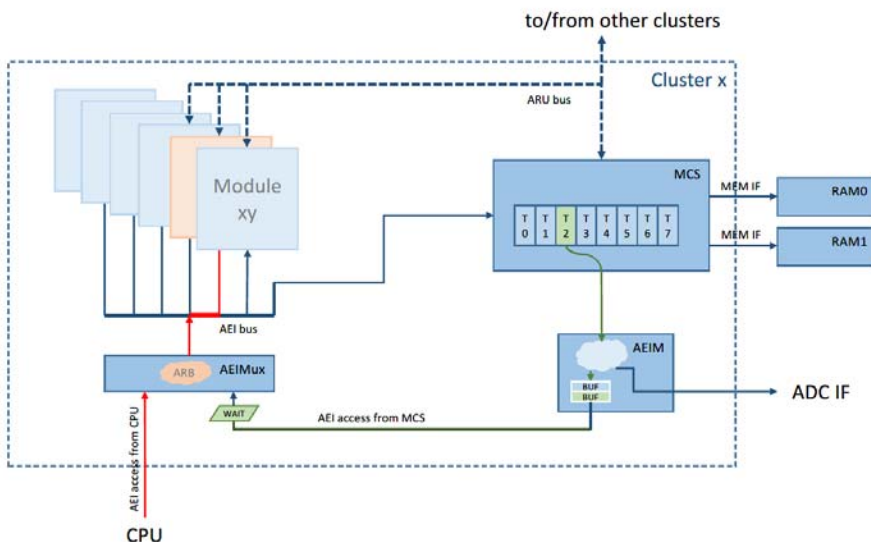
Figure 6 MCS AEI master access path

Figure 6 shows an uncritical traffic situation. Here an access of a MCS thread to the AEI bus (green access path) is temporary delayed due to an ongoing AEI bus access from the CPU (red access path). The MCS access to the AEI bus will be safely buffered at the AEIM (green buffer). As soon as the CPU access to the AEI bus completes, the buffered AEI bus access from MCS will be executed.

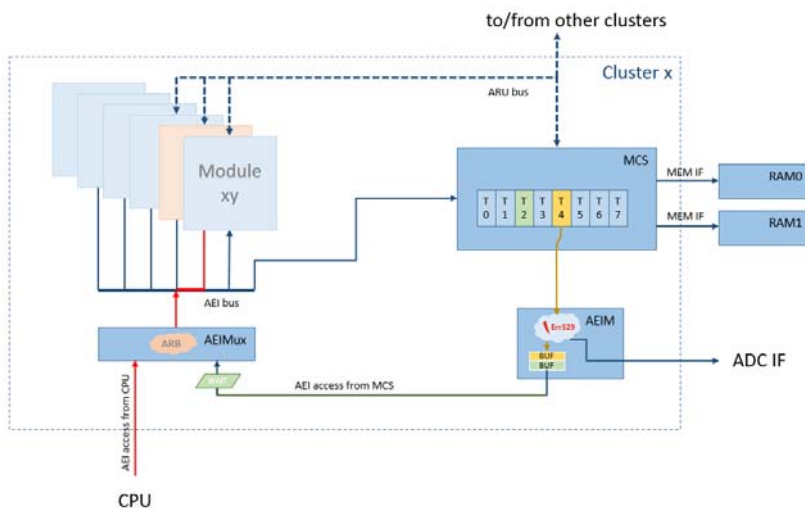
Figure 7 Critical MCS AEI master scenario

In [Figure 7](#), a potential risk for the occurrence of problem GTM_AI.329 is illustrated. Here the first buffer of the AEIM (green) is still waiting for the access to the AEI bus while a second AEI bus access from MCS arrives at the AEIM (yellow access path). Under certain, but for the user unpredictable timing conditions, this second AEI bus access arriving at the AEIM can trigger the misbehavior described in problem GTM_AI.329.

The workarounds described in the following section will ensure that not more than one AEIM buffer will be filled and therefore the occurrence of problem GTM_AI.329 is avoided. All workarounds have been tested and proven correct.

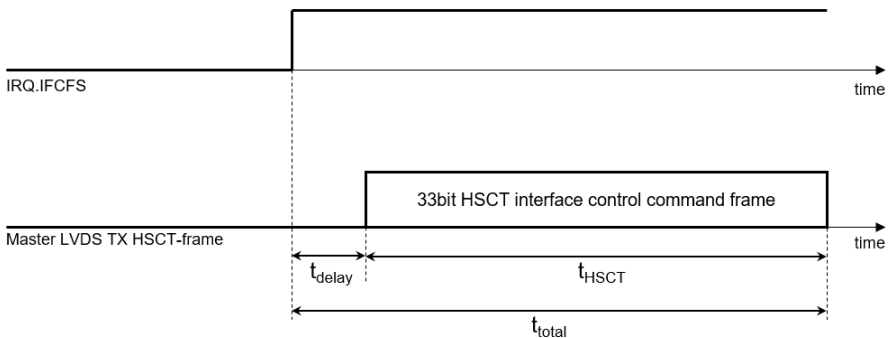
Figure 12 Timing of LVDS TX interface command sending in relation to IRQ.IFCFS

the user might falsely assume that also the actual sending on the LVDS TX port has already occurred once the IRQ.IFCFS flag is set, which is not true.

Instead the timing shown in **Figure 12** applies.
