Device TC38x
Marking/Step (E)ES-AE, AE
Package see Data Sheet

10293AERRA

This Errata Sheet describes the deviations from the current user documentation.

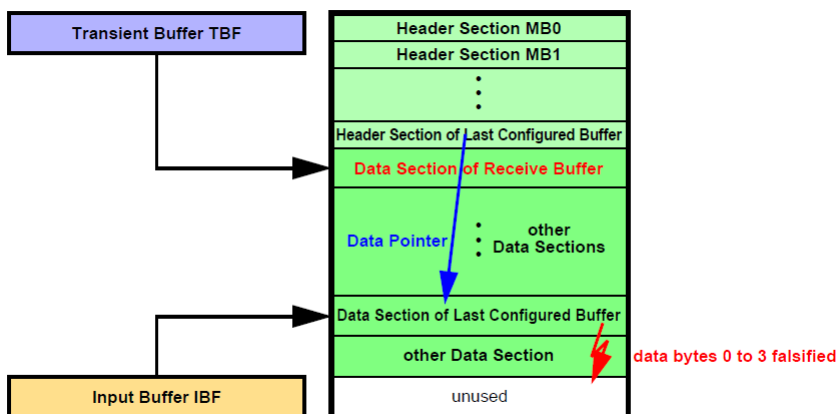
Figure 3 Message buffer transfer from IBF to Message RAM

After the Data Section of the selected message buffer in the Message RAM has been written, one additional write access overwrites the following word in the Message RAM which might be the first word of the next Data Section.

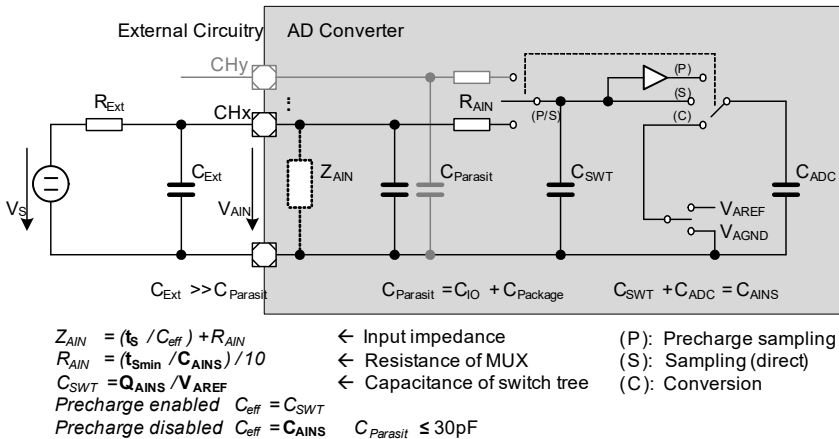
Figure 9 Equivalent Circuitry for Analog Inputs

Figure “Equivalent Circuitry for Analog Inputs” will be modified in future revisions of the Data Sheet, including the term $C_{Parasit} \leq 30 \text{ pF}$, as shown in the following figure:

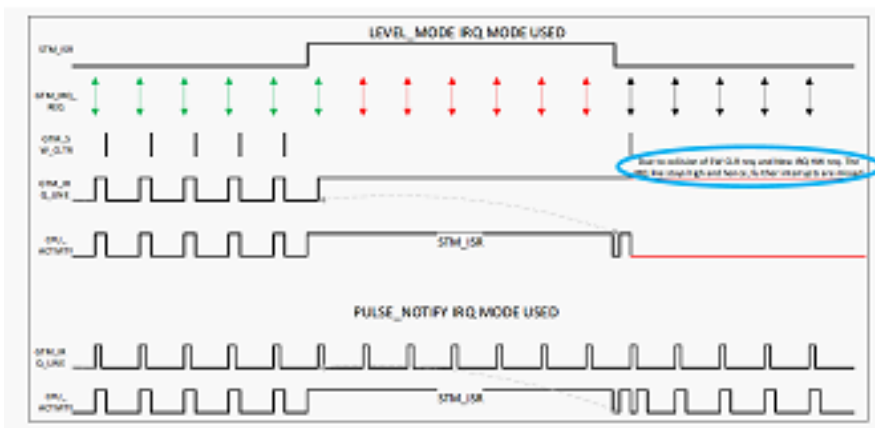
Figure 10 Interrupt Level vs. Pulse-Notify mode - Corner Case Example

Hence, in Level Mode, in some scenarios where another interrupt request is generated by GTM while the ISR handle also requests a SW clear, then, as the interrupt event is dominant over the clear event (for simultaneous interrupt and clear events), GTM_IRQ_XXX is not cleared and remains high. As a consequence, the IR observes no transition on GTM_IRQ_XX. Thus, any forthcoming interrupt events in this scenario are lost as there is no chance to release the CPU IRQ when a collision happens as shown in Figure below.
