Device TC39x
Marking/Step (E)ES-BD, BD
Package see Data Sheet

10291AERRA

This Errata Sheet describes the deviations from the current user documentation.

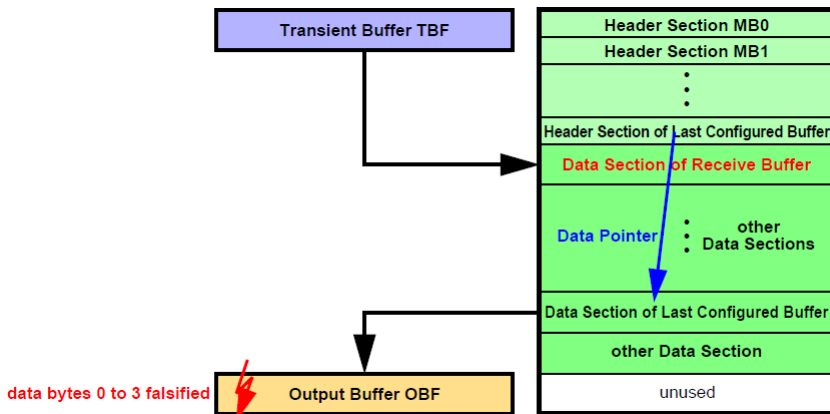
Figure 2 Message buffer transfer from Message RAM to OBF

When the message buffer has its payload configured to maximum length (**PLC** = 127), the OBF word on address 00h (payload data bytes 0 to 3) is overwritten with unexpected data at the end of the transfer.

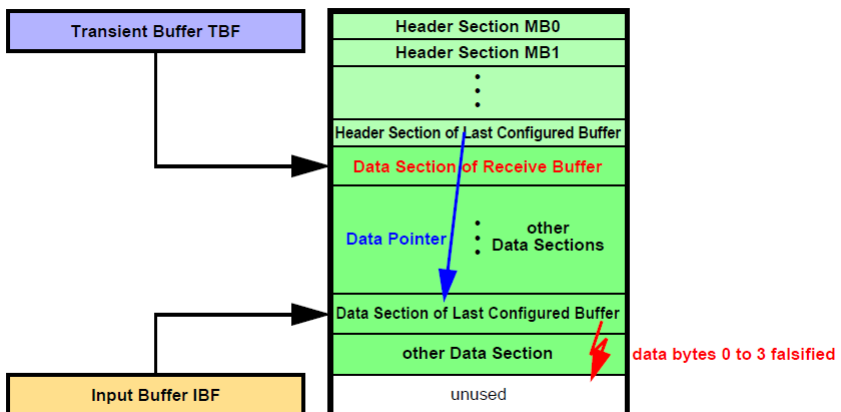
Figure 3 Message buffer transfer from IBF to Message RAM

After the Data Section of the selected message buffer in the Message RAM has been written, one additional write access overwrites the following word in the Message RAM which might be the first word of the next Data Section.

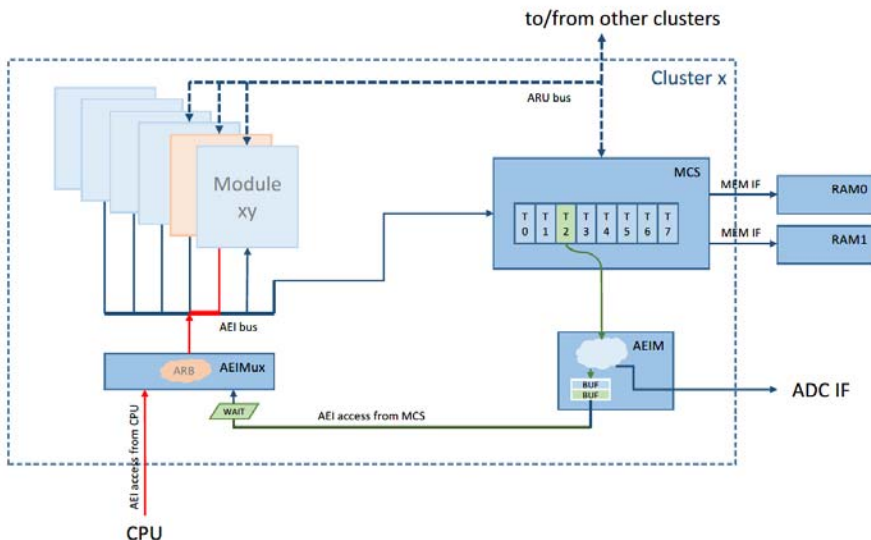
Figure 6 MCS AEI master access path

Figure 6 shows an uncritical traffic situation. Here an access of a MCS thread to the AEI bus (green access path) is temporary delayed due to an ongoing AEI bus access from the CPU (red access path). The MCS access to the AEI bus will be safely buffered at the AEIM (green buffer). As soon as the CPU access to the AEI bus completes, the buffered AEI bus access from MCS will be executed.

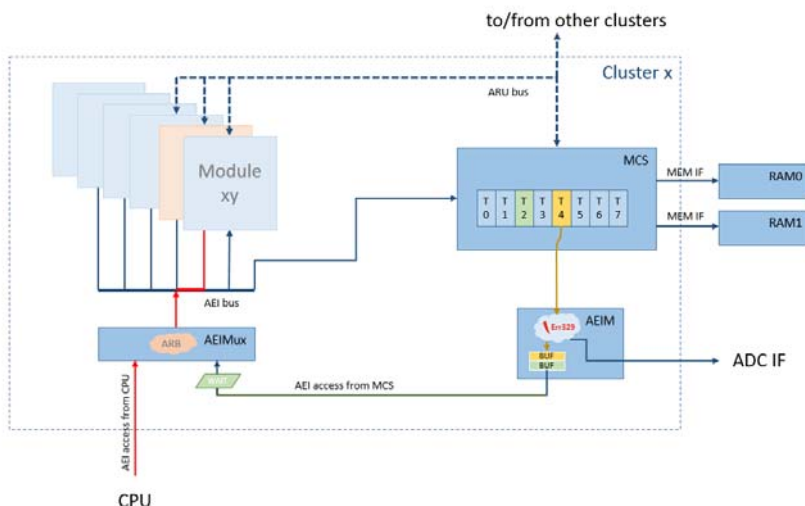
Figure 7 Critical MCS AEI master scenario

Problem GTM_AI.329 is related to a potential incorrect handling of MCS access requests to the AEI bus at the AEIM entry stage in case that one AEIM buffer is already filled. If in such a case a new access request from MCS enters the AEIM logic during a very specific time window (related to progress on the AEI bus), the AEIM logic might signalize incorrect parameters back to MCS that could result in incorrect data, the loss of data or a repetitive execution of MCS accesses to AEI.

In [Figure 7](#), a potential risk for the occurrence of problem GTM_AI.329 is illustrated. Here the first buffer of the AEIM (green) is still waiting for the access to the AEI bus while a second AEI bus access from MCS arrives at the AEIM (yellow access path). Under certain, but for the user unpredictable timing conditions, this second AEI bus access arriving at the AEIM can trigger the misbehavior described in problem GTM_AI.329.

The workarounds described in the following section will ensure that not more than one AEIM buffer will be filled and therefore the occurrence of problem GTM_AI.329 is avoided. All workarounds have been tested and proven correct.

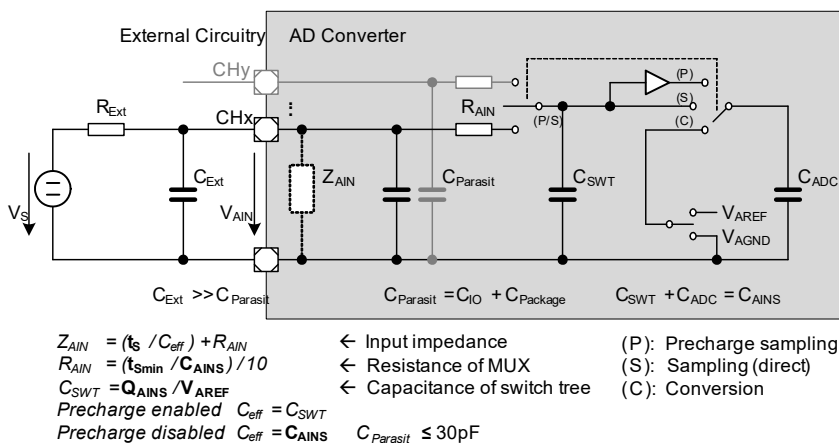
Figure 9 Equivalent Circuitry for Analog Inputs
EDSADC TC.P002 Parameters Input Current, Gain Error - Additional information

Figure “Equivalent Circuitry for Analog Inputs” will be modified in future revisions of the Data Sheet, including the term $C_{\text{Parasit}} \leq 30 \text{ pF}$, as shown in the following figure:

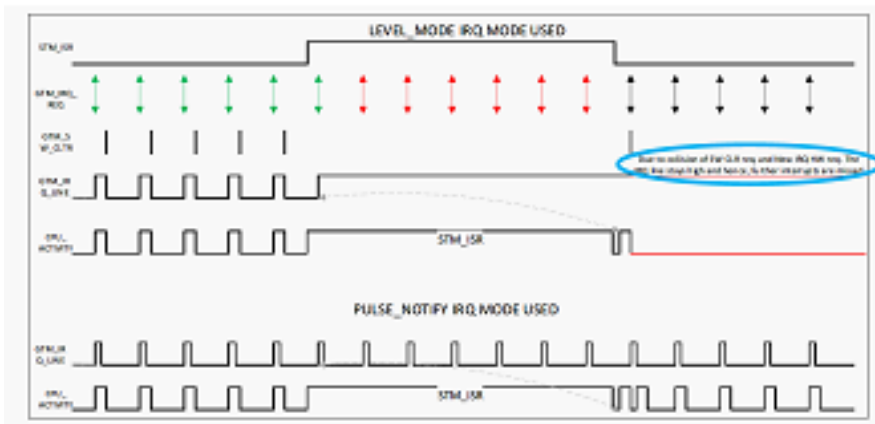
Figure 10 Interrupt Level vs. Pulse-Notify mode - Corner Case Example

Hence, in Level Mode, in some scenarios where another interrupt request is generated by GTM while the ISR handle also requests a SW clear, then, as the interrupt event is dominant over the clear event (for simultaneous interrupt and clear events), GTM_IRQ_XXX is not cleared and remains high. As a consequence, the IR observes no transition on GTM_IRQ_XX. Thus, any forthcoming interrupt events in this scenario are lost as there is no chance to release the CPU IRQ when a collision happens as shown in Figure below.

If Pulse-Notify mode is selected, every internal trigger will be forwarded to the IR, irrespective of the time of occurrence and the clear event, as the pulse-notify leads to set and reset of GTM_IRQ_XXX as compared to only setting of the GTM_IRQ_XXX line in Level mode.

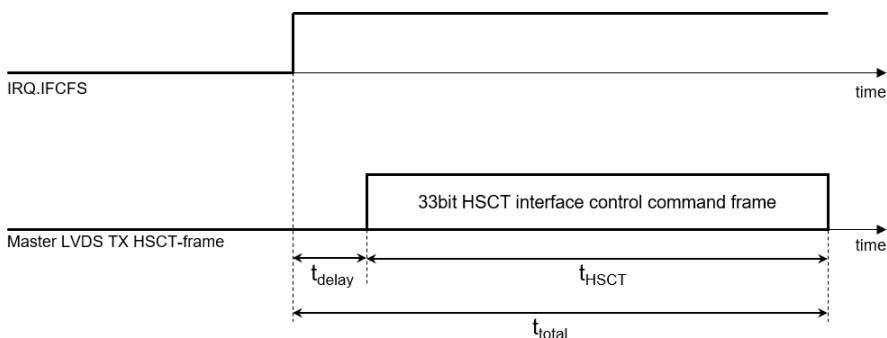
Figure 12 Timing of LVDS TX interface command sending in relation to IRQ.IFCFS

the user might falsely assume that also the actual sending on the LVDS TX port has already occurred once the IRQ.IFCFS flag is set, which is not true.

Instead the timing shown in **Figure 12** applies.
