Device	XMC4700/XMC4800
Marking/Step	ES-AA, AA
Package	PG-LQFP-100/144, PG-LFBGA-196

Document ID is **056/18**.

This “Errata Sheet” describes product deviations with respect to the user documentation listed below.

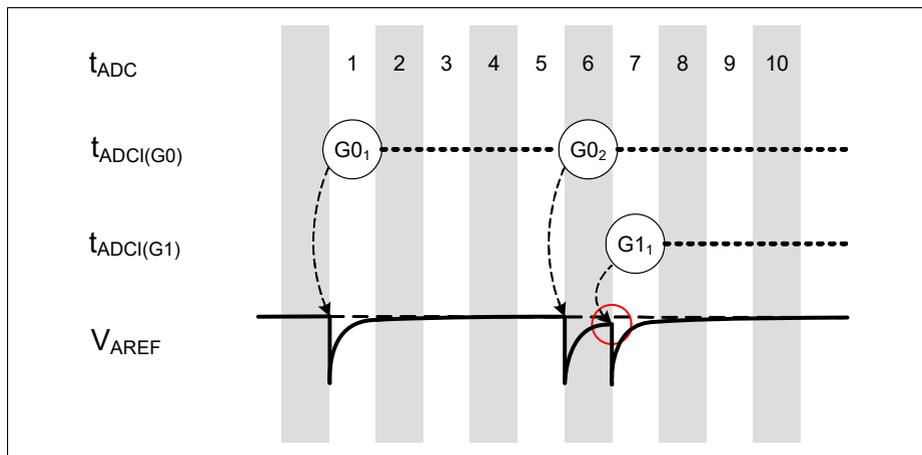
Figure 1 Influence of concurrent conversions on reference voltage

Due to this architecture, the individual prescalers may be displaced by one module clock as shown in the figure below for G0₂ and G1₁. In this example the division factor is 5 (DIVA=4).

In cycle 1 only the G0 conversion step is started. At start time the reference voltage is strobed and a certain amount of electric charge (see data sheet parameter Q_{CONV}) is consumed. This causes a drop of the reference voltage level V_{REF} . Quantity of voltage drop depends on analog voltage level to convert.

In repeated measurements using the example setup errors up to 25 LSB have been observed in 10-16 of 4096 conversions. Magnitude of the error however depends on the system configuration and load. The workaround therefore should be applied for all applications.

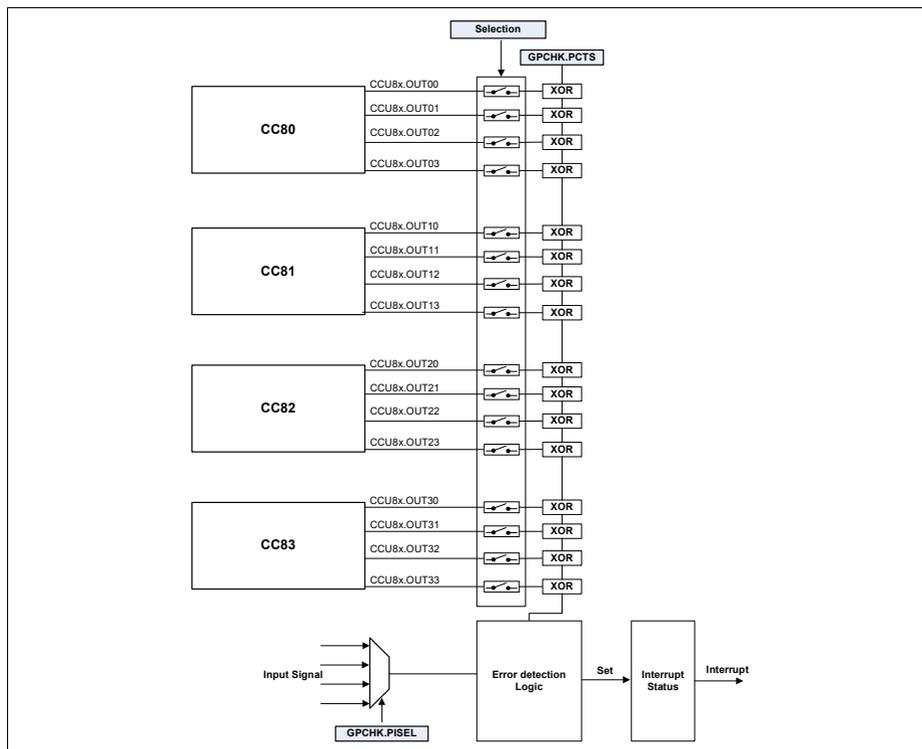
Figure 2 Parity Checker diagram

This means that if in the previous PWM cycle an error was detected and one interrupt was triggered, the software needs to read back the status register before the end of the immediately next PWM cycle.

This is indeed only necessary if multiple interrupt sources are ORed together in the same interrupt line. If this is not the case and the parity checker error source is the only one associated with an interrupt line, then there is no need to read back the status information. This is due to the fact, that only one action can be triggered in the software routine, the one linked with the parity checker error.

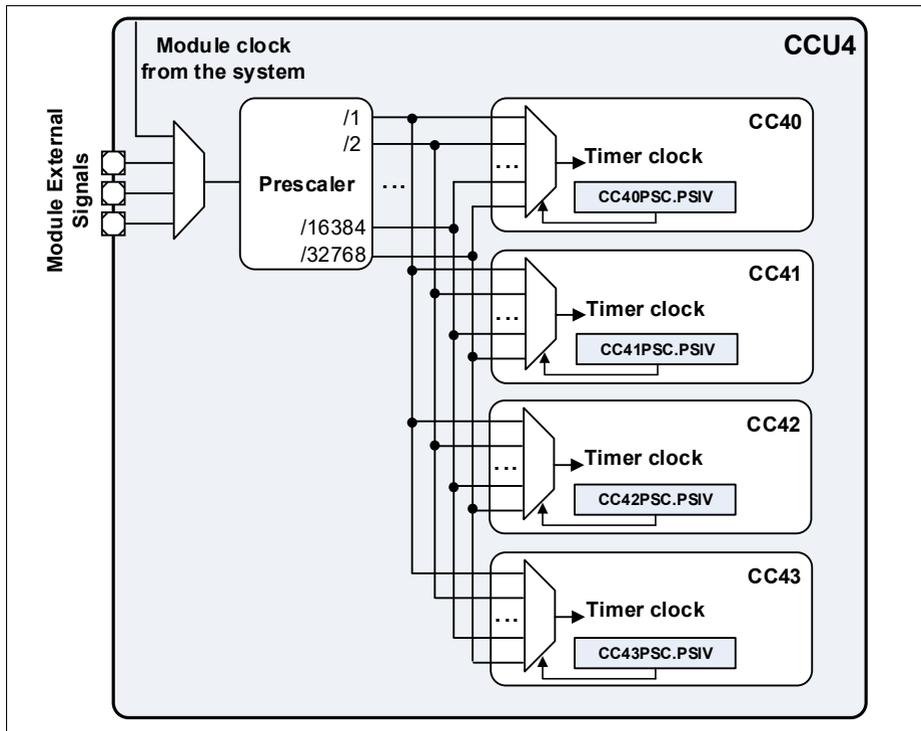
Figure 4 Clock Selection Diagram for CCU4

This is only applicable if the Module Clock provided by the system (the normal default configuration and use case scenario) is not being used. In the case that the normal clock configured and programmed at system level is being used, there is not any type of constraints.

One should not also confuse the usage of an external signal as clock for the module with the usage of an external signal for counting. These two features are completely unrelated and there are not any dependencies between both.

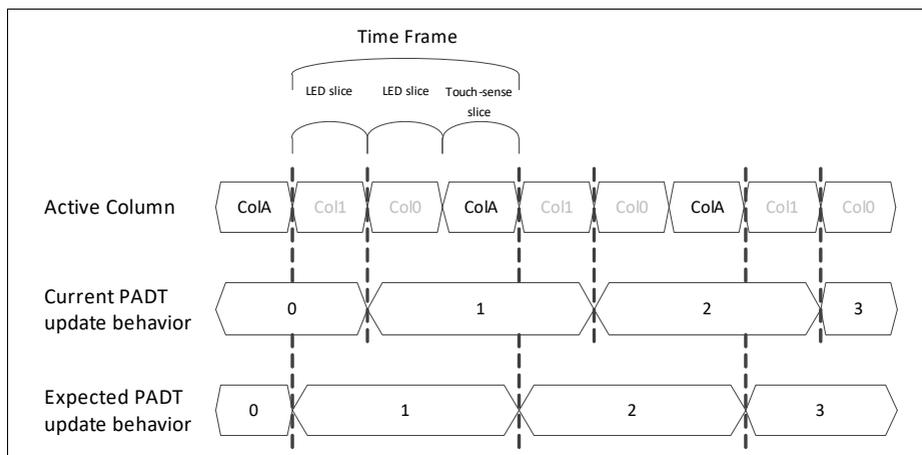
Figure 5 PADT update behavior

The touch-sense pad turn (PADT) value is updated, not at the end of the touch-sense time slice (ColA), but one time slice later (**Figure 5**).

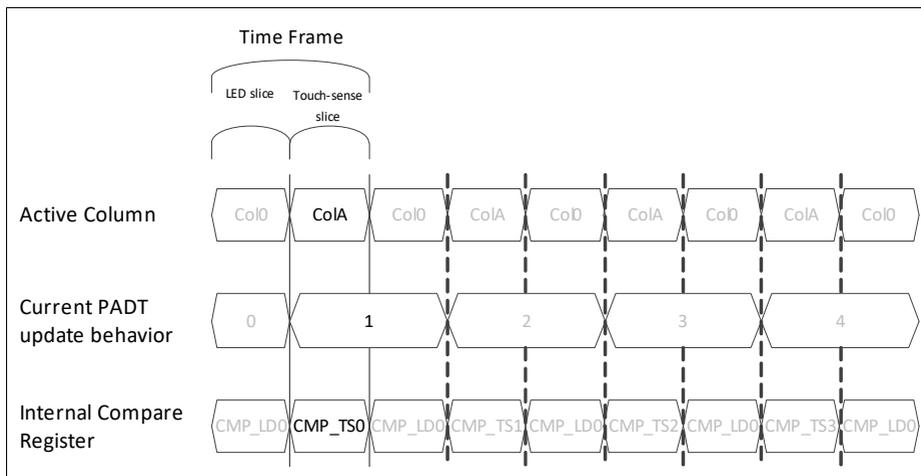
Figure 6 Effect of delay on the update of Internal Compare Register with 1 LED column enabled

If the number of LED columns enabled is smaller than 2, the delay will affect the activation period of the current active pad. At the beginning of every new Col A, the value of the current PADT's compare register is updated to the internal compare register. However, the delay causes the value of the previous PADT's compare register is updated to the internal compare register instead. This means that the current active pad would be activated with the duration of the previous pad's oscillation window (**Figure 6**). In addition to this, when no LEDs are enabled, pad turn 0 will prevail for one time slice longer before it gets updated (**Figure 7**).

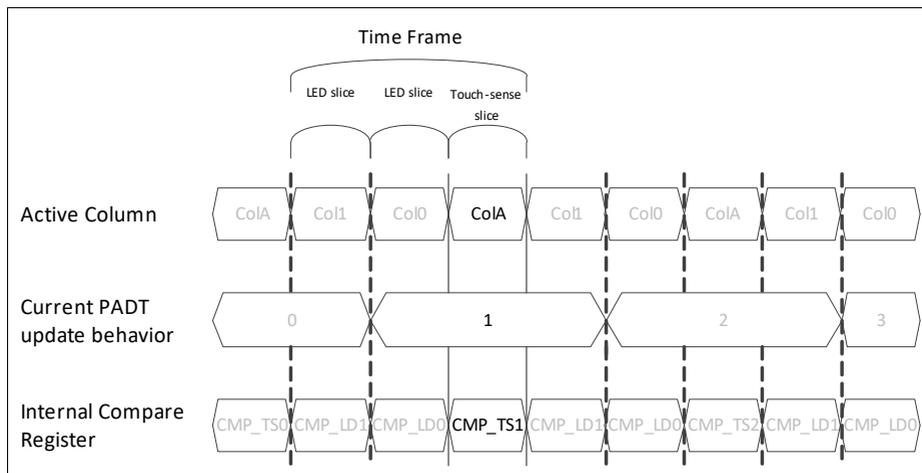
Figure 8 Internal Compare Register updated with correct compare register value with 2 LED columns enabled

If the number of LED columns enabled is 2 or more, the additional LED columns would provide some buffer time for the delay. So, at the start of a new touch-sense time slice, the update of PADT value would have taken place. Hence, the current active PADT compare register value is updated to the internal compare register (**Figure 8**).

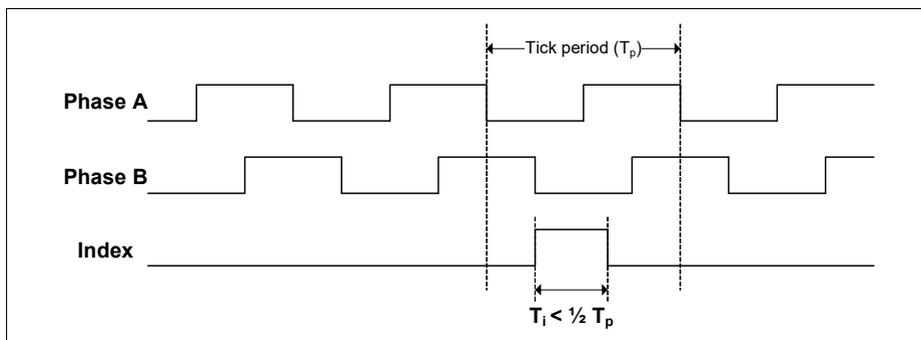
Figure 11 Different index signal types

When the index signal is smaller than 1/2 of the tick period, the POSIF module is not able to decode this signal properly, Figure 2 - notice that the reference edge of the index generation in this figure is the falling of Phase B, nevertheless this is an example and depending on the encoder type, this edge may be one of the other three.

Due to this fact it is not possible to use the POSIF to decode these type of signals (index with duration below 1/2 of the tick period).

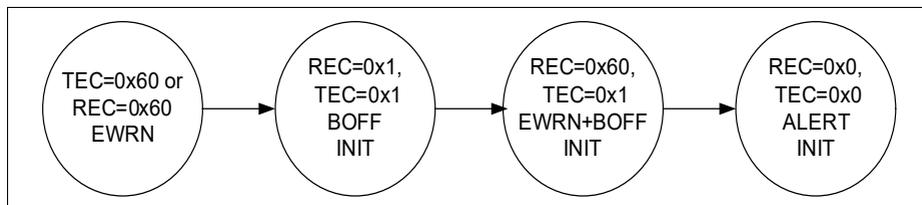
Figure 13 Alert Interrupt Behavior in case of Bus-Off

The MultiCAN module shows the following behavior in case of a bus-off status:

When the threshold for error warning (EWRN) is reached (default value of Error Warning Level EWRN = 0x60), then the EWRN interrupt is issued. The bus-off (BOFF) status is reached if $TEC > 255$ according to CAN specification, changing the MultiCAN module with REC and TEC to the same value 0x1, setting the INIT bit to 1_B, and issuing the BOFF interrupt. The bus-off recovery phase starts automatically. Every time an idle time is seen, REC is incremented. If REC = 0x60, a combined status EWRN+BOFF is reached. The corresponding interrupt can also be seen as a pre-warning interrupt, that the bus-off recovery phase will be finished soon. When the bus-off recovery phase has finished (128 times idle time have been seen on the bus), EWRN and BOFF are cleared, the ALERT interrupt bit is set and the INIT bit is still set.

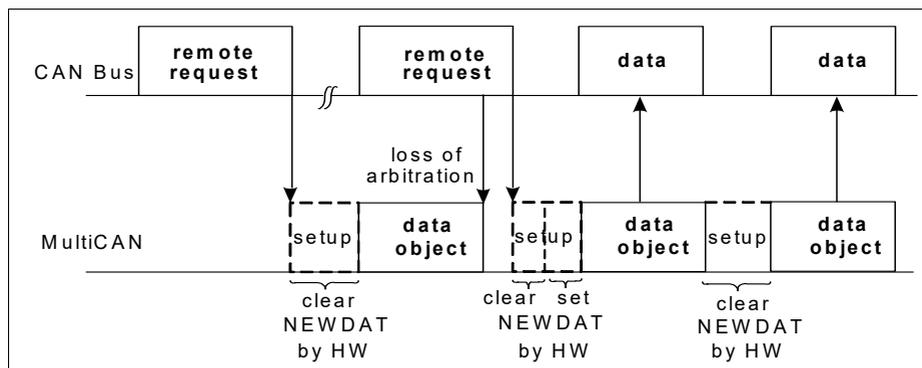
Figure 14 Loss of Arbitration

When the appropriate message object (data frame) triggered by the first remote frame wins the arbitration, it will be sent out and NEWDAT is not reset. This leads to an additional data frame, that will be sent by this message object (clearing NEWDAT).

There will, however, not be more data frames than there are corresponding remote requests.

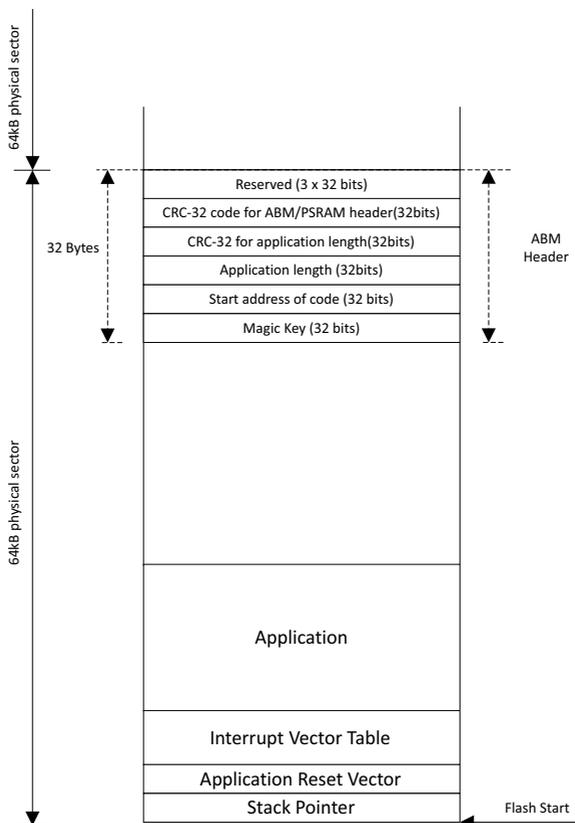
Figure 15 ABM/PSRAM Header - Location of reserved bytes

The reference manual is specifying PSRAM/ABM Header of 32 byte size. Only for 20byte of these 32 bytes the functionality is defined. The remaining 12bytes are reserved. Inside the chapter for Startup modes of the reference manual only the functional bytes are specified but not the location of the reserved bytes.

The following figure provides a detailed view on the location of the reserved bytes:
