Device	XMC4700/XMC4800
Marking/Step	ES-AA, AA
Package	PG-LQFP-100/144, PG-LFBGA-196

Document ID is **056/18**.

This “Errata Sheet” describes product deviations with respect to the user documentation listed below.

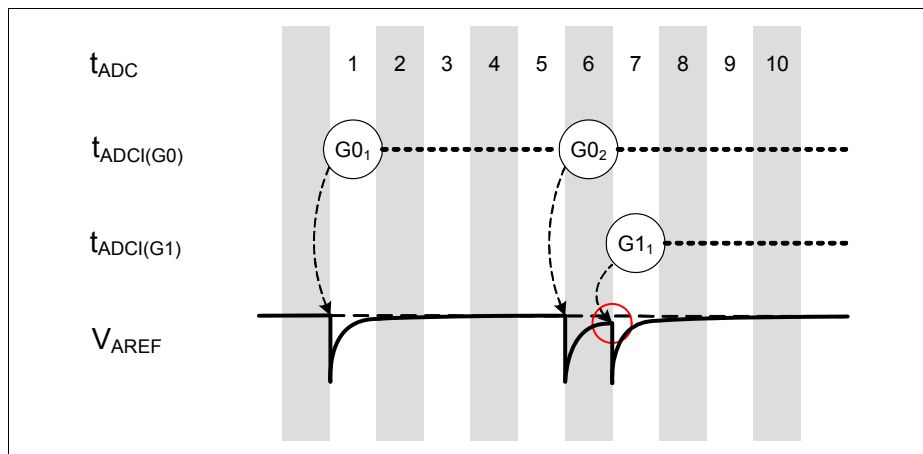
**Figure 1 Influence of concurrent conversions on reference voltage**

Due to this architecture, the individual prescalers may be displaced by one module clock as shown in the figure below for G0<sub>2</sub> and G1<sub>1</sub>. In this example the division factor is 5 (DIVA=4).

In cycle 1 only the G0 conversion step is started. At start time the reference voltage is strobed and a certain amount of electric charge (see data sheet parameter  $Q_{CONV}$ ) is consumed. This causes a drop of the reference voltage level  $V_{AREF}$ . Quantity of voltage drop depends on analog voltage level to convert.

In repeated measurements using the example setup errors up to 25 LSB have been observed in 10-16 of 4096 conversions. Magnitude of the error however depends on the system configuration and load. The workaround therefore should be applied for all applications.

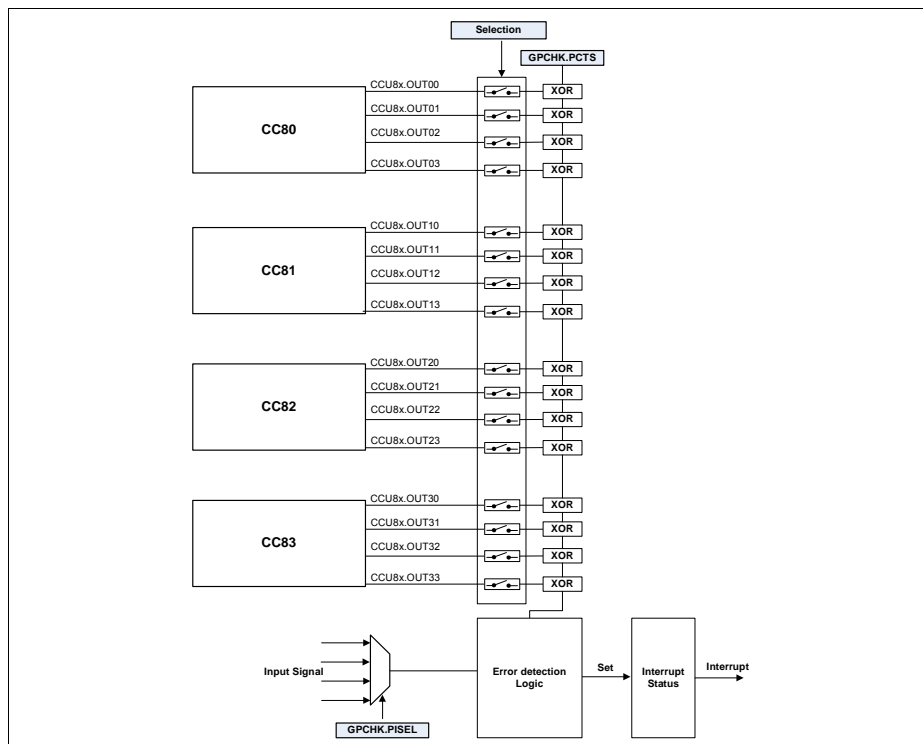
**Figure 2 Parity Checker diagram**

This means that if in the previous PWM cycle an error was detected and one interrupt was triggered, the software needs to read back the status register before the end of the immediately next PWM cycle.

This is indeed only necessary if multiple interrupt sources are ORed together in the same interrupt line. If this is not the case and the parity checker error source is the only one associated with an interrupt line, then there is no need to read back the status information. This is due to the fact, that only one action can be triggered in the software routine, the one linked with the parity checker error.

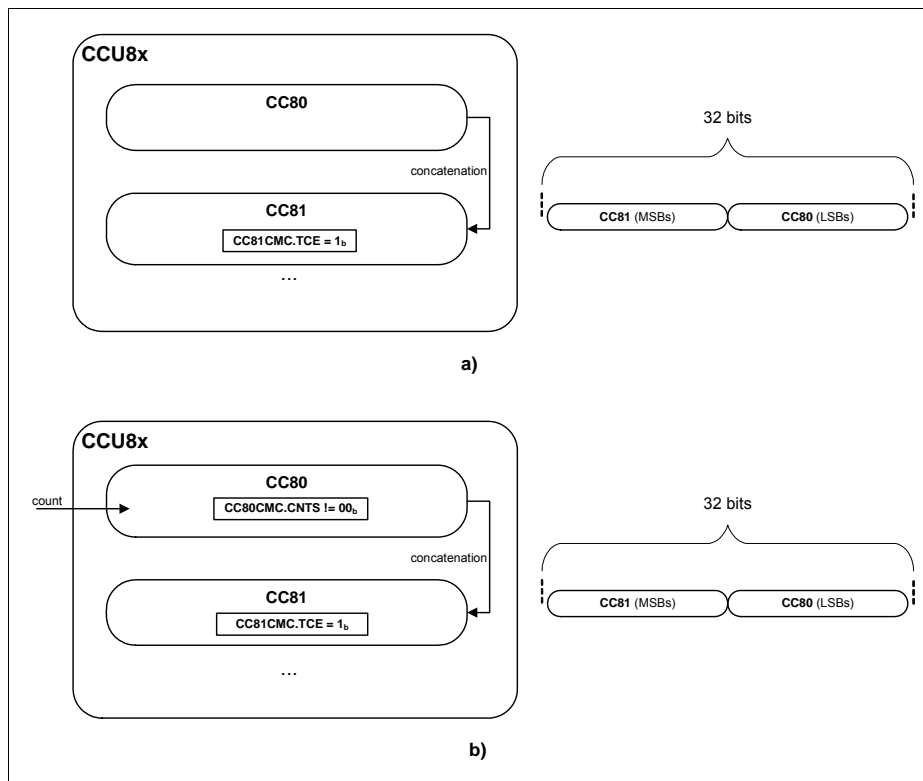
**Figure 3** CCU8x concatenation feature resource configuration - a) without external count function; b) with external count function

When an external count signal is enabled - by programming the CC8yCMC.CNTS with  $01_B$ ,  $10_B$  or  $11_B$  - the concatenation function does not work. One cannot use in parallel the timer concatenation and external count signal features.

*Note: On Figure 1, the count signal is used in CCU80 because this timer represents the LSBs. While the count signal could be enabled in the MSB timer (CC81), this does not make sense when the timers are concatenate - because the count should be used to increment the LSB timer. The LSB timer will then in each wrap around, increment the MSB timer.*

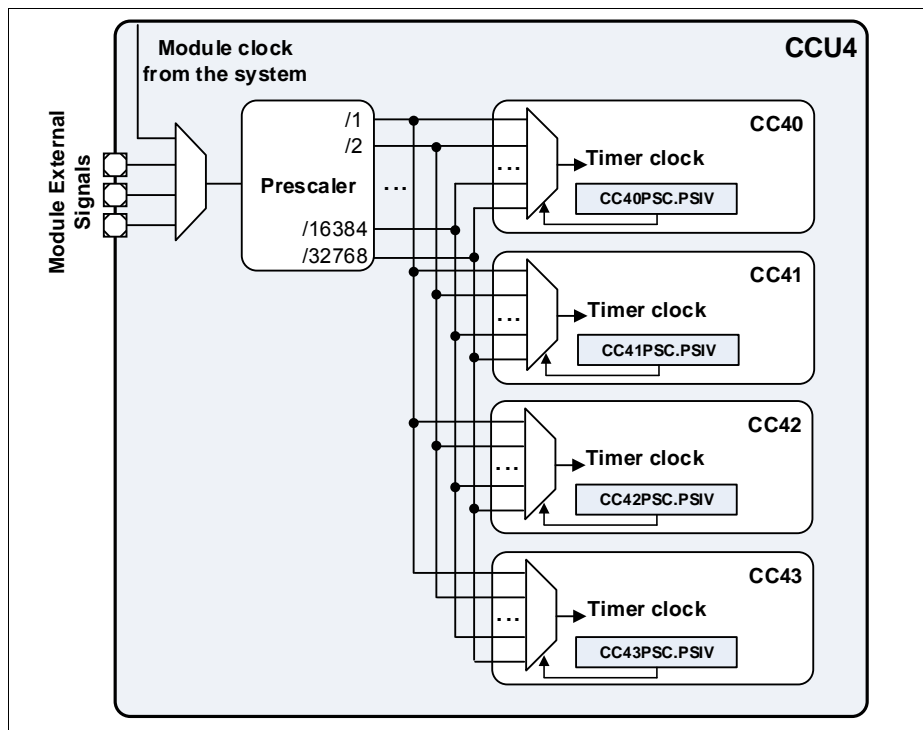
**Figure 4** Clock Selection Diagram for CCU4

This is only applicable if the Module Clock provided by the system (the normal default configuration and use case scenario) is not being used. In the case that the normal clock configured and programmed at system level is being used, there is not any type of constraints.

One should not also confuse the usage of an external signal as clock for the module with the usage of an external signal for counting. These two features are completely unrelated and there are not any dependencies between both.

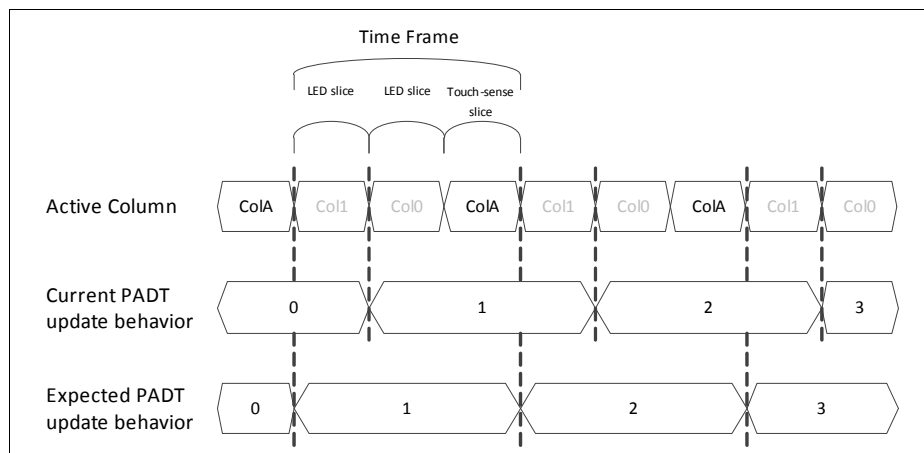
**Figure 5 PADT update behavior**

The touch-sense pad turn (PADT) value is updated, not at the end of the touch-sense time slice (ColA), but one time slice later (**Figure 5**).

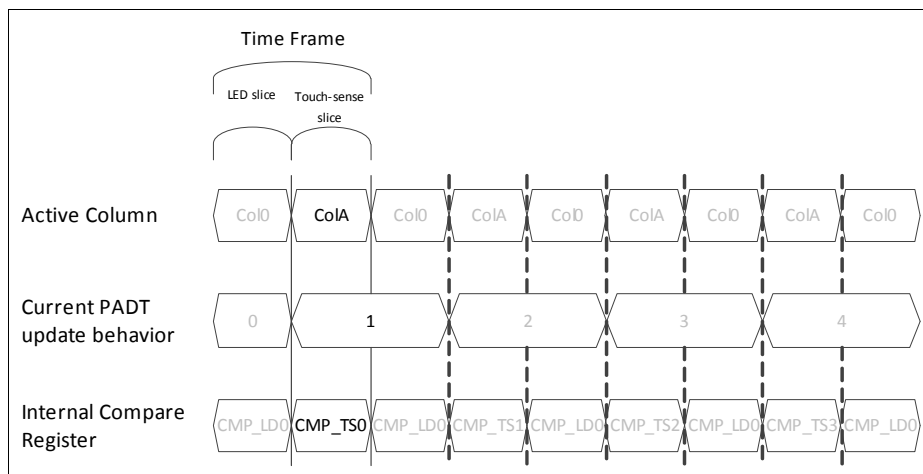
**Figure 6 Effect of delay on the update of Internal Compare Register with 1 LED column enabled**

If the number of LED columns enabled is smaller than 2, the delay will affect the activation period of the current active pad. At the beginning of every new Col A, the value of the current PADT's compare register is updated to the internal compare register. However, the delay causes the value of the previous PADT's compare register is updated to the internal compare register instead. This means that the current active pad would be activated with the duration of the previous pad's oscillation window (**Figure 6**). In addition to this, when no LEDs are enabled, pad turn 0 will prevail for one time slice longer before it gets updated (**Figure 7**).

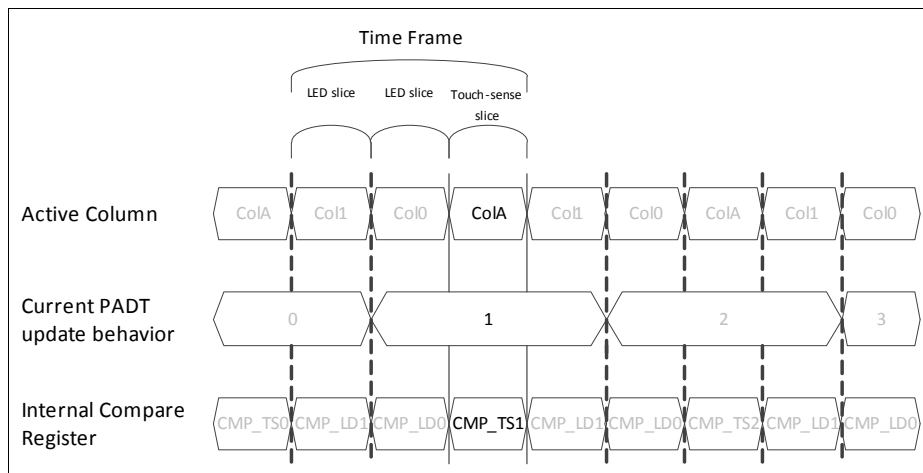
**Figure 8 Internal Compare Register updated with correct compare register value with 2 LED columns enabled**

If the number of LED columns enabled is 2 or more, the additional LED columns would provide some buffer time for the delay. So, at the start of a new touch-sense time slice, the update of PADT value would have taken place. Hence, the current active PADT compare register value is updated to the internal compare register ([Figure 8](#)).

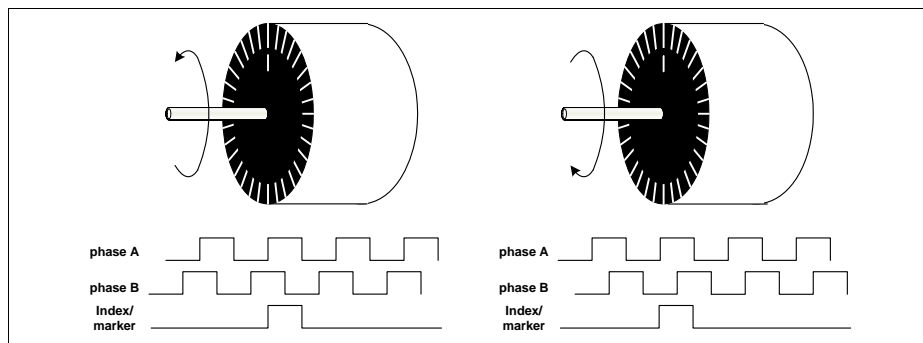
**Figure 10 Rotary Encoder outputs - Phase A, Phase B and Index**

Each POSIF module can be used as an input interface for a Rotary Encoder. It is possible to configure the POSIF module to decode 3 different signals: Phase A, Phase B (these two signals are 90° out of phase) and Index. The index signal is normally understood as the marker for the zero position of the motor Figure 1.

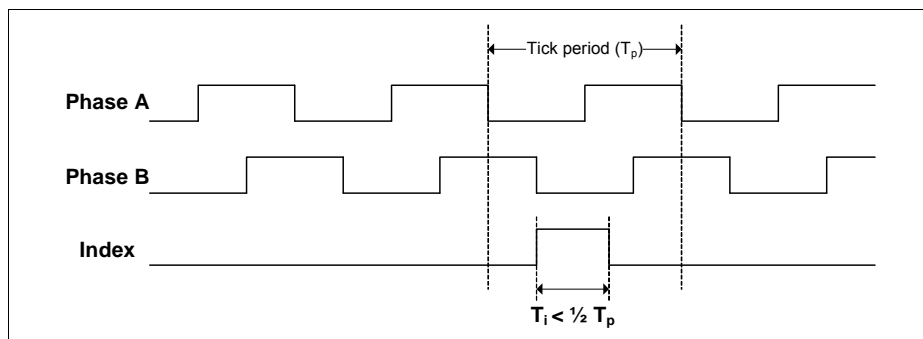
**Figure 11 Different index signal types**

When the index signal is smaller than 1/2 of the tick period, the POSIF module is not able to decode this signal properly, Figure 2 - notice that the reference edge of the index generation in this figure is the falling of Phase B, nevertheless this is an example and depending on the encoder type, this edge may be one of the other three.

Due to this fact it is not possible to use the POSIF to decode these type of signals (index with duration below 1/2 of the tick period).

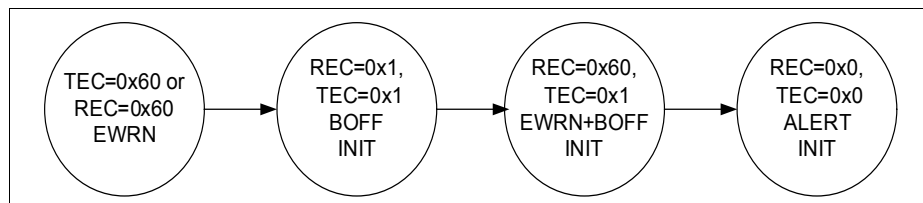
**Figure 13 Alert Interrupt Behavior in case of Bus-Off**

The MultiCAN module shows the following behavior in case of a bus-off status:

When the threshold for error warning (EWRN) is reached (default value of Error Warning Level EWRN = 0x60), then the EWRN interrupt is issued. The bus-off (BOFF) status is reached if  $TEC > 255$  according to CAN specification, changing the MultiCAN module with REC and TEC to the same value 0x1, setting the INIT bit to 1<sub>B</sub>, and issuing the BOFF interrupt. The bus-off recovery phase starts automatically. Every time an idle time is seen, REC is incremented. If REC = 0x60, a combined status EWRN+BOFF is reached. The corresponding interrupt can also be seen as a pre-warning interrupt, that the bus-off recovery phase will be finished soon. When the bus-off recovery phase has finished (128 times idle time have been seen on the bus), EWRN and BOFF are cleared, the ALERT interrupt bit is set and the INIT bit is still set.

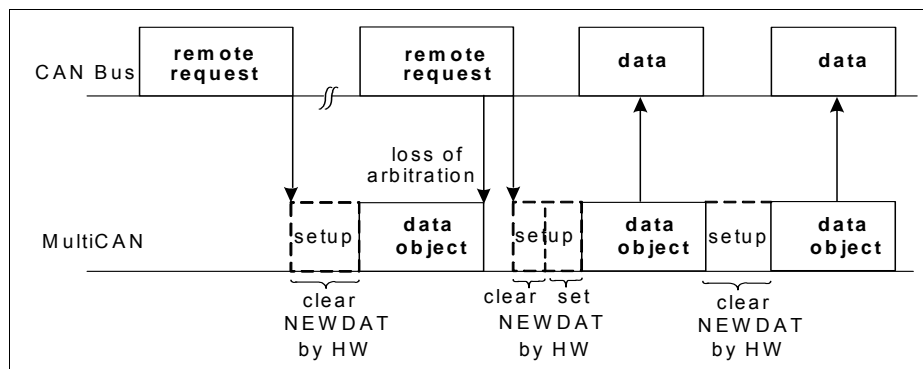
**Figure 14 Loss of Arbitration**

When the appropriate message object (data frame) triggered by the first remote frame wins the arbitration, it will be sent out and NEWDAT is not reset. This leads to an additional data frame, that will be sent by this message object (clearing NEWDAT).

There will, however, not be more data frames than there are corresponding remote requests.

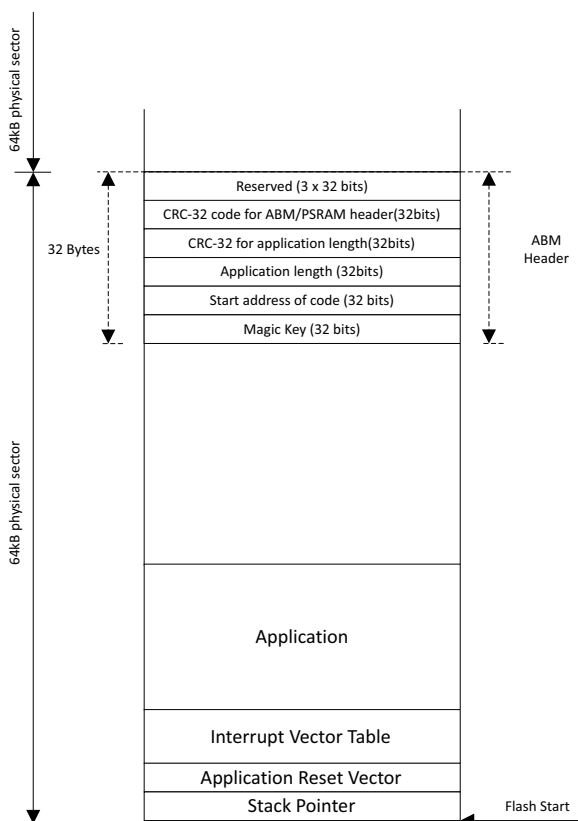
**Figure 15 ABM/PSRAM Header - Location of reserved bytes**

The reference manual is specifying PSRAM/ABM Header of 32 byte size. Only for 20byte of these 32 bytes the functionality is defined. The remaining 12bytes are reserved. Inside the chapter for Startup modes of the reference manual only the functional bytes are specified but not the location of the reserved bytes.

The following figure provides a detailed view on the location of the reserved bytes:
