IRPS5401 Errata

Documentation of errata items for the PMIC IRPS5401.

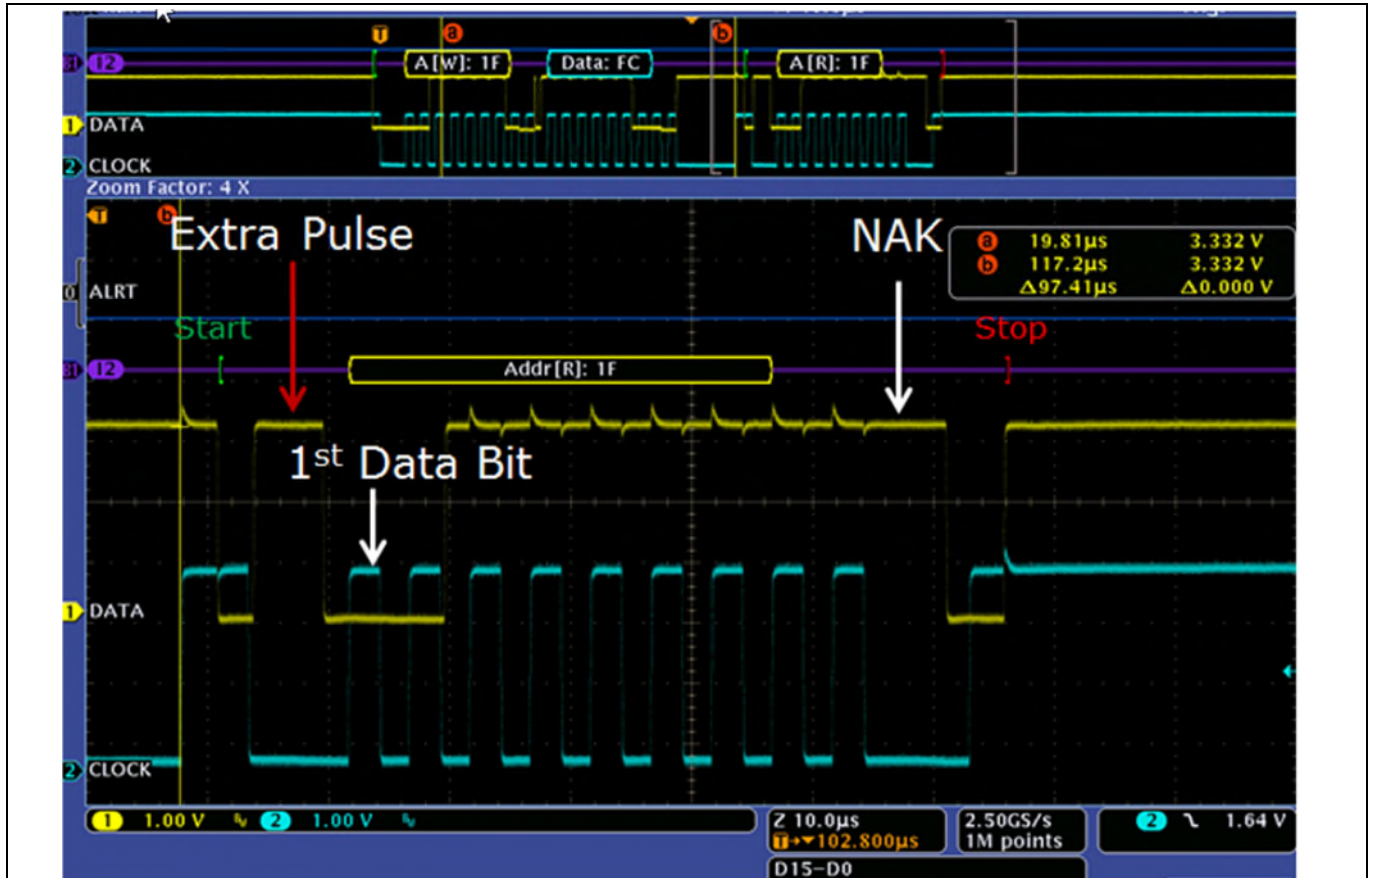
Figure 2 I²C extra pulse error

- Erratum:** I²C/PMBus is not tolerant of the DATA changing between the start symbol and the first data bit while the clock is low.
- Issue:** If a low-high-low pulse on DATA occurs between a start (or repeated start) symbol and the first data bit while the clock is low, the device will NAK (Not acknowledge) the transaction.
- Workaround:** The I²C/PMBus master should avoid issuing an extra pulse following the start symbol while the clock is low.
- Corrective action:** None.

The problem with having an extra pulse before the first clock pulse is not that an active pulsing of the data line is happening, rather than the idle state setting for the data line. If the default is low after the start condition was issued, there is no extra pulse. With a high as default and the first address bit (MSB) being “0”, an additional pulse has been created. To prevent this becoming a problem one can select addresses that begin with “1” in the MSB, i.e. 40 h or higher.

The USB005 dongle assumes that the PMBus address is bigger than the I²C address, or else it will not find the PMBus address during scanning.

Therefore, a recommended address setting for third-party interfaces is to set the I²C base address to 40 h and the PMBus base address to 50 h.
