IRPS5401 Errata Final Silicon

PSS DCDC Enterprise Power
January 2021

IRPS5401 Errata Final Si --Summary

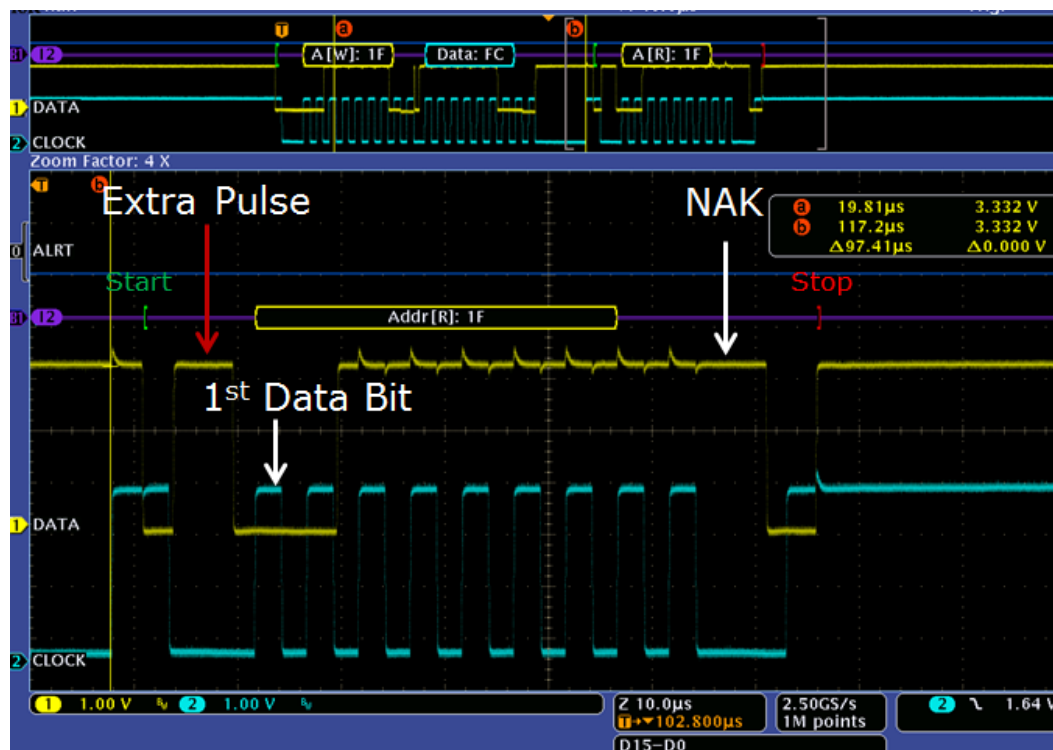
Item	Errata Description	
6	Errata:	I2C/PMBus is not tolerant of the Data changing between the Start Symbol and the first Data bit while the Clock is low.
	Issue:	If a low-high-low pulse on DATA occurs between a Start (or Repeated Start) symbol and the 1st data bit while clock is low, the device will NAK the transaction.
	Workaround:	The I2C/PMBus Master should avoid issuing an extra pulse following the Start Symbol while the clock is low
	Corrective Action:	Will not be fixed
