XDPL8221 errata sheet

XDPTM Digital Power

This errata sheet lists the known issues of [XDPL8221](#) digital PFC + flyback controller IC with the firmware version 1.0.0.

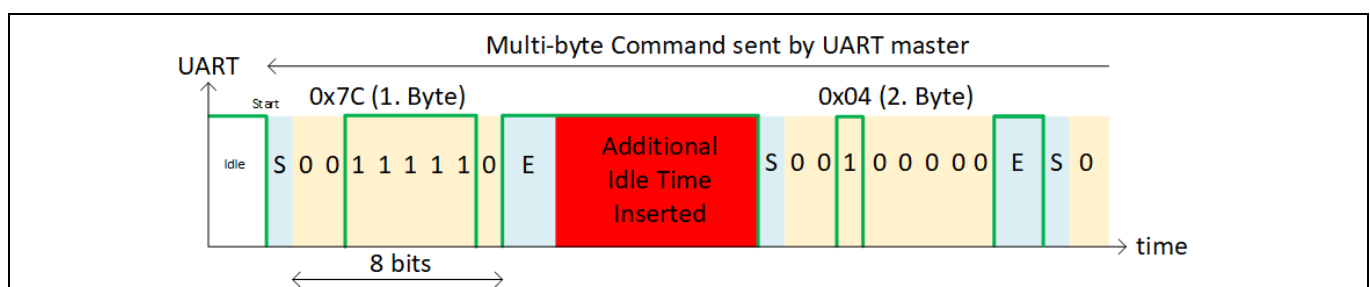
Figure 1 Required Additional Idle Time after the First Byte

XDPL8221 with firmware version 1.0.0 will not answer with ACK (0x00) to a UART command independent of the operation code. The communication fails and does not recover. It can be re-established through a new V_{CC} power cycle (XDPL8221 V_{CC} voltage must first be discharged under off-threshold and then charged to exceed on-threshold).

XDPL8221 changes its originally fixed (slave) baud rate 57.600 baud beyond +/- 6.25% (allowed tolerance range) by mistake due to the occasional mistracking of UART (master) baudrate. This wrong UART transmission speed of XDPL8221 leads to communication stop.

To avoid XDPL8221 mistracking of UART (master) baudrate, a recommended additional idle time of 100us must be inserted between the first and the second byte of a multi-byte command sent by UART master as illustrated in the **Figure 1** below.
