**Device** TC1782  
**Marking/Step** BA  
**Package** see Data Sheet

## 04074AERRA

This Errata Sheet describes the deviations from the current user documentation.

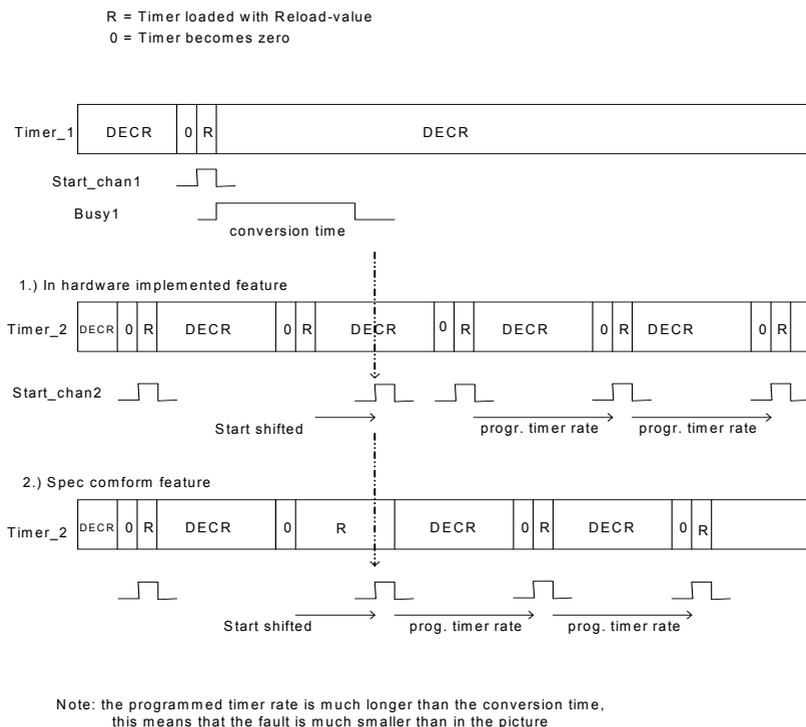
**Figure 1 Timing concerning equidistant multiple timers**

The correct behavior would be a reload when the requested conversion (of channel\_2) is started.

Therefore the start of conversion for channel\_2 is delayed by maximum one conversion-time. After this delay it will be continued with equidistant conversion-starts. Please refer to the following figure.

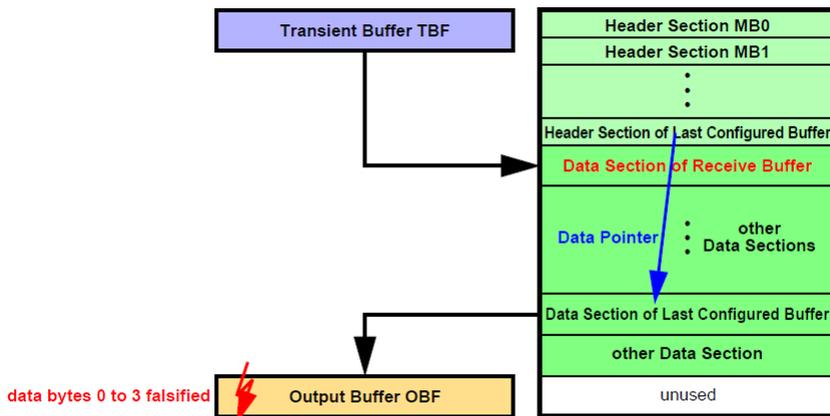
**Figure 2 Message buffer transfer from Message RAM to OBF**

a) Message buffer transfer from Message RAM to OBF

When the message buffer has its payload configured to maximum length (PLC = 127), the OBF word on address 00h (payload data bytes 0 to 3) is overwritten with unexpected data at the end of the transfer.

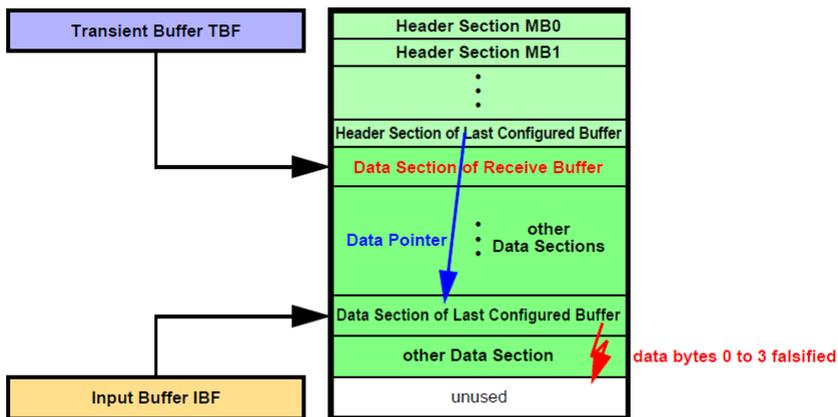
**Figure 3 Message buffer transfer from IBF to Message RAM**

b) Message buffer transfer from IBF to Message RAM

After the Data Section of the selected message buffer in the Message RAM has been written, one additional write access overwrites the following word in the Message RAM which might be the first word of the next Data Section.

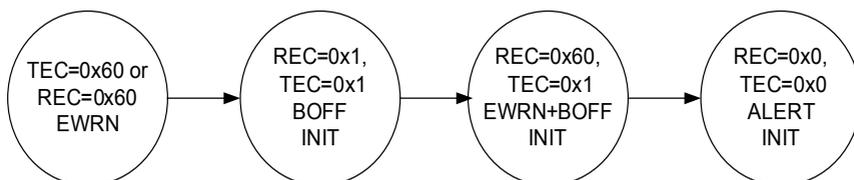
**Figure 5 Alert Interrupt Behavior in case of Bus-Off**

**MultiCAN AI.H007 Alert Interrupt Behavior in case of Bus-Off**

The MultiCAN module shows the following behavior in case of a bus-off status:

When the threshold for error warning (EWRN) is reached (default value of Error Warning Level EWRN = 0x60), then the EWRN interrupt is issued. The bus-off (BOFF) status is reached if TEC > 255 according to CAN specification, changing the MultiCAN module with REC and TEC to the same value 0x1, setting the INIT bit to 1<sub>B</sub>, and issuing the BOFF interrupt. The bus-off recovery phase starts automatically. Every time an idle time is seen, REC is incremented. If REC = 0x60, a combined status EWRN+BOFF is reached. The corresponding interrupt can also be seen as a pre-warning interrupt, that the bus-off recovery phase will be finished soon. When the bus-off recovery phase has finished (128 times idle time have been seen on the bus), EWRN and BOFF are cleared, the ALERT interrupt bit is set and the INIT bit is still set.

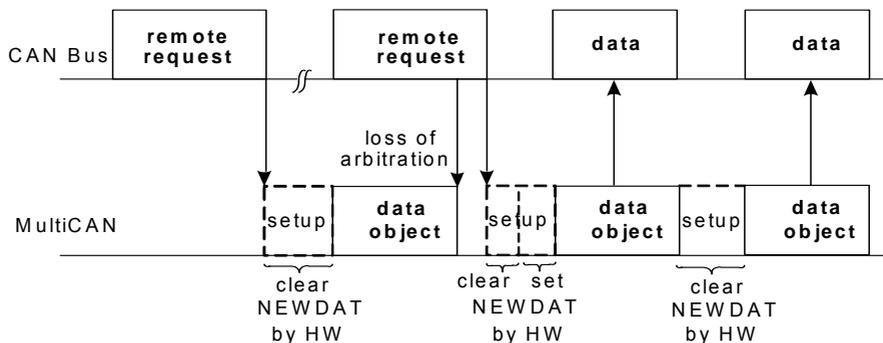
**Figure 6 Loss of Arbitration**

When the appropriate message object (data frame) triggered by the first remote frame wins the arbitration, it will be sent out and `NEWDAT` is not reset. This leads to an additional data frame, that will be sent by this message object (clearing `NEWDAT`).

There will, however, not be more data frames than there are corresponding remote requests.
