Device TC22x/TC21x
Marking/Step ES-AC, AC
Package see Data Sheet

10208AERRA

This Errata Sheet describes the deviations from the current user documentation.

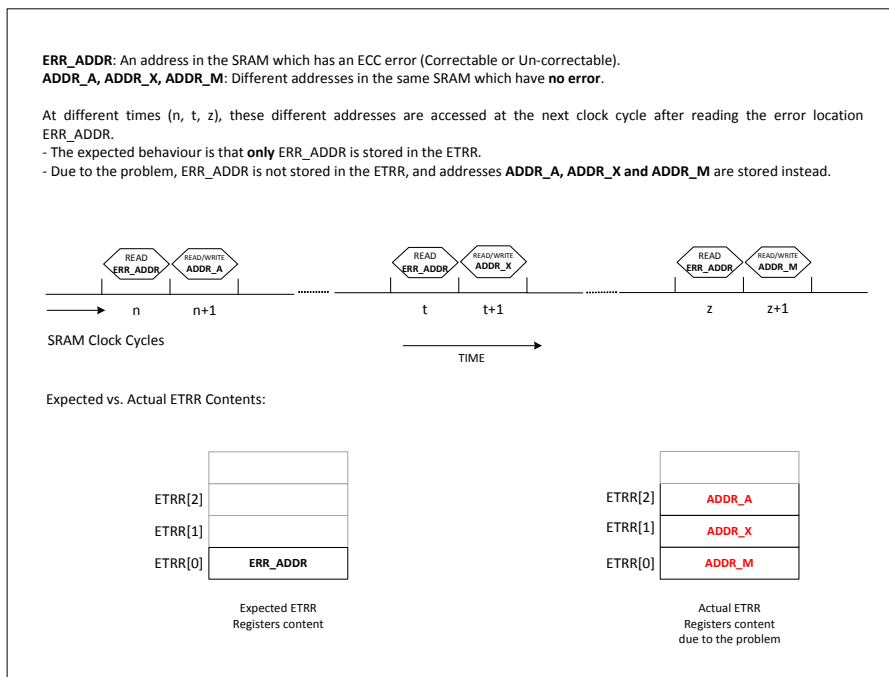
Figure 1 Example sequence showing how registers ETRRx may be filled with “Error Free” addresses

are filled with addresses that have actually no error – and the SRAM address which actually has an error is not stored indeed. **Figure 1** shows such an example scenario.

The consequence of the scenario explained in **Figure 1** is that a single error in the SRAM – example just one correctable error at a location ERR_ADDR – can result in registers ETRRx getting filled with fault-free address, and thus potentially even triggering an ETRR overflow.

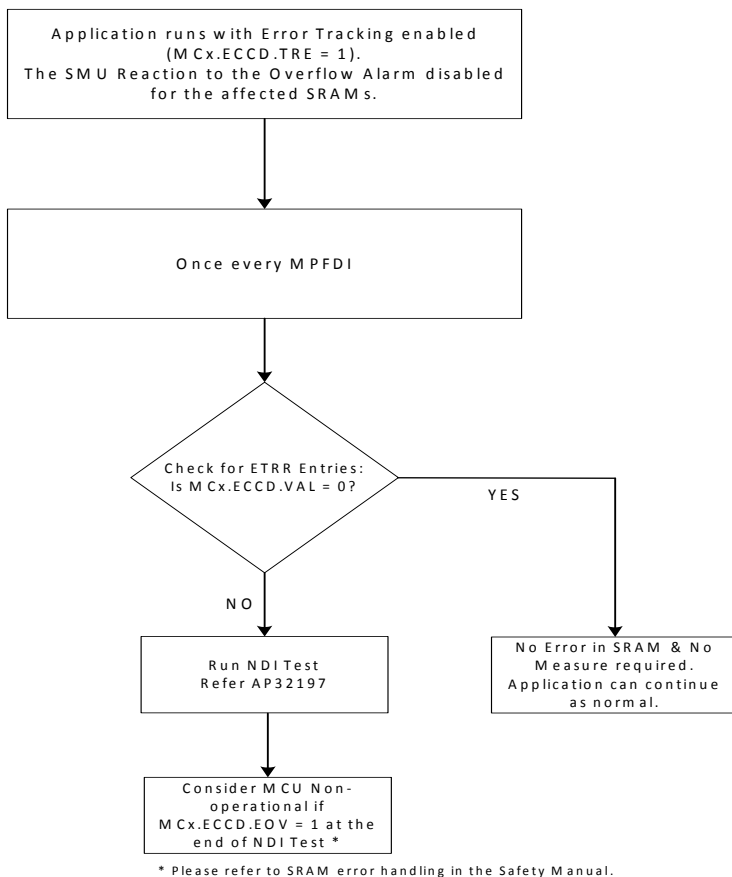
Figure 2 Recommended Software Handling - Flowchart

If there is at least one valid ETRR entry (i.e. $MCx.ECCD.VAL \neq 0$) then the software shall run a Non-Destructive-Inversion (NDI) Test on the affected SRAM. Please refer to application note AP32197 (AURIX™ Memory tests using the MTU) for an example regarding running this test.

At the end of this test, if an ETRR overflow is detected ($MCx.ECCD.EOV = 1_B$) then the MCU shall be considered non-operational. Refer to section on Correctable SRAM Error handling in the Safety Manual.

A flowchart of the recommended software handling is shown in [Figure 2](#).

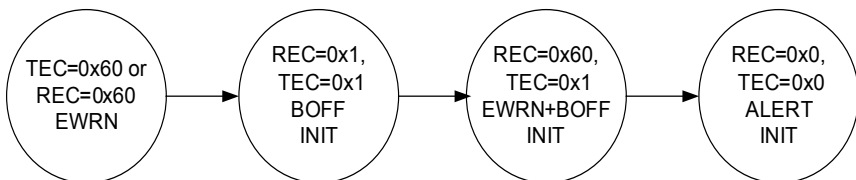
Figure 4 Alert Interrupt Behavior in case of Bus-Off

MultiCAN_AI.H007 Alert Interrupt Behavior in case of Bus-Off

When the threshold for error warning (EWRN) is reached (default value of Error Warning Level EWRN = 0x60), then the EWRN interrupt is issued. The bus-off (BOFF) status is reached if $TEC > 255$ according to CAN specification, changing the MultiCAN module with REC and TEC to the same value 0x1, setting the INIT bit to 1_B, and issuing the BOFF interrupt. The bus-off recovery phase starts automatically. Every time an idle time is seen, REC is incremented. If REC = 0x60, a combined status EWRN+BOFF is reached. The corresponding interrupt can also be seen as a pre-warning interrupt, that the bus-off recovery

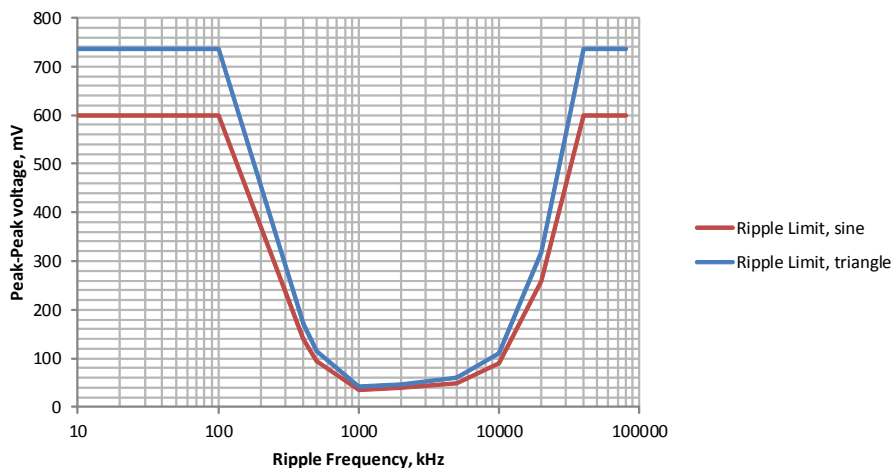
Figure 8 Ripple Voltage vs. Frequency Characteristic

improper behavior of the start-up scheme of the back-up clock, and thus stuck-at state during the start-up of the microcontroller until this condition is removed.

The diagram reflects acceptable ripple level during the cold start of the microcontroller at the respective VDDP3/VEXT/VEVRSB supply of the PMS subsystem, depending on the device and package type, as shown in the following table.
