Device TC23x
Marking/Step ES-AB, AB
Package see Data Sheet

10209AERRA

This Errata Sheet describes the deviations from the current user documentation.

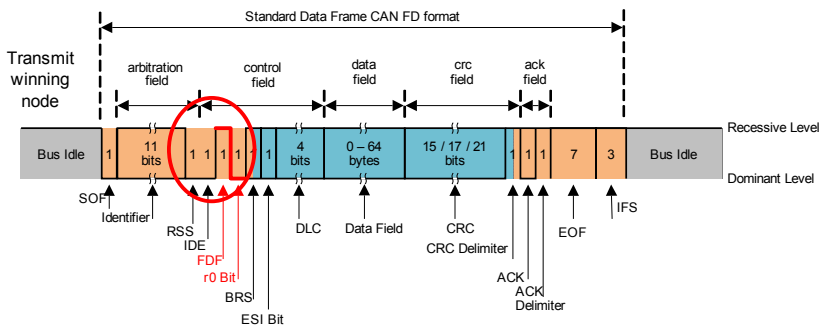
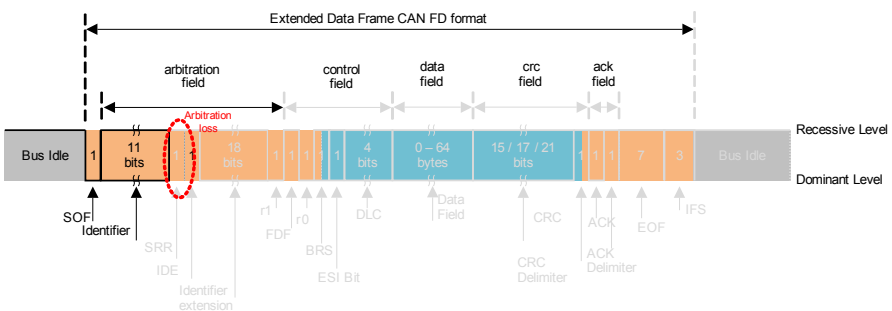
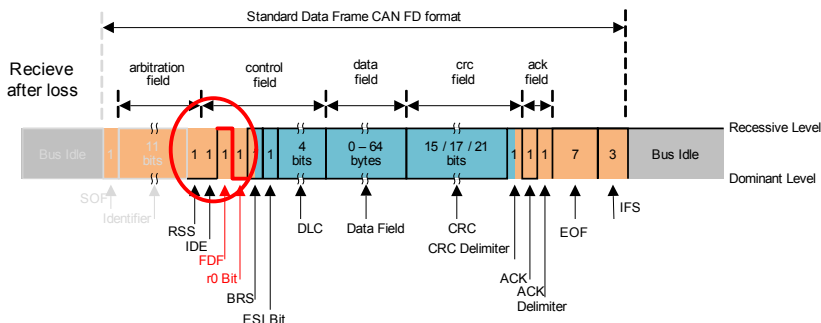
The device is producing more error frames within a network than a device with a hardsync at the FDF bit.

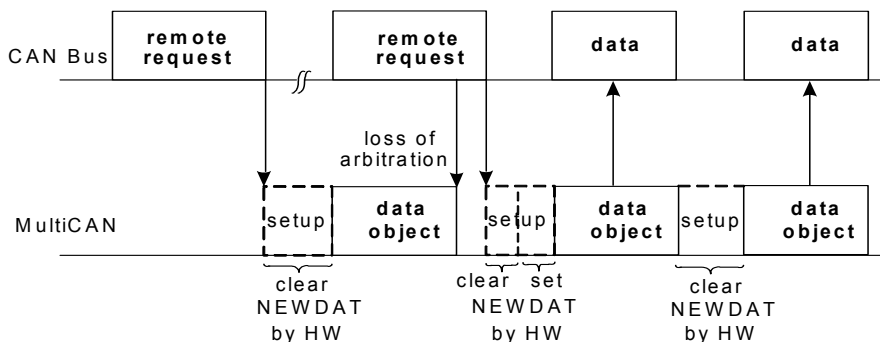
Expected vs. Actual ETRR Contents:

When the appropriate message object (data frame) triggered by the first remote frame wins the arbitration, it will be sent out and NEWDAT is not reset. This leads to an additional data frame, that will be sent by this message object (clearing NEWDAT).

There will, however, not be more data frames than there are corresponding remote requests.

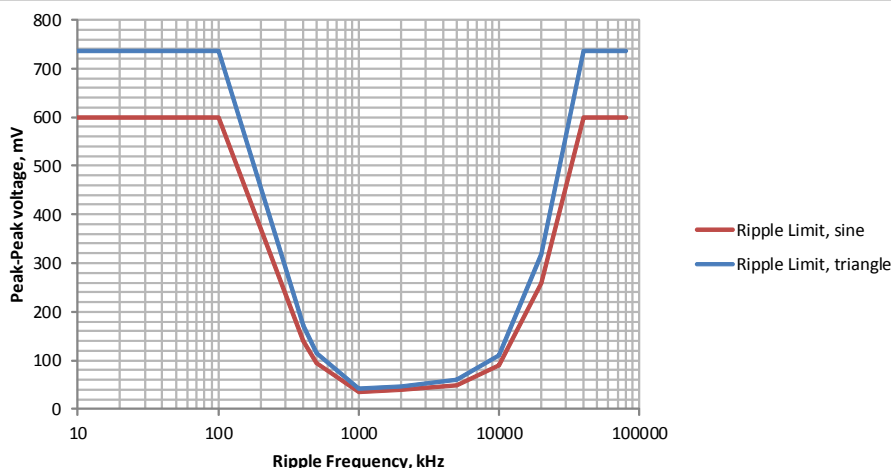
Figure 12 Ripple Voltage vs. Frequency Characteristic

The internal back-up clock is sensitive to specific power supply voltage disturbance/ripple caused by a voltage ripple intrinsic to DC-DC converters. Specific conditions such as insufficient filtering of the ripple may lead to improper behavior of the start-up scheme of the back-up clock, and thus stuck-at state during the start-up of the microcontroller until this condition is removed.

The acceptable voltage vs. frequency characteristic is portrayed below on the chart:
