Device TC23x
Marking/Step ES-AC, AC
Package see Data Sheet

10210AERRA

This Errata Sheet describes the deviations from the current user documentation.

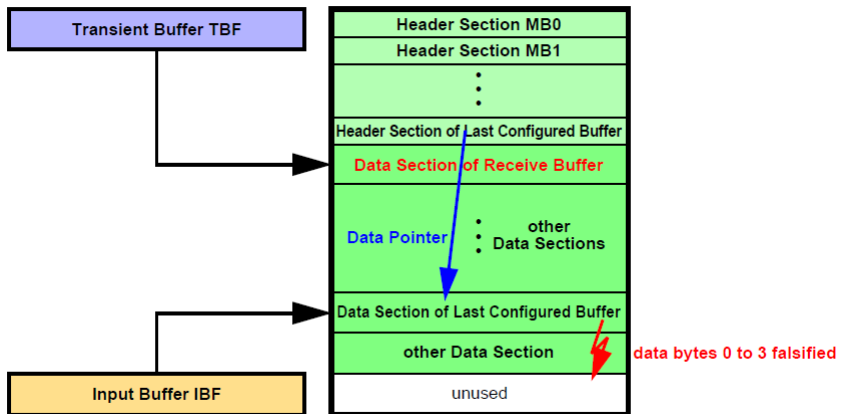
Figure 2 Message buffer transfer from IBF to Message RAM

After the Data Section of the selected message buffer in the Message RAM has been written, one additional write access overwrites the following word in the Message RAM which might be the first word of the next Data Section.

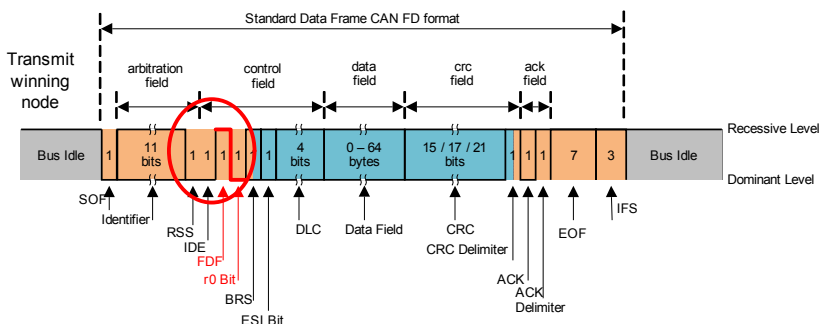
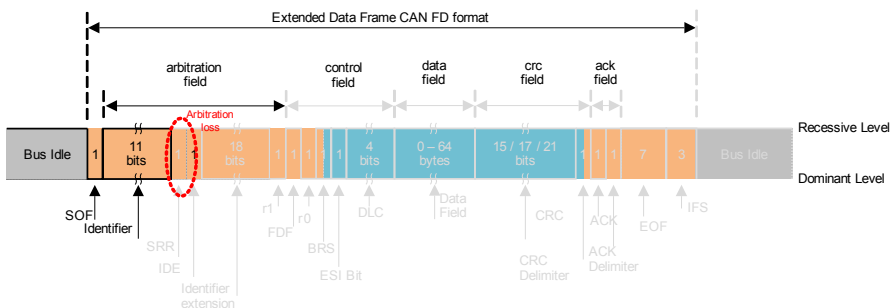
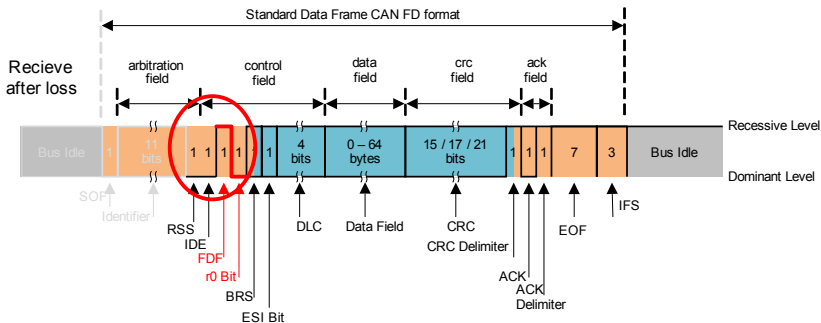
The device is producing more error frames within a network than a device with a hardsync at the FDF bit.

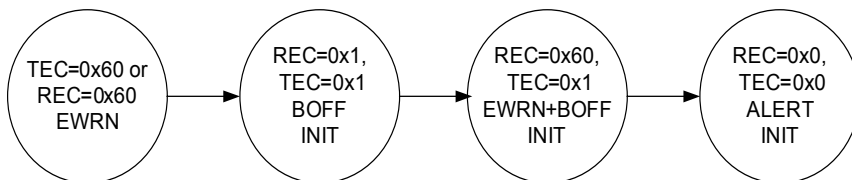
Figure 8 Alert Interrupt Behavior in case of Bus-Off

When the threshold for error warning (EWRN) is reached (default value of Error Warning Level EWRN = 0x60), then the EWRN interrupt is issued. The bus-off (BOFF) status is reached if $TEC > 255$ according to CAN specification, changing the MultiCAN module with REC and TEC to the same value 0x1, setting the INIT bit to 1_B, and issuing the BOFF interrupt. The bus-off recovery phase starts automatically. Every time an idle time is seen, REC is incremented. If REC = 0x60, a combined status EWRN+BOFF is reached. The corresponding interrupt can also be seen as a pre-warning interrupt, that the bus-off recovery phase will be finished soon. When the bus-off recovery phase has finished (128 times idle time have been seen on the bus), EWRN and BOFF are cleared, the ALERT interrupt bit is set and the INIT bit is still set.

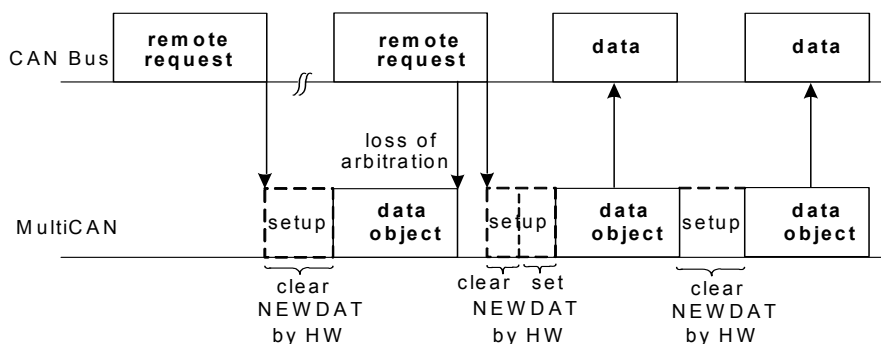
Figure 9 Loss of Arbitration

When the appropriate message object (data frame) triggered by the first remote frame wins the arbitration, it will be sent out and NEWDAT is not reset. This leads to an additional data frame, that will be sent by this message object (clearing NEWDAT).

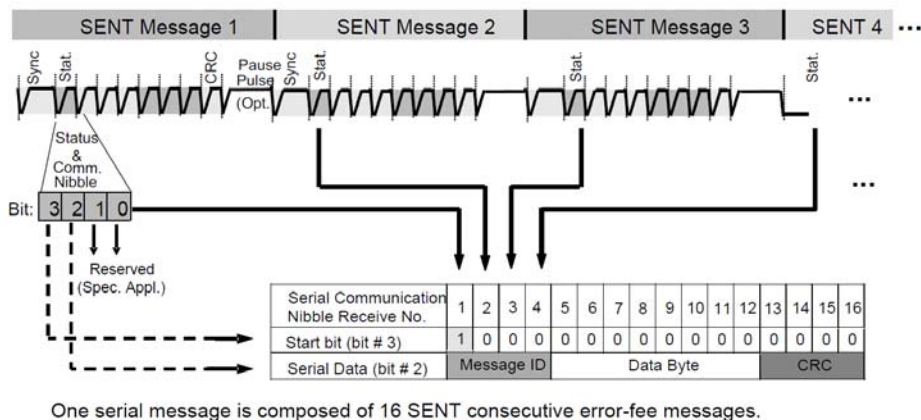
Figure 13 Short Serial Message, Serial Data Encoding over 16 messages

Figure 13 shows a corrected version of this figure.
