**Device** TC27x  
**Marking/Step** ES-DC, DC  
**Package** see Data Sheet

## 10216AERRA

This Errata Sheet describes the deviations from the current user documentation.

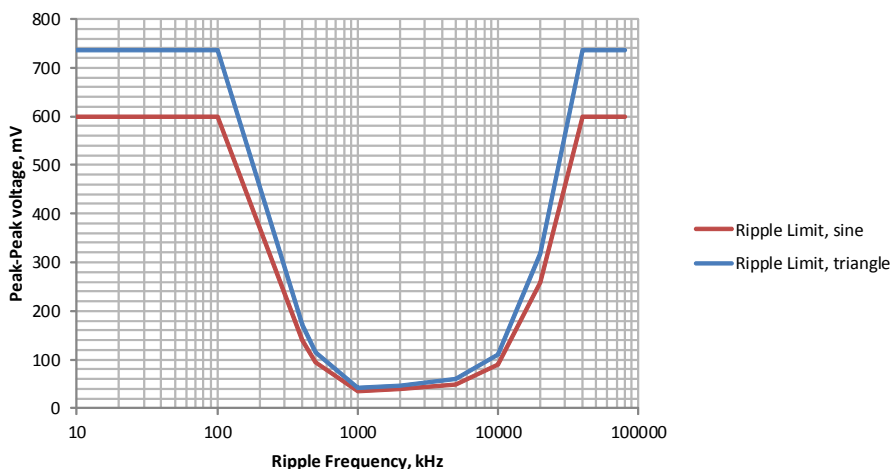
**Figure 14** Ripple Voltage vs. Frequency Characteristic

The internal back-up clock is sensitive to specific power supply voltage disturbance/ripple caused by a voltage ripple intrinsic to DC-DC converters. Specific conditions such as insufficient filtering of the ripple may lead to improper behavior of the start-up scheme of the back-up clock, and thus stuck-at state during the start-up of the microcontroller until this condition is removed.

The diagram reflects acceptable ripple level during the cold start of the microcontroller at the respective VDDP3/VEXT/VEVRSB supply of the PMS subsystem, depending on the device and package type, as shown in the following table.

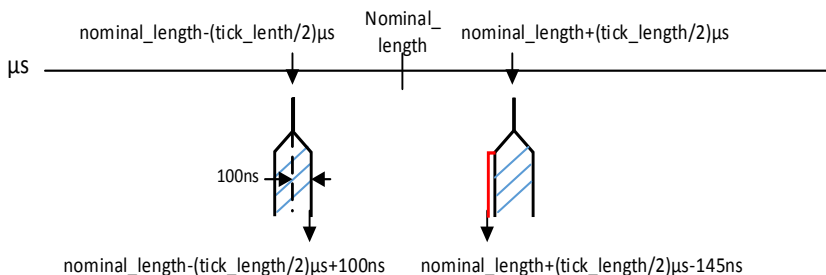
**Figure 16 SENT Tolerance of this Design Step**

In this design step the range is delimited as follows:

- The lower border is  $\text{nominal\_value} - (\text{tick\_length}/2) \mu\text{s} + 100 \text{ ns}$
- The upper border is  $\text{nominal\_value} + (\text{tick\_length}/2) \mu\text{s} - 145 \text{ ns}$ .

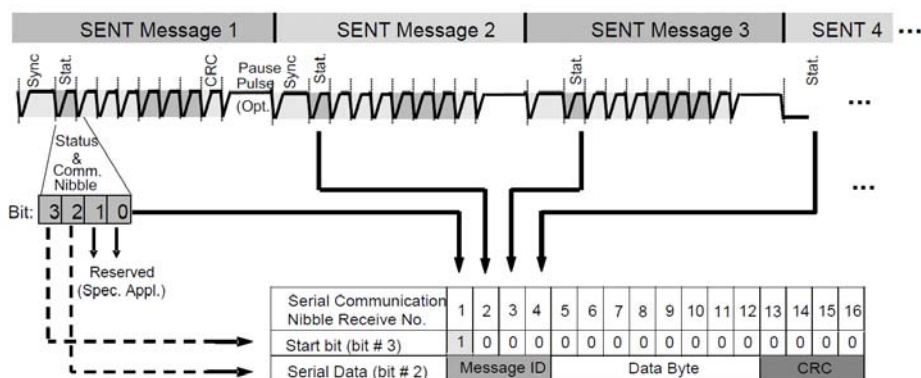
**Figure 17 Short Serial Message, Serial Data Encoding over 16 messages**

**Figure 17** shows a corrected version of this figure.
