Device TC29x
Marking/Step ES-BC, BC
Package see Data Sheet

This Errata Sheet describes the deviations from the current user documentation.

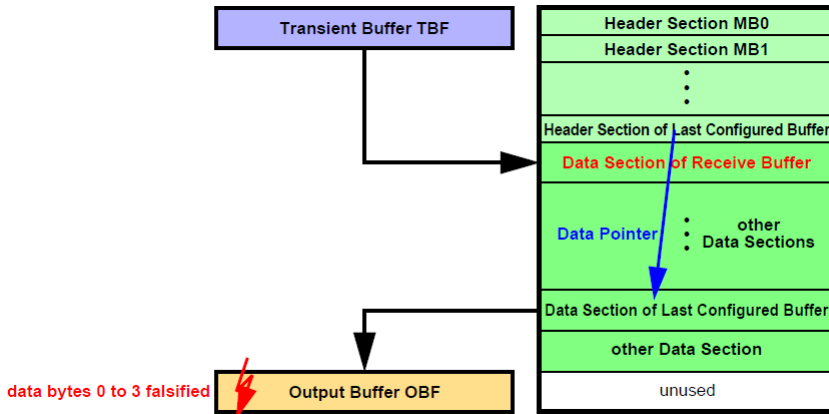
Figure 1 Message buffer transfer from Message RAM to OBF

When the message buffer has its payload configured to maximum length (PLC = 127), the OBF word on address 00h (payload data bytes 0 to 3) is overwritten with unexpected data at the end of the transfer.

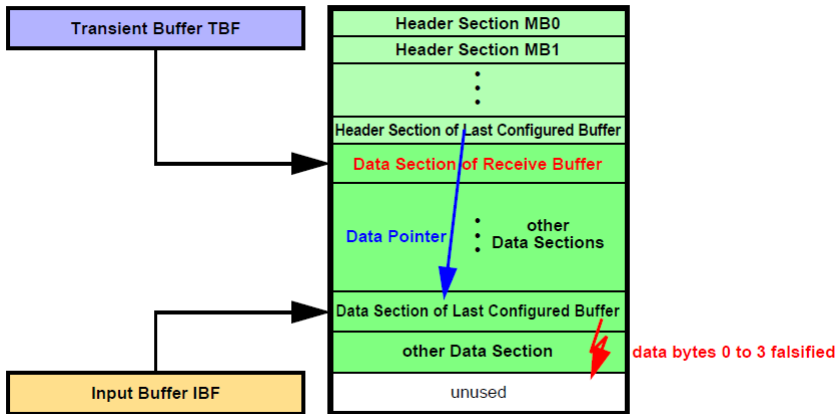
Figure 2 Message buffer transfer from IBF to Message RAM

After the Data Section of the selected message buffer in the Message RAM has been written, one additional write access overwrites the following word in the Message RAM which might be the first word of the next Data Section.

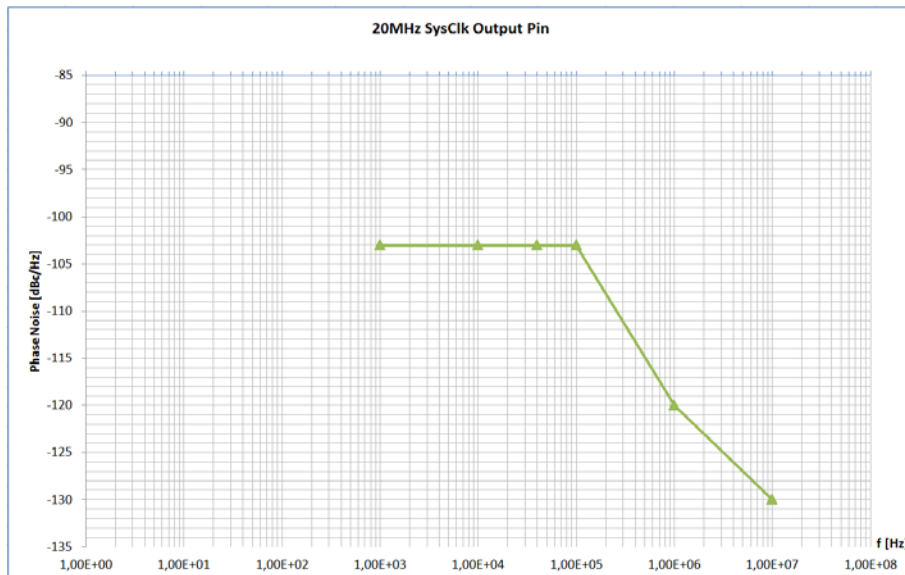
Figure 5 Phase Noise Density on SysClk Output Pin

The diagram below shows the phase noise density on the SysClk pin when no application pattern but only the HSSL/HSCT subsystem is running:

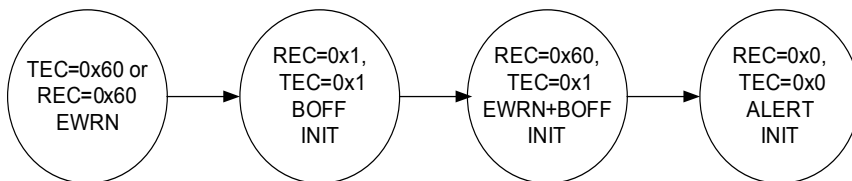
Figure 7 Alert Interrupt Behavior in case of Bus-Off

When the threshold for error warning (EWRN) is reached (default value of Error Warning Level EWRN = 0x60), then the EWRN interrupt is issued. The bus-off (BOFF) status is reached if $TEC > 255$ according to CAN specification, changing the MultiCAN module with REC and TEC to the same value 0x1, setting the INIT bit to 1_B, and issuing the BOFF interrupt. The bus-off recovery phase starts automatically. Every time an idle time is seen, REC is incremented. If REC = 0x60, a combined status EWRN+BOFF is reached. The corresponding interrupt can also be seen as a pre-warning interrupt, that the bus-off recovery phase will be finished soon. When the bus-off recovery phase has finished (128 times idle time have been seen on the bus), EWRN and BOFF are cleared, the ALERT interrupt bit is set and the INIT bit is still set.

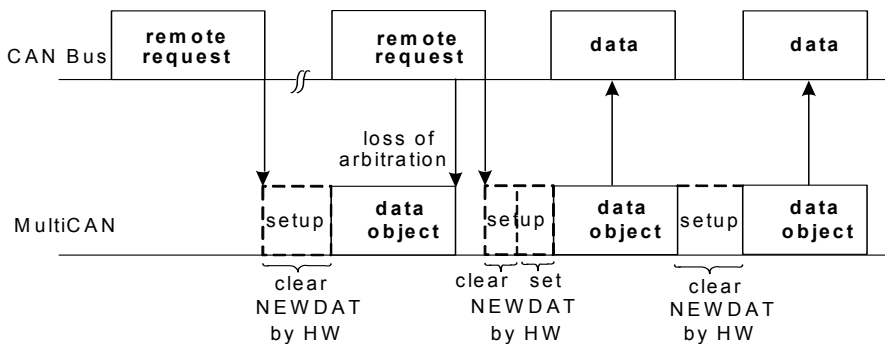
Figure 8 Loss of Arbitration

When the appropriate message object (data frame) triggered by the first remote frame wins the arbitration, it will be sent out and `NEWDAT` is not reset. This leads to an additional data frame, that will be sent by this message object (clearing `NEWDAT`).

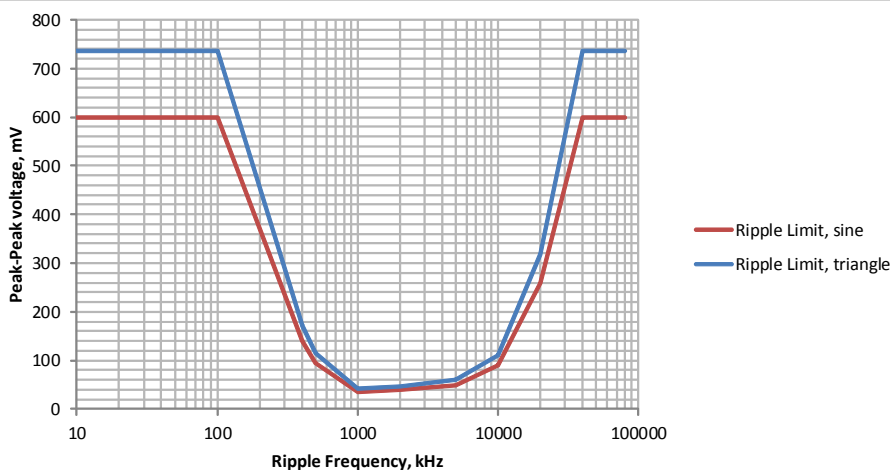
Figure 11 Ripple Voltage vs. Frequency Characteristic

The internal back-up clock is sensitive to specific power supply voltage disturbance/ripple caused by a voltage ripple intrinsic to DC-DC converters. Specific conditions such as insufficient filtering of the ripple may lead to improper behavior of the start-up scheme of the back-up clock, and thus stuck-at state during the start-up of the microcontroller until this condition is removed.

The diagram reflects acceptable ripple level during the cold start of the microcontroller at the respective VDDP3/VEXT/VEVRSB supply of the PMS subsystem, depending on the device and package type, as shown in the following table.

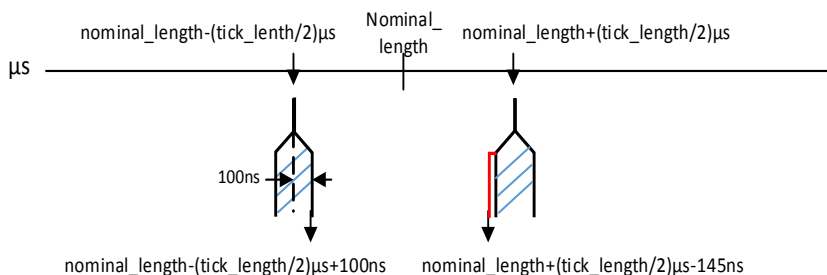
Figure 13 SENT Tolerance of this Design Step

- The lower border is $\text{nominal_value} - (\text{tick_length}/2) \mu\text{s} + 100 \text{ ns}$
- The upper border is $\text{nominal_value} + (\text{tick_length}/2) \mu\text{s} - 145 \text{ ns}$.
