Device TC33x/TC32x
Marking/Step (E)ES-AA, AA
Package see Data Sheet

10300AERRA

This Errata Sheet describes the deviations from the current user documentation.

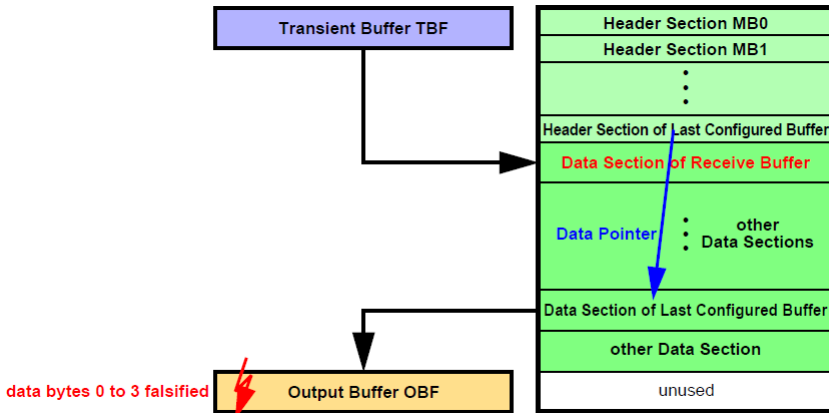
Figure 1 Message buffer transfer from Message RAM to OBF

When the message buffer has its payload configured to maximum length (**PLC** = 127), the OBF word on address 00h (payload data bytes 0 to 3) is overwritten with unexpected data at the end of the transfer.

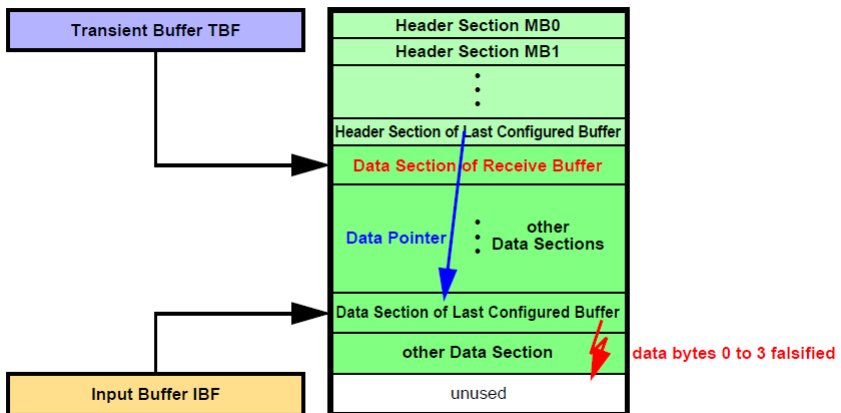
Figure 2 Message buffer transfer from IBF to Message RAM

After the Data Section of the selected message buffer in the Message RAM has been written, one additional write access overwrites the following word in the Message RAM which might be the first word of the next Data Section.

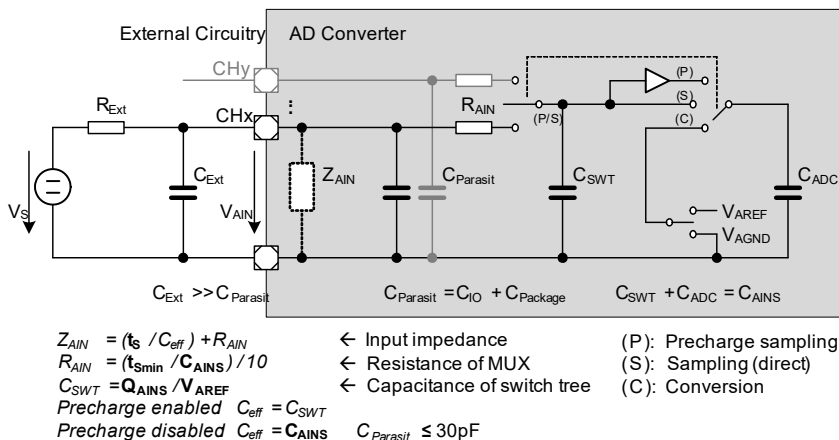
Figure 4 Equivalent Circuitry for Analog Inputs

Figure “Equivalent Circuitry for Analog Inputs” will be modified in future revisions of the Data Sheet, including the term $C_{\text{Parasit}} \leq 30 \text{ pF}$, as shown in the following figure:

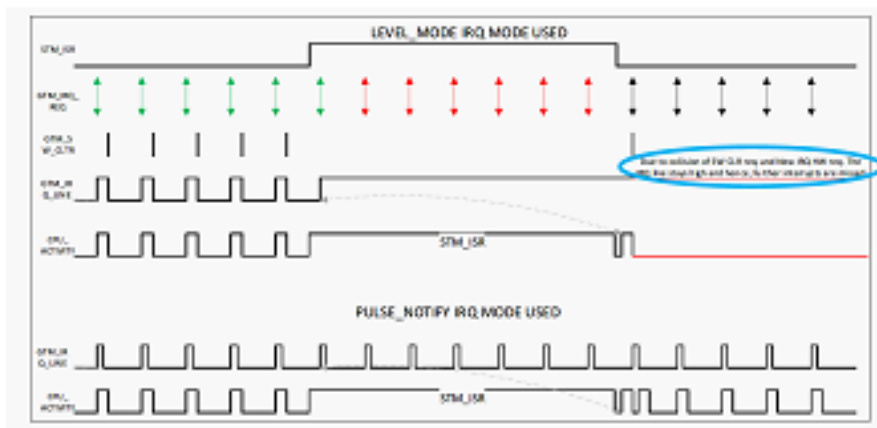
Figure 5 Interrupt Level vs. Pulse-Notify mode - Corner Case Example

Hence, in Level Mode, in some scenarios where another interrupt request is generated by GTM while the ISR handle also requests a SW clear, then, as the interrupt event is dominant over the clear event (for simultaneous interrupt and clear events), GTM_IRQ_XXX is not cleared and remains high. As a consequence, the IR observes no transition on GTM_IRQ_XX. Thus, any forthcoming interrupt events in this scenario are lost as there is no chance to release the CPU IRQ when a collision happens as shown in Figure below.

Therefore, it is recommended to use the Pulse-Notify mode to ensure that none of the interrupts might be lost by the IR even in corner timing cases.
