# AURIX™ TC33x/TC32x errata sheet

Marking/Step: (E)ES-AA, AA

This document describes the deviations of the device from the current user documentation, to support the assessment of the effects of these deviations on your custom hardware and software implementations.

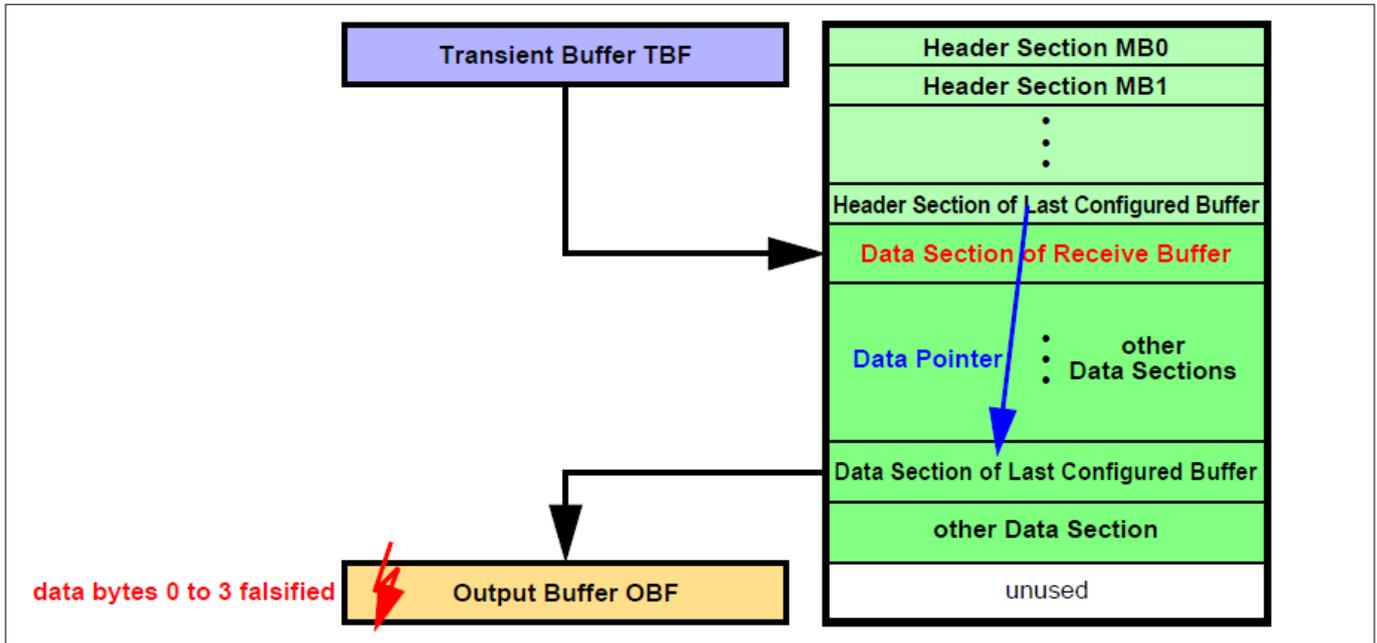
**Figure 1** Message buffer transfer from Message RAM to OBF

When the message buffer has its payload configured to maximum length (`PLC = 127`), the OBF word on address `00h` (payload data bytes 0 to 3) is overwritten with unexpected data at the end of the transfer.

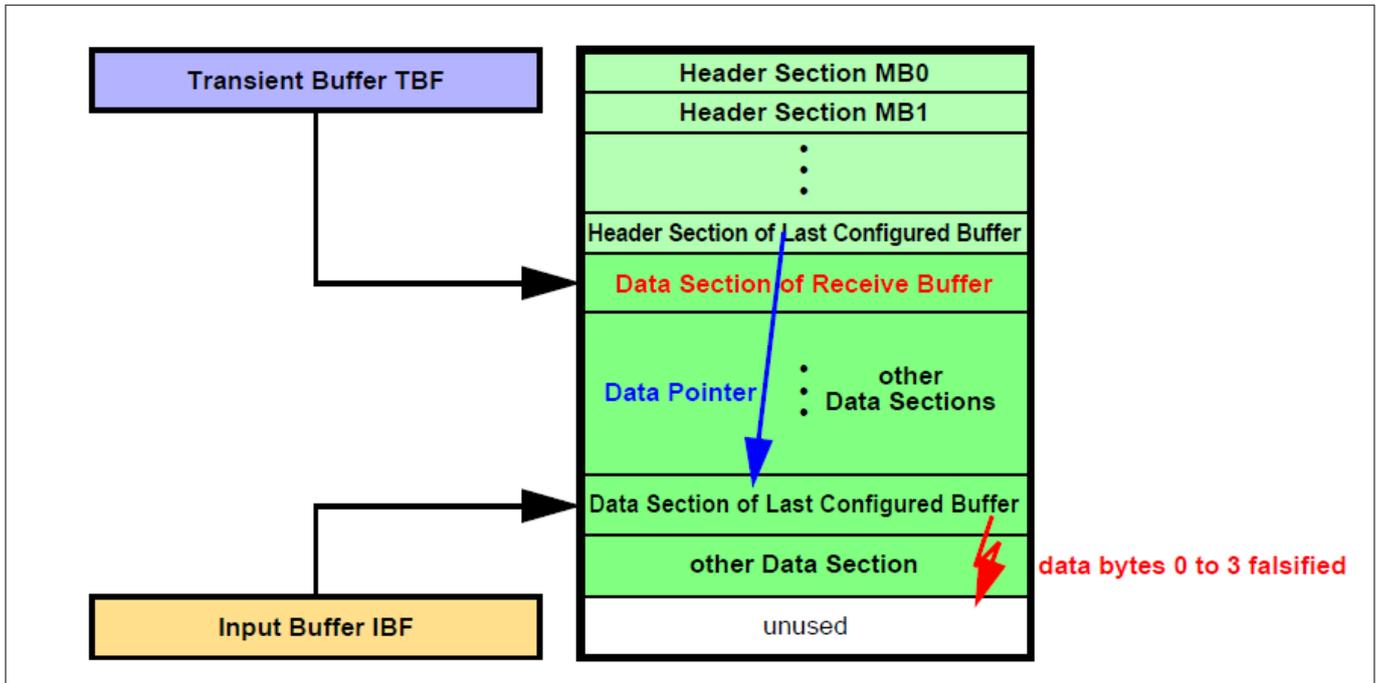
**Figure 2** Message buffer transfer from IBF to Message RAM

After the Data Section of the selected message buffer in the Message RAM has been written, one additional write access overwrites the following word in the Message RAM which might be the first word of the next Data Section.

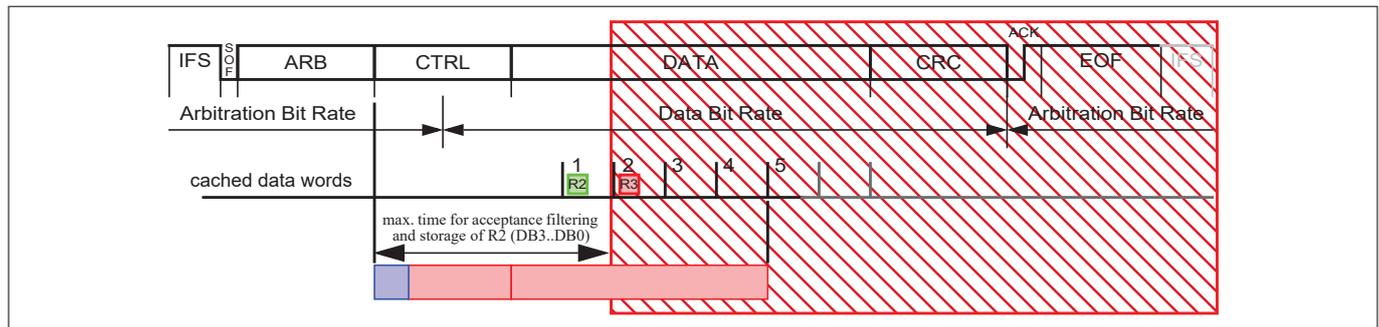
**Figure 5** CAN Frame with DLC > 4

Under the following conditions a received message will have corrupted data while the received message is signaled as valid to the host.

The figure that follows shows how the available time for acceptance filtering and storage is reduced.

Due to condition 3) the issue only occurs sporadically. Use an end-to-end (E2E) protection (for example, checksum or CRC covering the data field) and add it to all messages in the CAN system, to detect data corruption in received frames.

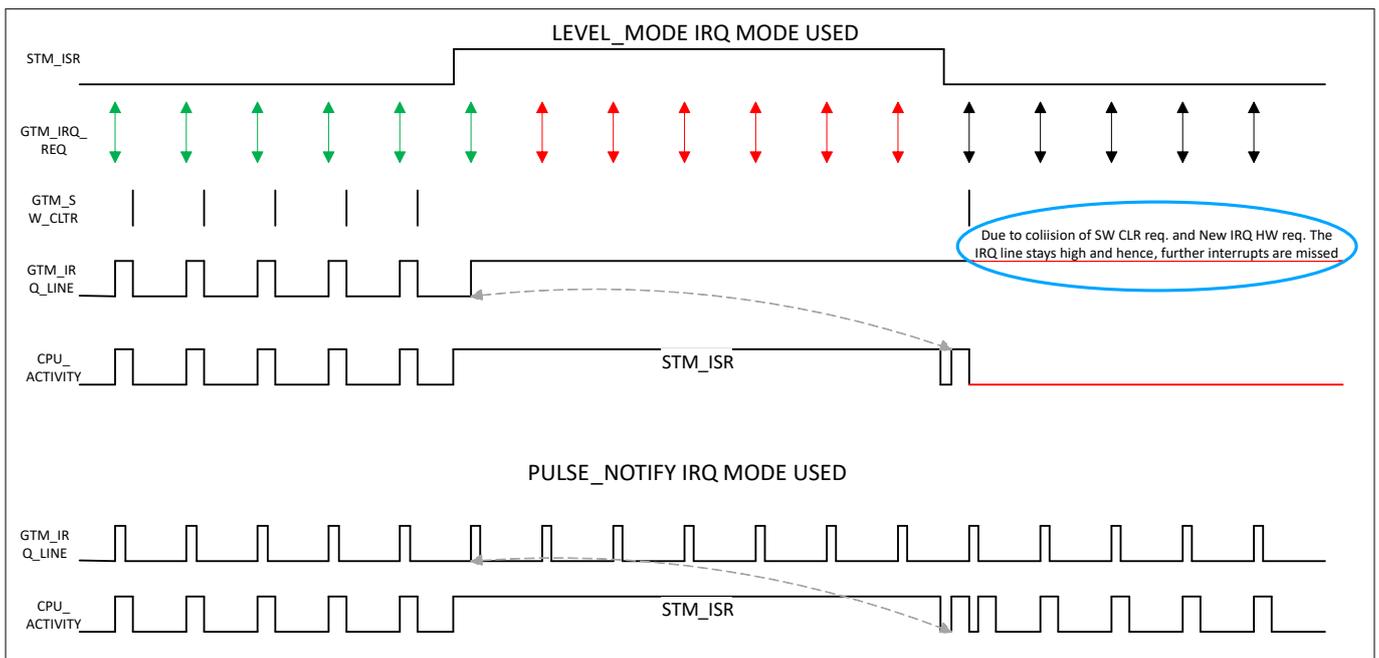
**Figure 6 Interrupt Level vs. Pulse-Notify mode - Corner Case Example**

The default setting for field IRQ\_MODE in register IRQ\_MODE is Interrupt Level mode (00<sub>B</sub> ). Figure “GTM interrupts” in chapter “GTM Implementation” of the TC3xx User’s Manual shows how the interrupt signal (GTM\_IRQ\_XXX) triggers an interrupt towards the Interrupt Router (IR), depending on IRQ\_MODE. As described in the text below this figure, while using Level mode, if more internal “interrupt” events are generated (i.e. two TOM channels generating a CCU0 interrupt), just one interrupt signal is sent to the IR, and no more interrupts are triggered until the SW clears the GTM\_IRQ\_XXX line towards the IR. Hence, in Level Mode, in some scenarios where another interrupt request is generated by GTM while the ISR handle also requests a SW clear, then, as the interrupt event is dominant over the clear event (for simultaneous interrupt and clear events), GTM\_IRQ\_XXX is not cleared and remains high. As a consequence, the IR observes no transition on GTM\_IRQ\_XX. Thus, any forthcoming interrupt events in this scenario are lost as there is no chance to release the CPU IRQ when a collision happens as shown in Figure below.

If Pulse-Notify mode is selected, every internal trigger will be forwarded to the IR, irrespective of the time of occurrence and the clear event, as the pulse-notify leads to set and reset of GTM\_IRQ\_XXX as compared to only setting of the GTM\_IRQ\_XXX line in Level mode.

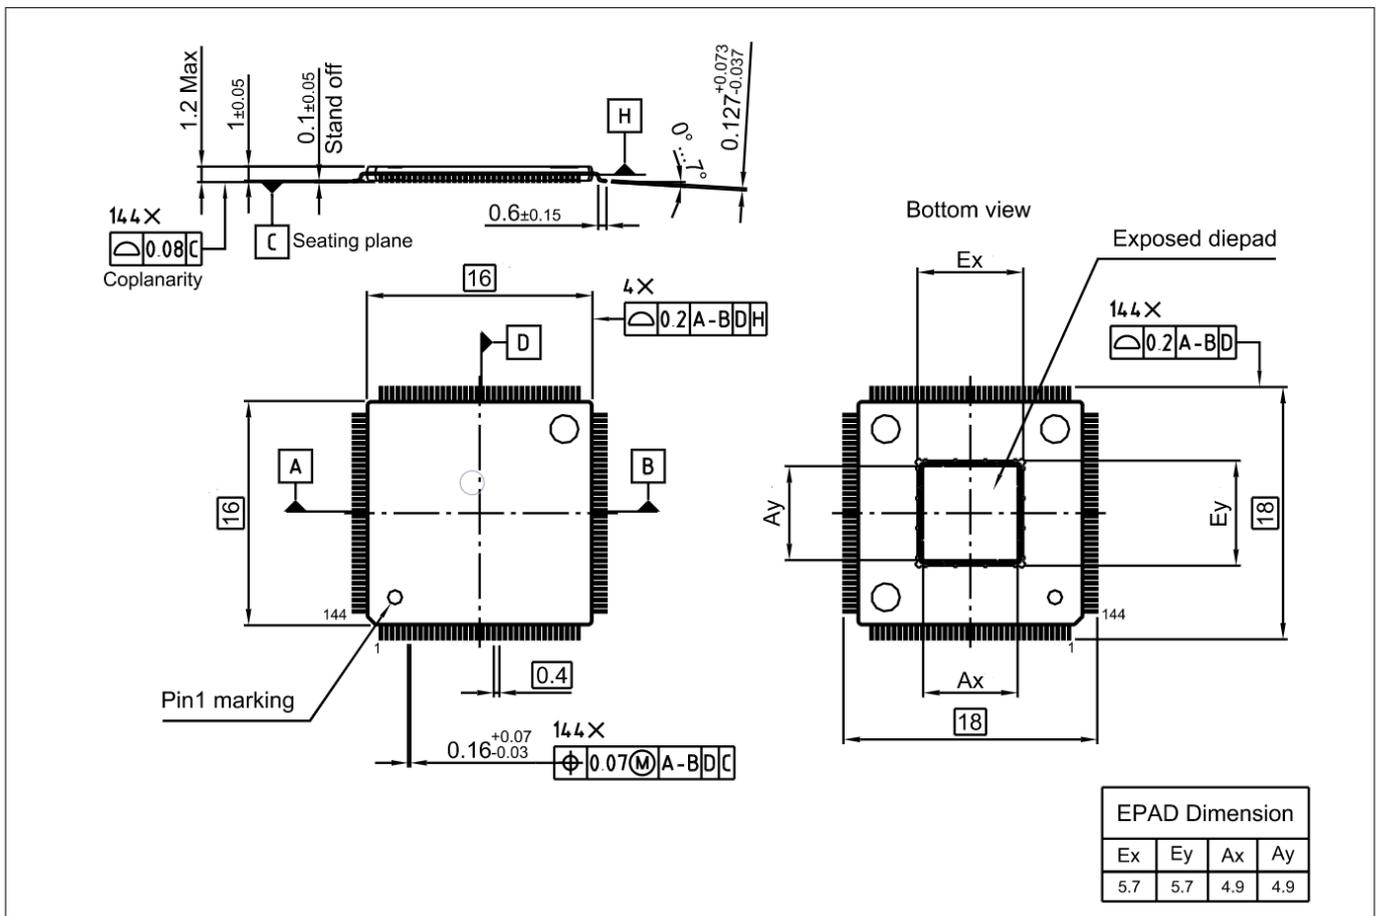
Figure 7 Package Outlines TQFP-144 for TC33x/TC32x

**Note:** For the exposed diepad of the TQFP-144 package of the TC33x/TC32x, structural corner protrusions have to be considered for purposes of system design and integration with a maximum boundary of 6.2 mm.

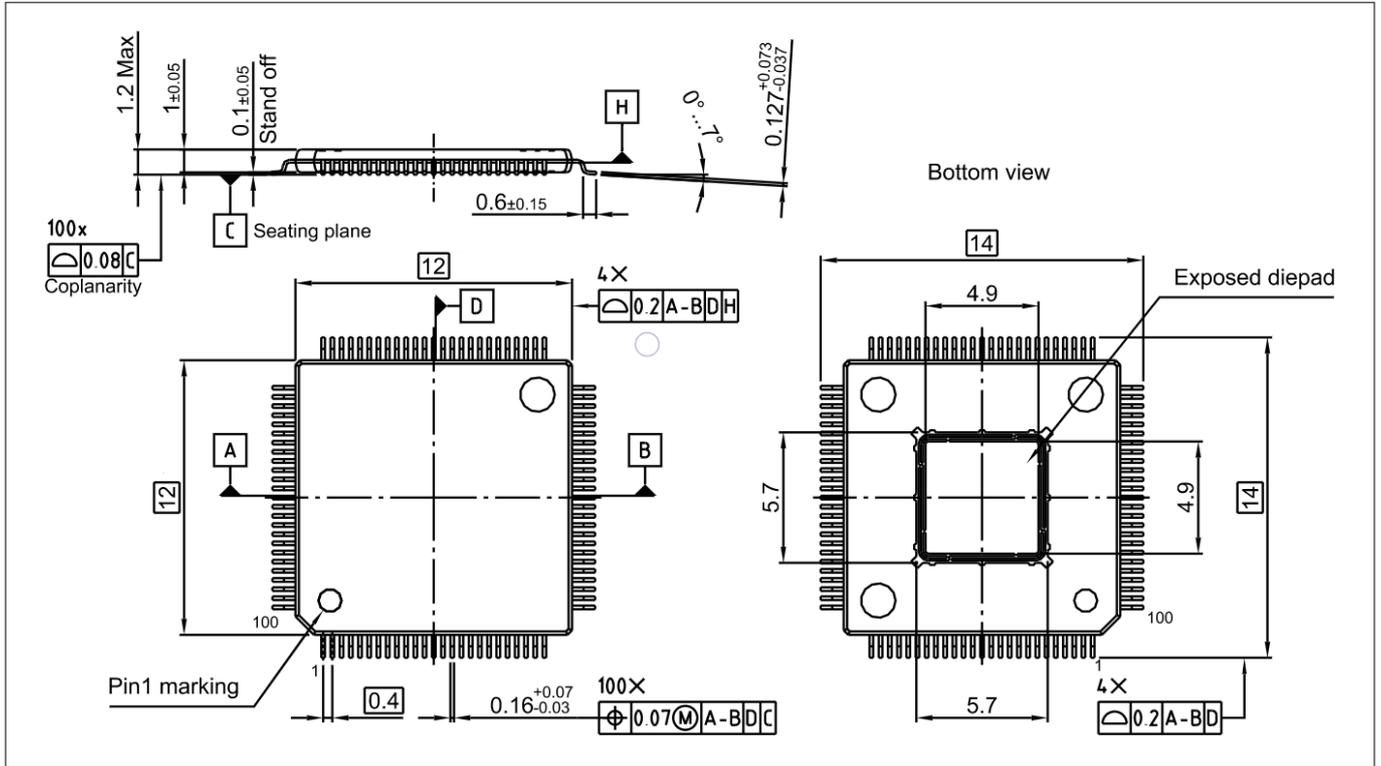
**Figure 8 Package Outlines TQFP-100 for TC33x/TC32x**

**Note:** For the exposed diepad of the TQFP-100 package of the TC33x/TC32x, structural corner protrusions have to be considered for purposes of system design and integration with a maximum boundary of 6.3 mm.
