## XC2300 Derivatives

16/32-Bit Single-Chip Microcontroller  
with 32-Bit Performance

Errata Sheet

V1.9 2014-10

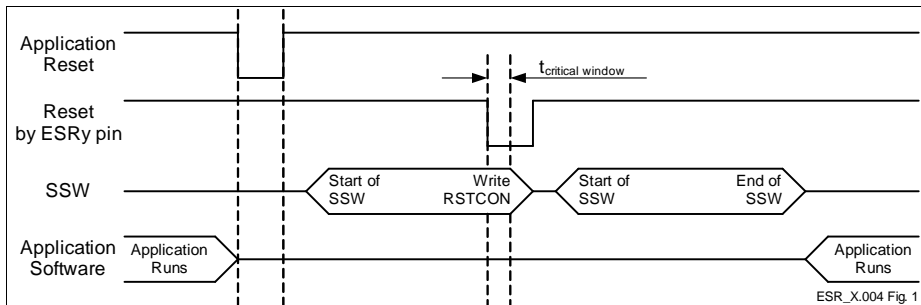
**Figure 1 Critical application reset sequence**

SCU\_RSTCONx registers are reset only by Power-On, but they may be wrongly affected after a second application reset requested by an ESRy pin. This may lead to the SCU\_RSTCONx register values being set to zero, which could unexpectedly disable reset sources within the user application. The conditions which lead to this behavior are:

1. First, an application reset by SW (software), CPU (Central Processing Unit), MP (Memory), WDT (Watchdog Timer) or ESRy (External Service Request y) occurs.
2. Following this, an application reset on an ESRy pin occurs.
3. If the above mentioned ESRy reset occurs during a critical time window of the SSW (startup software), then it's possible that the application will operate with the wrong SCU\_RSTCONx register value. The critical time window occurs when the SSW is writing the SCU\_RSTCONx registers, and at the same time, the ESRy reset request is processed by the reset circuitry. The width of this critical window  $f_{critical\ window}$  is less than 13 cycles.

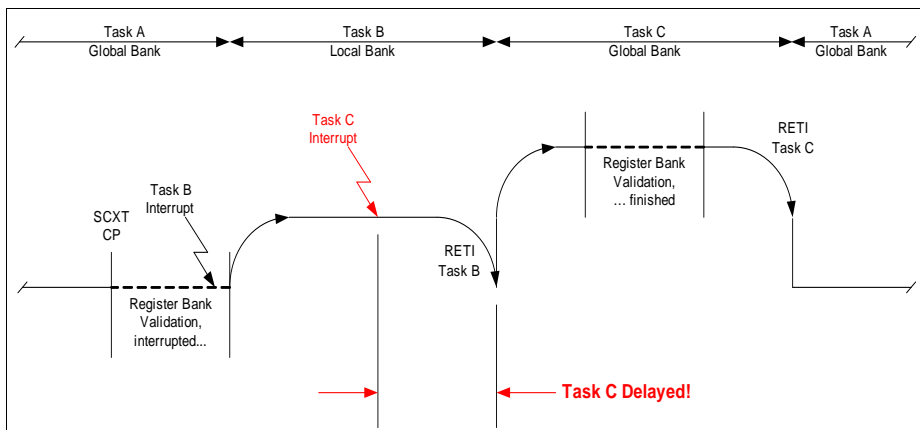
**Figure 2 Example for Case 2: Interrupt Service for Task C delayed**

- The Context Pointer CP is written to (e.g. by POP, MOV, SCXT ... instructions) within a routine (Task A) that uses a **global** register bank (bit field PSW.BANK = 00<sub>B</sub>), i.e. the context for this routine will be modified,
- This context switch procedure (19 cycles) is interrupted by an interrupt request (Task B) which is programmed (with GPRSELx = 1X<sub>B</sub>) to automatically use one of the **local** banks via the bank selection registers BNKSEL0...3 (i.e. the interrupting routine has a priority level  $\geq 12$ ),
- Before the corresponding interrupt service routine is finished, another interrupt request (Task C) occurs which is programmed (with GPRSELx = 00<sub>B</sub>) to automatically use the **global** bank via the bank selection registers BNKSEL0...3 (i.e. the interrupting routine has a priority level  $\geq 13$ ).

In this case service of this interrupt request (for Task C) is delayed until bit field PSW.BANK becomes 00<sub>B</sub> after executing the RETI instruction at the end of the routine (Task B) using the local bank.

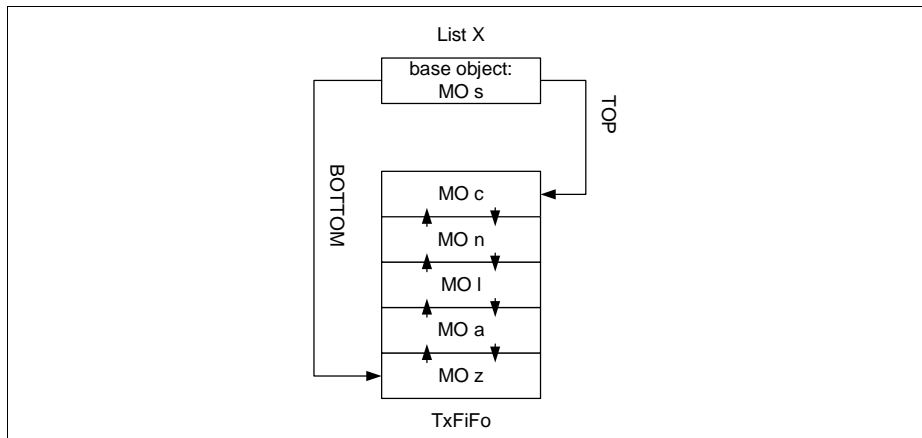
**Figure 3** FIFO structure

After the successful transmission of a Tx FIFO element, a Tx overflow interrupt is generated if the FIFO base object fulfils these conditions:

If Tx FIFO overflow interrupt needed, take the FIFO base object out of the circular list of the Tx message objects. That is to say, just use the FIFO base object for FIFO control, but not to store a Tx message.

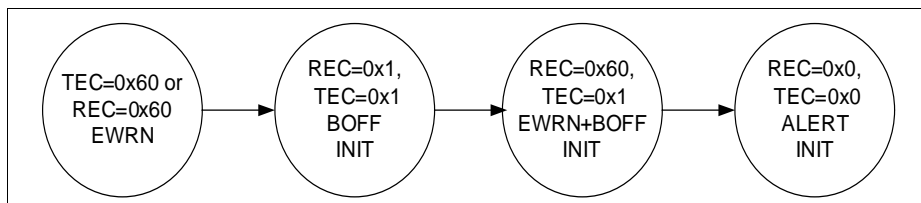
**Figure 5 Alert Interrupt Behavior in case of Bus-Off**

The MultiCAN module shows the following behavior in case of a bus-off status:

When the threshold for error warning (EWRN) is reached (default value of Error Warning Level EWRN = 0x60), then the EWRN interrupt is issued. The bus-off (BOFF) status is reached if TEC > 255 according to CAN specification, changing the MultiCAN module with REC and TEC to the same value 0x1, setting the INIT bit to 1<sub>B</sub>, and issuing the BOFF interrupt. The bus-off recovery phase starts automatically. Every time an idle time is seen, REC is incremented. If REC = 0x60, a combined status EWRN+BOFF is reached. The corresponding interrupt can also be seen as a pre-warning interrupt, that the bus-off recovery phase will be finished soon. When the bus-off recovery phase has finished (128 times idle time have been seen on the bus), EWRN and BOFF are cleared, the ALERT interrupt bit is set and the INIT bit is still set.

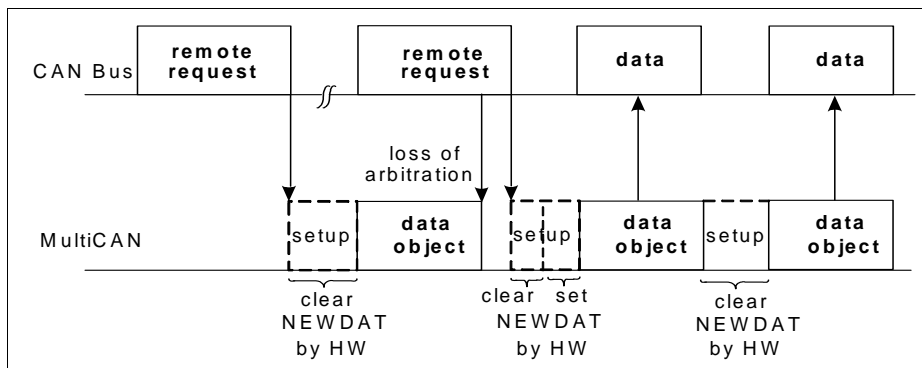
Figure 6 Loss of Arbitration

When the appropriate message object (data frame) triggered by the first remote frame wins the arbitration, it will be sent out and NEWDAT is not reset. This leads to an additional data frame, that will be sent by this message object (clearing NEWDAT).

There will, however, not be more data frames than there are corresponding remote requests.
