<b>Device</b>	<b>XMC1100</b>
<b>Marking/Step</b>	<b>EES-AA, ES-AA, AA</b>
<b>Package</b>	<b>PG-TSSOP-16/38, PG-VQFN-24/40</b>

This “Errata Sheet” describes product deviations with respect to the user documentation listed below.

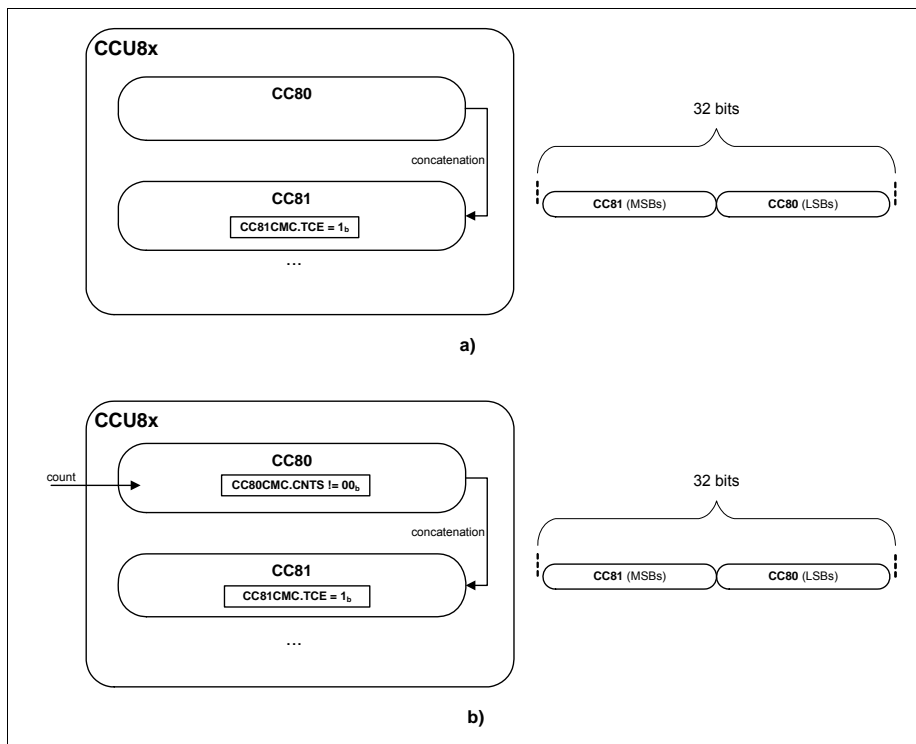
Each CCU4/CCU8 module offers the possibility of selecting an external signal to be used as the master clock for every timer inside the module Figure 1. External signal in this context is understood as a signal connected to other module/IP or connected to the device ports.

Currently is only possible to use an external signal as Timer Clock when a division ratio of 2 or higher is selected. When no division is selected (divided by 1), the external signal cannot be used.

The user must program the PSIV field of each Timer Slice with a value different from 0000<sub>B</sub> - minimum division value is /2.

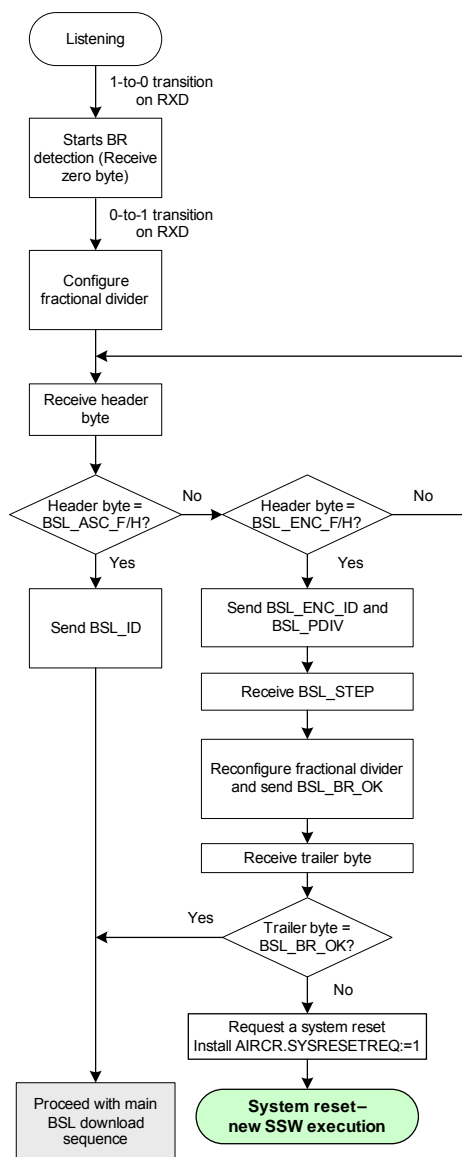
**Figure 2 Baud Rate configuration sequence during ASC BSL entry**

The ASC Bootstrap Loader allows the user to switch to baudrates higher than the initial baudrate when the communication is established for faster downloading of code/data.

With the current implementation (refer to the “Bootstrap Loaders and User Routines” chapter in Reference Manual) the host device (e.g. a PC) may have problem to switch the baudrate fast enough after sending the request (BSL\_STEP as of [Figure 2](#)) and is not able to receive the device acknowledge (BSL\_BR\_OK) correctly with the changed ASC channel speed. If this happens, the host will get some error condition - wrong response, start bit not detected, etc. In such a case the host has to ignore the error and send the trailer Byte (BSL\_BR\_OK) with the new baudrate. The correctness of the communication speed settings will be then decided by the host upon the response from the device after sending the length of code for downloading (refer to [Figure 3](#)).
