Device	XMC1300
Marking/Step	EES-AA, ES-AA, AA
Package	PG-TSSOP-16/38, PG-VQFN-24/40

Overview

This “Errata Sheet” describes product deviations with respect to the user documentation listed below.

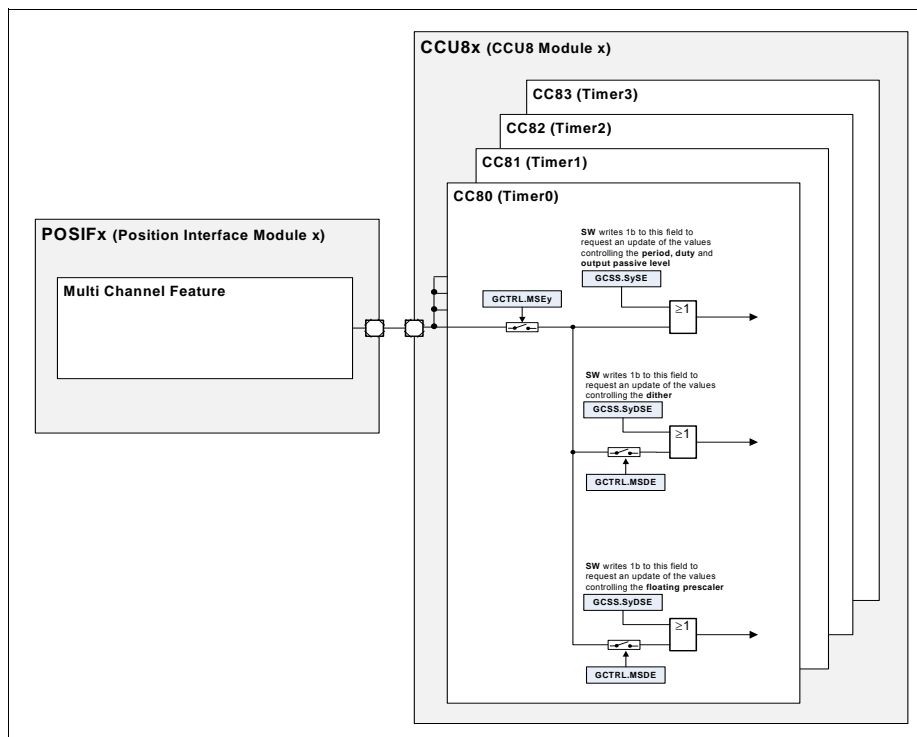
Figure 2 Value update trigger connection between CCU8x and POSIFx

On Figure 2, the SW has updated the next values for the duty cycle on a CCU8x Timer (it can be also for the period, output passive level and clock prescaler). After that it updates also the next value of the multi channel pattern inside the POSIFx module. After that, the POSIF reaches an internal state (dictated by specific conditions) where an update of the values is needed. It generates a trigger signal to the CCU8x Timer to signalize that an update of the duty cycle value needs to be done. After that timeframe, the POSIF waits for the handshake trigger of the CCU8x Timer to indicate that an update is going to be performed. At this specific time, both the values of the CCU8x Timer and POSIF are updated completely synchronous.

This feature cannot be used with the Timer2 (defined as CC82 in the documentation) of the CCU8x module(s) (more than one CCU8 module can be contained on a specific device).

All the other 3 Timers (defined as CC80, CC81, CC83) inside the CCU8x module are not affected by this issue.

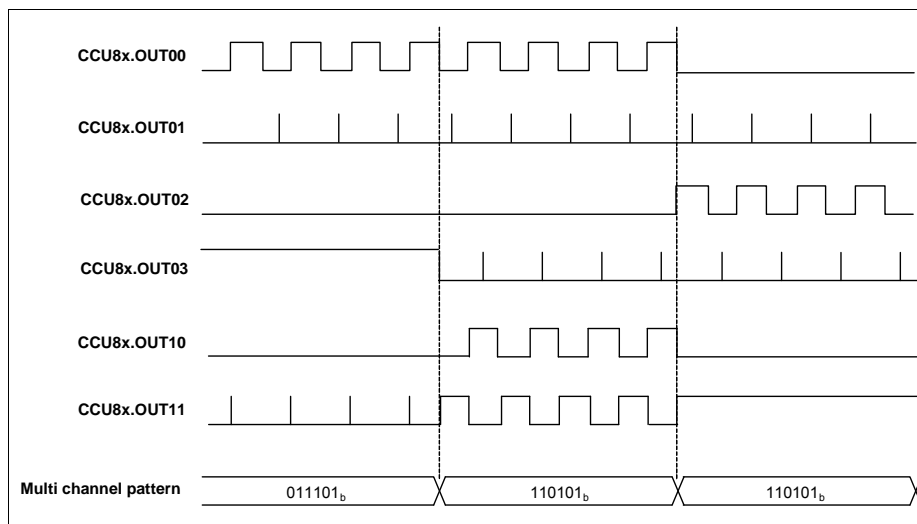
Figure 7 PWM output glitch

This glitch only affects the PWM output that is linked to the inverting ST path of each compare channel (non inverting outputs are not affected).

The effect of this glitch can be seen in Figure 3. The duration of the PWM glitch has the same length has the dead time value programmed into the CC8yDC1R.DT1F field (for compare channel 1) or into the CC8yDC1R.DT2F.

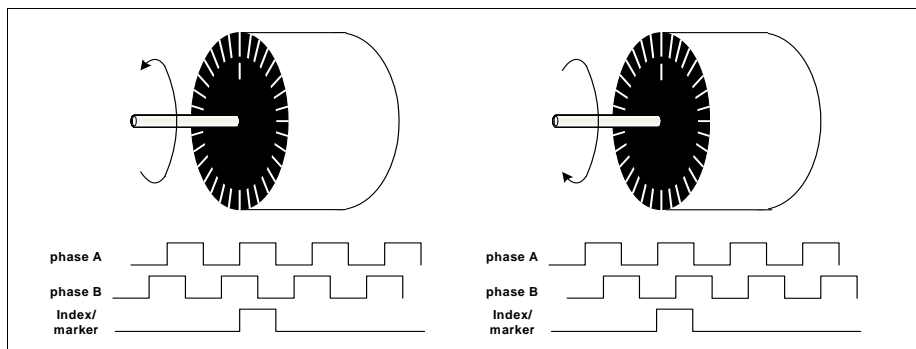
Figure 10 Different index signal types

When the index signal is smaller than 1/2 of the tick period, the POSIF module is not able to decode this signal properly, Figure 2 - notice that the reference edge of the index generation in this figure is the falling of Phase B, nevertheless this is an example and depending on the encoder type, this edge may be one of the other three.

Due to this fact it is not possible to use the POSIF to decode these type of signals (index with duration below 1/2 of the tick period).

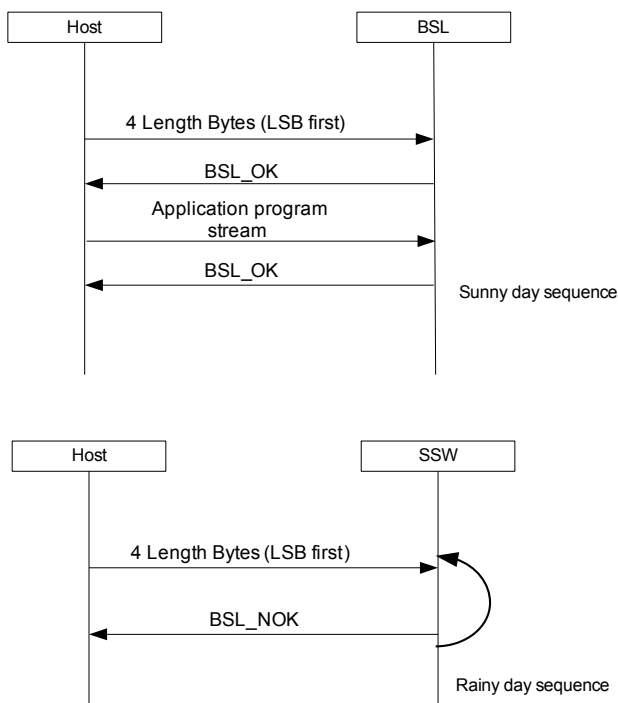
Figure 13 Standard ASC BSL: Application download protocol

With the current implementation (refer to the “Bootstrap Loaders and User Routines” chapter in Reference Manual) the host device (e.g. a PC) may have problem to switch the baudrate fast enough after sending the request (BSL_STEP as of [Figure 12](#)) and is not able to receive the device acknowledge (BSL_BR_OK) correctly with the changed ASC channel speed. If this happens, the host will get some error condition - wrong response, start bit not detected, etc. In such a case the host has to ignore the error and send the trailer Byte (BSL_BR_OK) with the new baudrate. The correctness of the communication speed settings will be then decided by the host upon the response from the device after sending the length of code for downloading (refer to [Figure 13](#)).
