Device	XMC1400
Marking/Step	EES-AA, ES-AA
Package	PG-VQFN-40/48/64, PG-LQFP-64

Overview

This “Errata Sheet” describes product deviations with respect to the user documentation listed below.

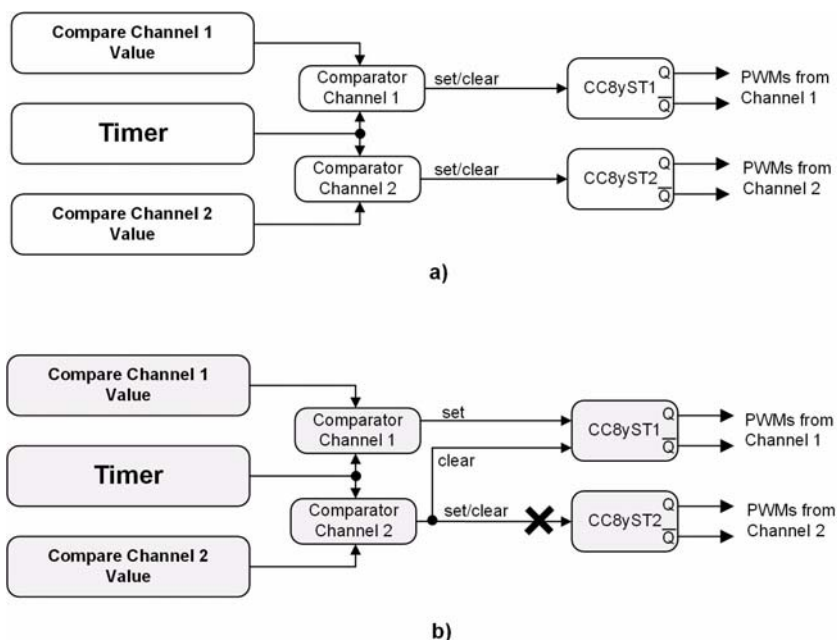
Figure 1 CCU8 simplifier PWM generation scheme - a) normal mode; b) asymmetric mode

CCU8 AI.005 PWM outputs from Compare Channel 2 are disabled in asymmetric mode

The asymmetric mode has a bug, where the PWM signal of Compare Channel 2 is not stored in CC8yST2. This means that from the Compare Channel 2 the timer cannot generate any PWM signal - depicted by the cross on **Figure 1 b)**.

Note that the asymmetric PWM is still stored in CC8yST1 and can be used normally by the application.

Workaround

None

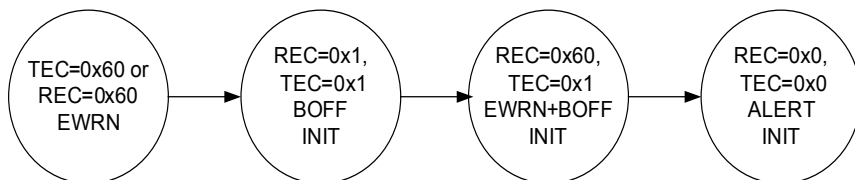
Figure 2 Alert Interrupt Behavior in case of Bus-Off

MultiCAN AI.H007 Alert Interrupt Behavior in case of Bus-Off

When the threshold for error warning (EWRN) is reached (default value of Error Warning Level EWRN = 0x60), then the EWRN interrupt is issued. The bus-off (BOFF) status is reached if $TEC > 255$ according to CAN specification, changing the MultiCAN module with REC and TEC to the same value 0x1, setting the INIT bit to 1_B, and issuing the BOFF interrupt. The bus-off recovery phase starts automatically. Every time an idle time is seen, REC is incremented. If REC = 0x60, a combined status EWRN+BOFF is reached. The corresponding interrupt can also be seen as a pre-warning interrupt, that the bus-off recovery phase will be finished soon. When the bus-off recovery phase has finished (128 times idle time have been seen on the bus), EWRN and BOFF are cleared, the ALERT interrupt bit is set and the INIT bit is still set.

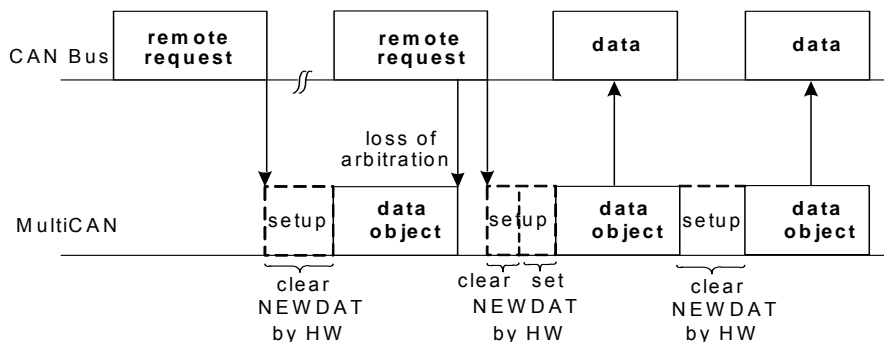
Figure 3 Loss of Arbitration

MultiCAN_TC.H004 Double remote request

Assume the following scenario: A first remote frame (dedicated to a message object) has been received. It performs a transmit setup (TXRQ is set) with clearing NEWDAT. MultiCAN starts to send the receiver message object (data frame), but loses arbitration against a second remote request received by the same message object (NEWDAT will be set).

When the appropriate message object (data frame) triggered by the first remote frame wins the arbitration, it will be sent out and NEWDAT is not reset. This leads to an additional data frame, that will be sent by this message object (clearing NEWDAT).

There will, however, not be more data frames than there are corresponding remote requests.
