Device	XMC1400
Marking/Step	EES-AA, ES-AA, AA
Package	PG-VQFN-40/48/64, PG-LQFP-64, PG-TSSOP-38

Overview

This “Errata Sheet” describes product deviations with respect to the user documentation listed below.

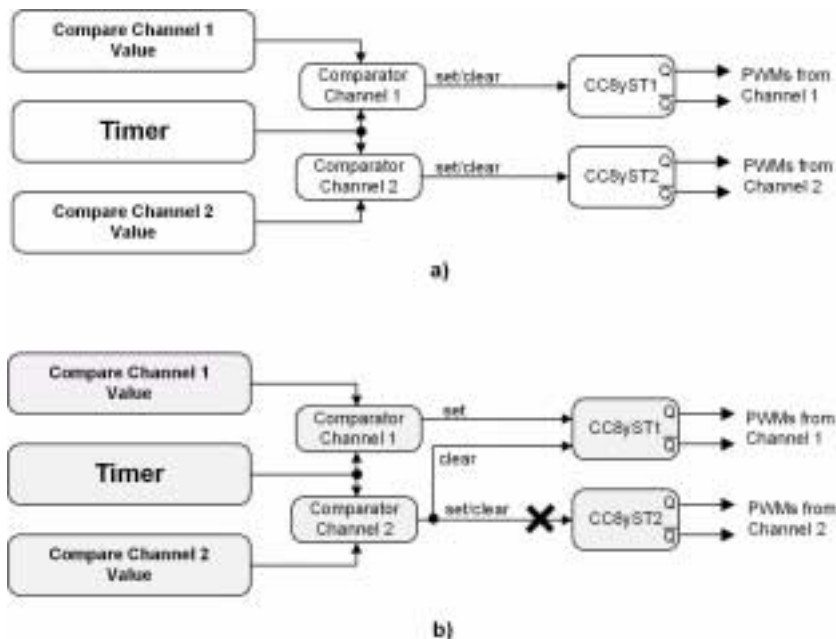
Figure 1 CCU8 simplifier PWM generation scheme - a) normal mode; b) asymmetric mode

CCU8_AI.005 PWM outputs from Compare Channel 2 are disabled in asymmetric mode

The asymmetric mode has a bug, where the PWM signal of Compare Channel 2 is not stored in CC8yST2. This means that from the Compare Channel 2 the timer cannot generate any PWM signal - depicted by the cross on **Figure 1 b)**.

Note that the asymmetric PWM is still stored in CC8yST1 and can be used normally by the application.

None

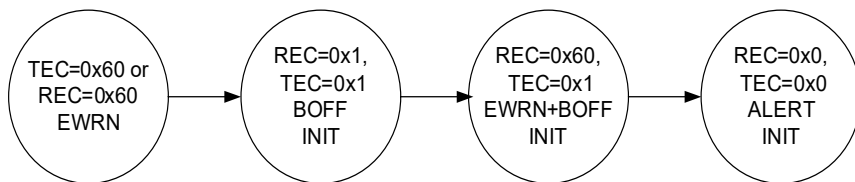
Figure 3 Alert Interrupt Behavior in case of Bus-Off

MultiCAN_AI.H007 Alert Interrupt Behavior in case of Bus-Off

When the threshold for error warning (EWRN) is reached (default value of Error Warning Level EWRN = 0x60), then the EWRN interrupt is issued. The bus-off (BOFF) status is reached if TEC > 255 according to CAN specification, changing the MultiCAN module with REC and TEC to the same value 0x1, setting the INIT bit to 1_B, and issuing the BOFF interrupt. The bus-off recovery phase starts automatically. Every time an idle time is seen, REC is incremented. If REC = 0x60, a combined status EWRN+BOFF is reached. The corresponding interrupt can also be seen as a pre-warning interrupt, that the bus-off recovery phase will be finished soon. When the bus-off recovery phase has finished (128 times idle time have been seen on the bus), EWRN and BOFF are cleared, the ALERT interrupt bit is set and the INIT bit is still set.

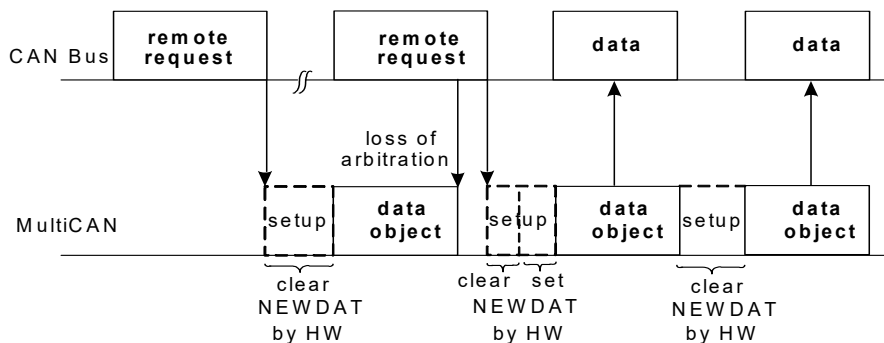
Figure 4 Loss of Arbitration

When the appropriate message object (data frame) triggered by the first remote frame wins the arbitration, it will be sent out and NEWDAT is not reset. This leads to an additional data frame, that will be sent by this message object (clearing NEWDAT).

There will, however, not be more data frames than there are corresponding remote requests.
