Device	XMC4100/XMC4200
Marking/Step	EES-AA, ES-AA
Package	PG-VQFN-48, PG-LQFP-64

Overview

Document ID is **02530AERRA**.

This “Errata Sheet” describes product deviations with respect to the user documentation listed below.

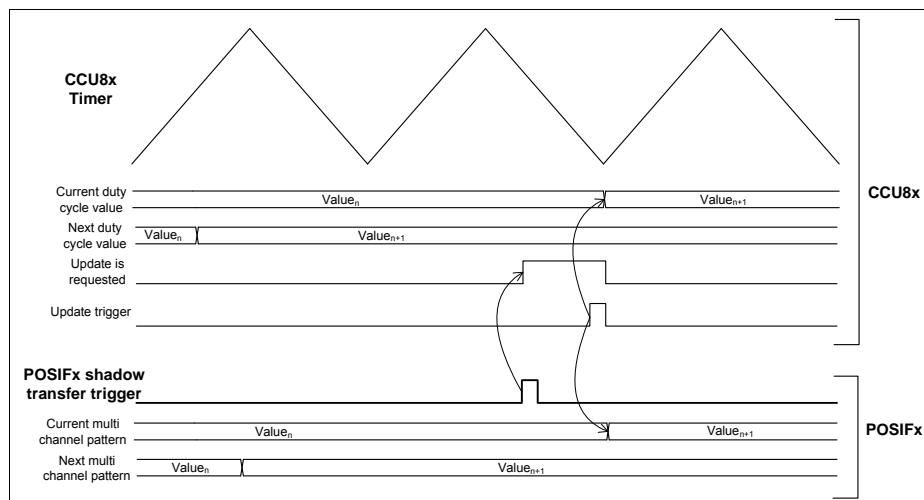
Figure 2 Value update handshake between CCU8x and POSIFx

This feature cannot be used with the Timer2 (defined as CC82 in the documentation) of the CCU8x module(s) (more than one CCU8 module can be contained on a specific device).

All the other 3 Timers (defined as CC80, CC81, CC83) inside the CCU8x modul are not affected by this issue.

None

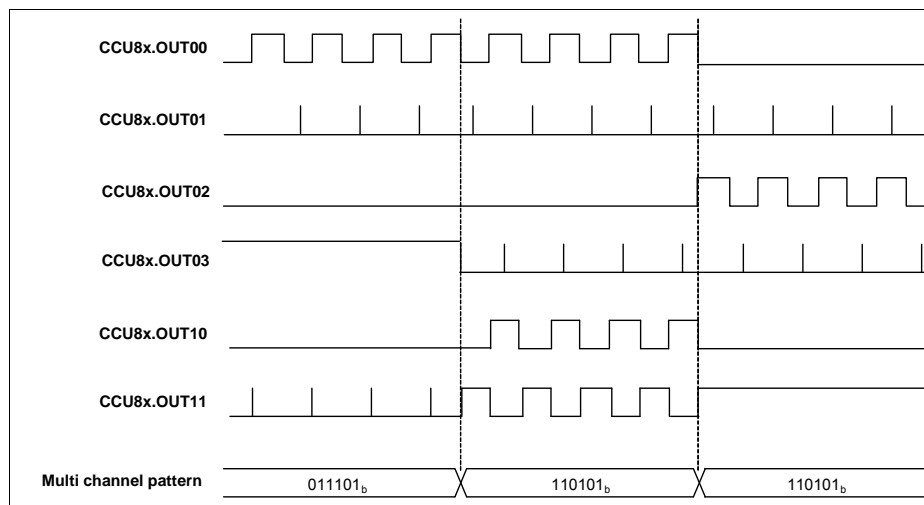
Figure 6 PWM output glitch

This glitch only affects the PWM output that is linked to the inverting ST path of each compare channel (non inverting outputs are not affected).

The effect of this glitch can be seen in Figure 3. The duration of the PWM glitch has the same length has the dead time value programmed into the CC8yDC1R.DT1F field (for compare channel 1) or into the CC8yDC1R.DT2F.

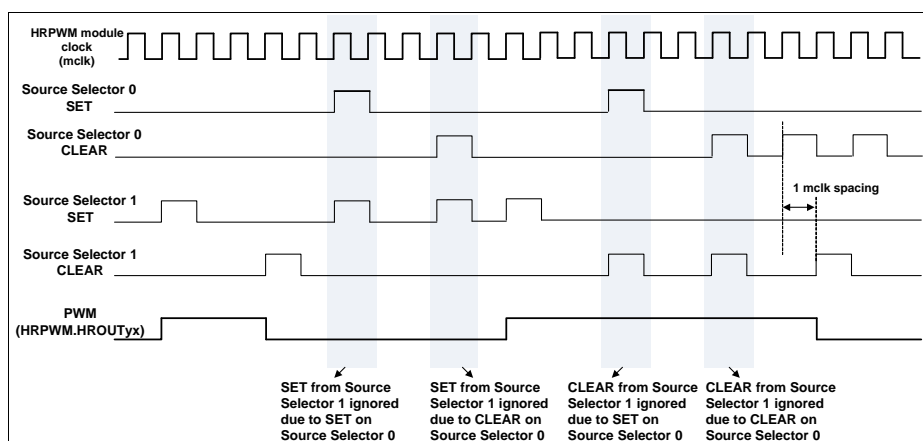
Figure 11 Collision between signals of the two Source Selectors - valid

- at the same module clock time frame Source Selector 0 and Source Selector 1 both decode a signal (a PWM set or PWM clear).

If the described condition occurs, then the signal generated by Source Selector 1 is lost and the PWM signal is not handled properly - **Figure 11**.

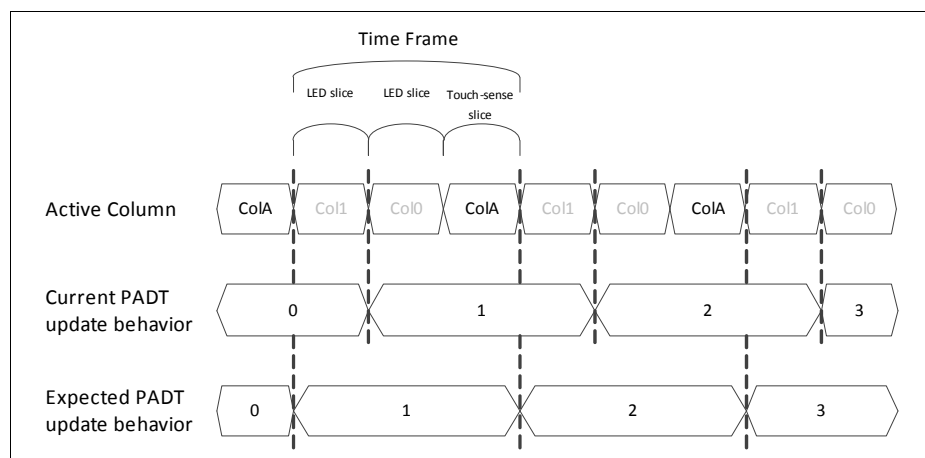
Figure 14 PADT update behavior

The touch-sense pad turn (PADT) value is updated, not at the end of the touch-sense time slice (ColA), but one time slice later ([Figure 14](#)).

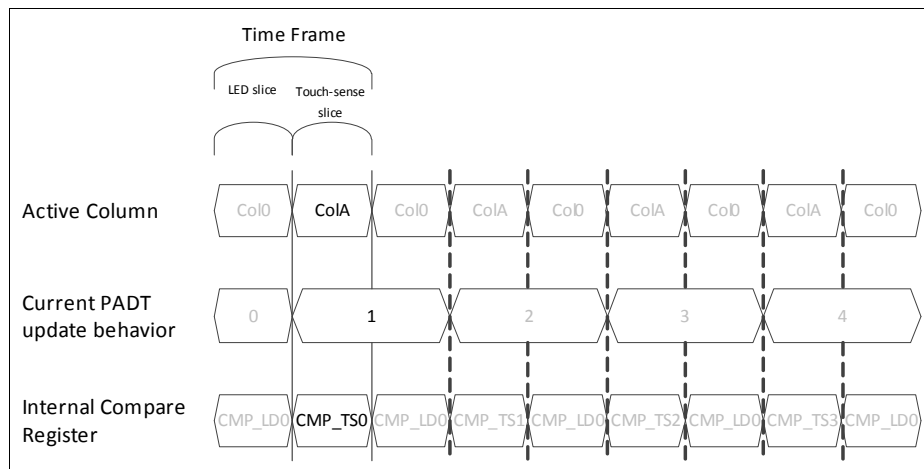
Figure 15 Effect of delay on the update of Internal Compare Register with 1 LED column enabled

If the number of LED columns enabled is smaller than 2, the delay will affect the activation period of the current active pad. At the beginning of every new Col A, the value of the current PADT's compare register is updated to the internal compare register. However, the delay causes the value of the previous PADT's compare register is updated to the internal compare register instead. This means that the current active pad would be activated with the duration of the previous pad's oscillation window ([Figure 15](#)). In addition to this, when no LEDs

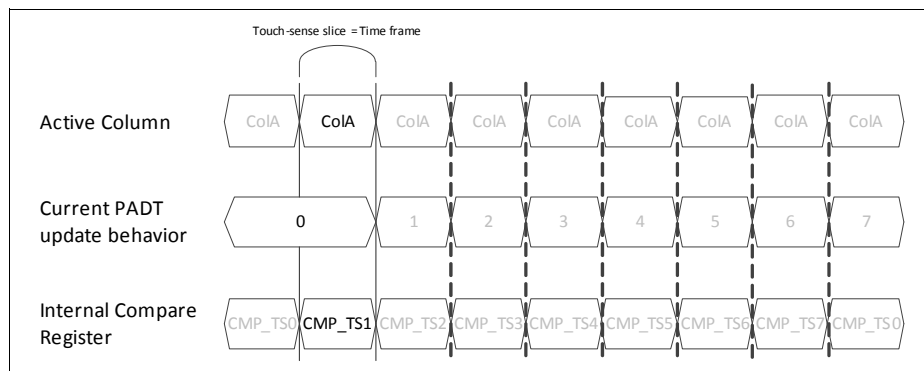
Figure 16 Pad turn 0 prevails for one time slice longer when no LEDs are enabled

are enabled, pad turn 0 will prevail for one time slice longer before it gets updated (**Figure 16**).

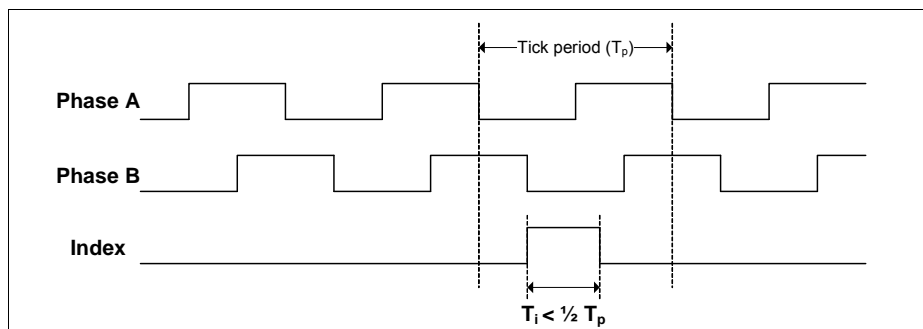
Figure 20 Different index signal types

When the index signal is smaller than 1/2 of the tick period, the POSIF module is not able to decode this signal properly, Figure 2 - notice that the reference edge of the index generation in this figure is the falling of Phase B, nevertheless this is an example and depending on the encoder type, this edge may be one of the other three.

Due to this fact it is not possible to use the POSIF to decode these type of signals (index with duration below 1/2 of the tick period).

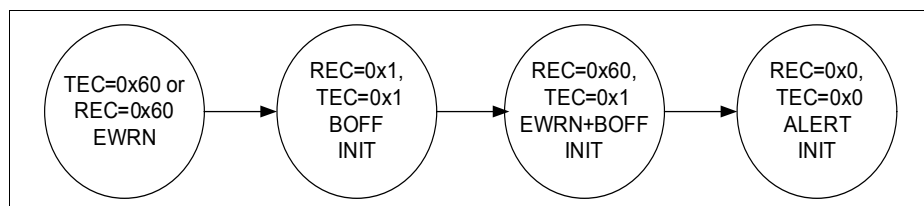
Figure 22 Alert Interrupt Behavior in case of Bus-Off

When the threshold for error warning (EWRN) is reached (default value of Error Warning Level EWRN = 0x60), then the EWRN interrupt is issued. The bus-off (BOFF) status is reached if $TEC > 255$ according to CAN specification, changing the MultiCAN module with REC and TEC to the same value 0x1, setting the INIT bit to 1_B, and issuing the BOFF interrupt. The bus-off recovery phase starts automatically. Every time an idle time is seen, REC is incremented. If REC = 0x60, a combined status EWRN+BOFF is reached. The corresponding interrupt can also be seen as a pre-warning interrupt, that the bus-off recovery phase will be finished soon. When the bus-off recovery phase has finished (128 times idle time have been seen on the bus), EWRN and BOFF are cleared, the ALERT interrupt bit is set and the INIT bit is still set.
