Device	XMC4100/XMC4200
Marking/Step	ES-AB, AB
Package	PG-VQFN-48, PG-LQFP-64

Document ID is **087/18**.

This “Errata Sheet” describes product deviations with respect to the user documentation listed below.

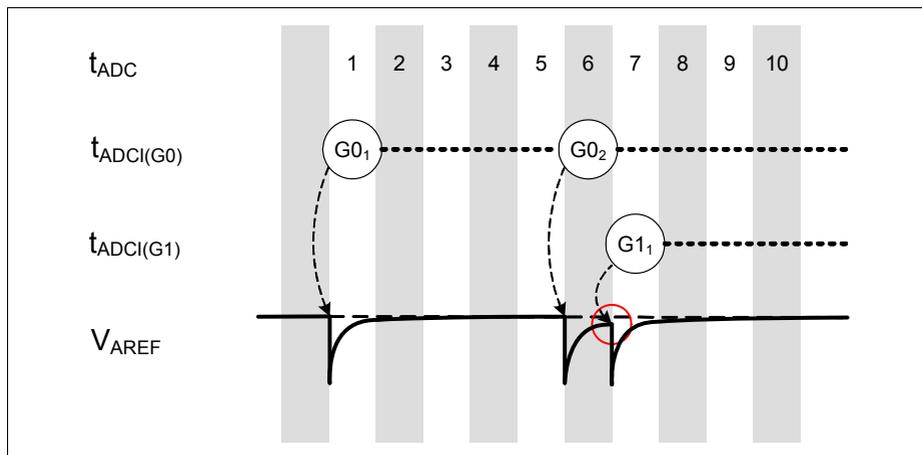
Figure 1 Influence of concurrent conversions on reference voltage

Due to this architecture, the individual prescalers may be displaced by one module clock as shown in the figure below for G0₂ and G1₁. In this example the division factor is 5 (DIVA=4).

In cycle 1 only the G0 conversion step is started. At start time the reference voltage is strobed and a certain amount of electric charge (see data sheet parameter Q_{CONV}) is consumed. This causes a drop of the reference voltage level V_{AREF} . Quantity of voltage drop depends on analog voltage level to convert.

In repeated measurements using the example setup errors up to 25 LSB have been observed in 10-16 of 4096 conversions. Magnitude of the error however depends on the system configuration and load. The workaround therefore should be applied for all applications.

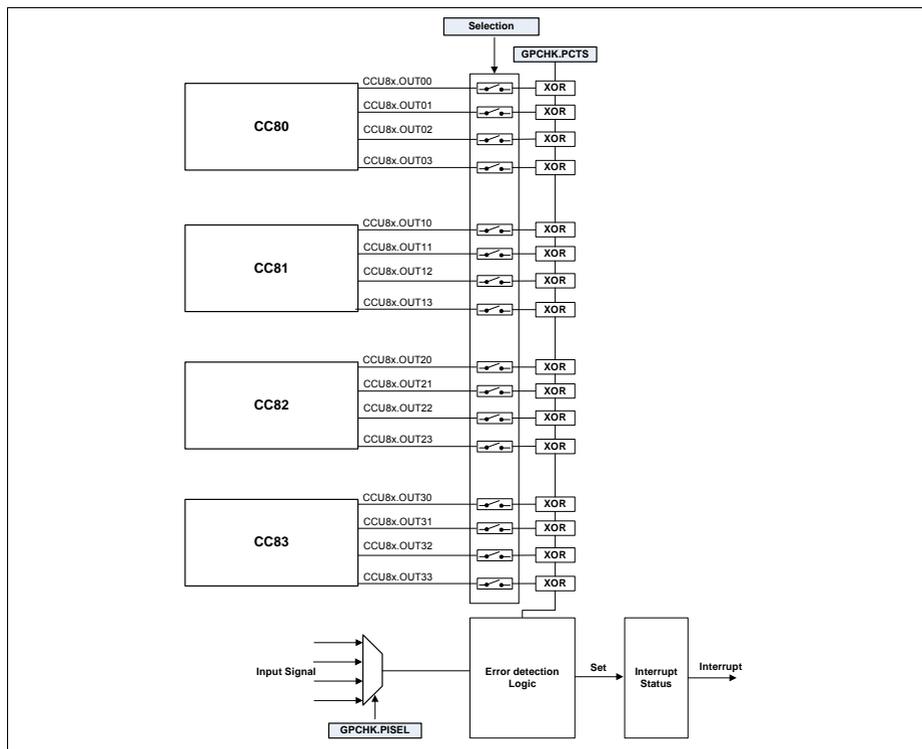
Figure 2 Parity Checker diagram

This means that if in the previous PWM cycle an error was detected and one interrupt was triggered, the software needs to read back the status register before the end of the immediately next PWM cycle.

This is indeed only necessary if multiple interrupt sources are ORed together in the same interrupt line. If this is not the case and the parity checker error source is the only one associated with an interrupt line, then there is no need to read back the status information. This is due to the fact, that only one action can be triggered in the software routine, the one linked with the parity checker error.

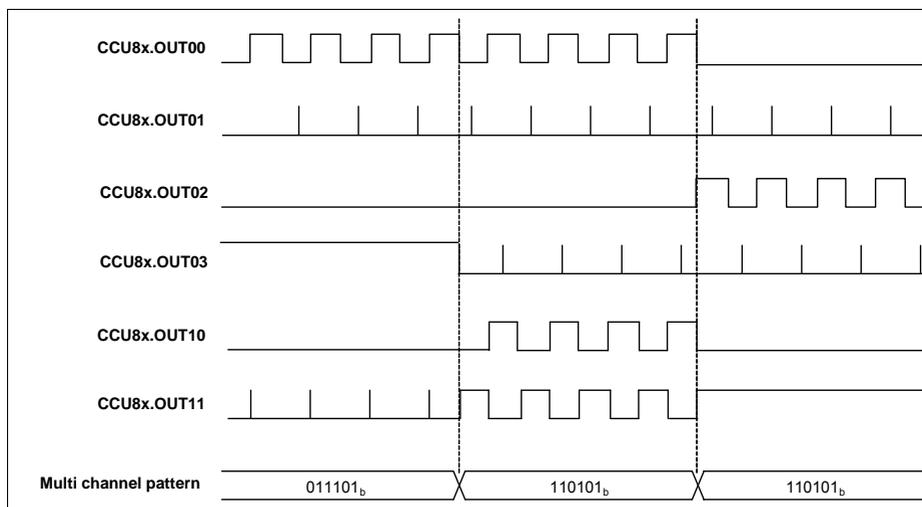
Figure 5 PWM output glitch

A glitch is present at the PWM outputs whenever the dead time of the specific compare channel is enabled - CC8yDTC.DTE1 and/or CC8yDTC.DTE2 set to 1_B (each compare channel has a separate dead time function) - and the specific multi channel pattern for the channel is 01_B or 10_B.

This glitch only affects the PWM output that is linked to the inverting ST path of each compare channel (non inverting outputs are not affected).

The effect of this glitch can be seen in Figure 3. The duration of the PWM glitch has the same length has the dead time value programmed into the CC8yDC1R.DT1F field (for compare channel 1) or into the CC8yDC1R.DT2F.

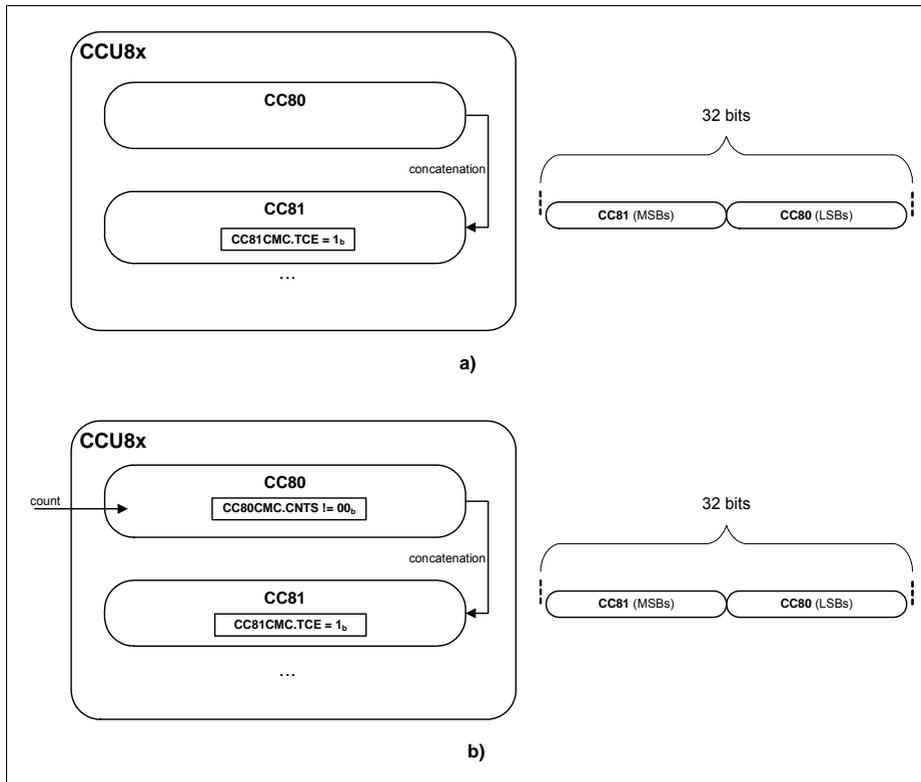
Figure 6 CCU8x concatenation feature resource configuration - a) without external count function; b) with external count function

When an external count signal is enabled - by programming the CC8yCMC.CNTS with 01_B , 10_B or 11_B - the concatenation function does not work. One cannot use in parallel the timer concatenation and external count signal features.

Note: On Figure 1, the count signal is used in CCU80 because this timer represents the LSBs. While the count signal could be enabled in the MSB timer (CC81), this does not make sense when the timers are concatenate - because the count should be used to increment the LSB timer. The LSB timer will then in each wrap around, increment the MSB timer.

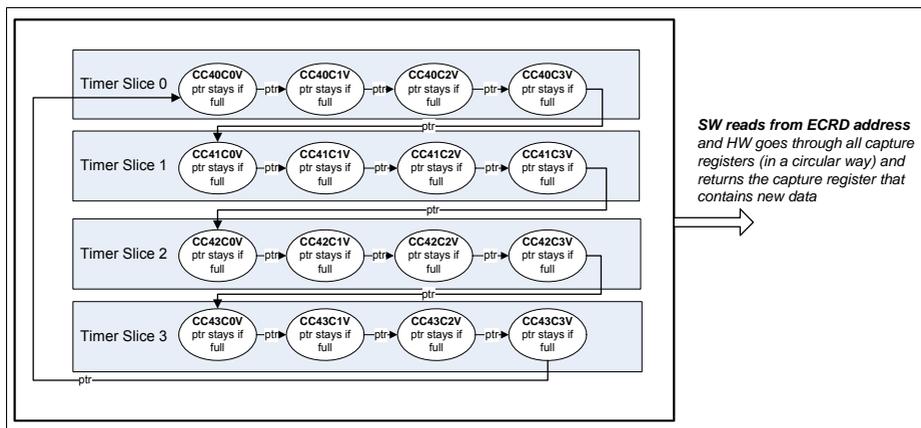
Figure 7 Extended Read Back access - example for CCU4 (CCU8 structure is the same)

- Timer X has 4 capture registers and is the only Timer set with ECM = 1_B. At the moment that the software starts reading the capture registers via the ECRD address, we have already capture two values. The ECRD read back will output CC4xC2V -> CC4xC2V (CC4xC3V value is lost)

- Timer X and Timer Y have 4 capture registers each and they are both configured with ECM = 1_B. At the moment that the software starts reading the capture registers via the ECRD address, we have already capture two values on Timer X and 4 on Timer Y. The ECRD read back will output CC4xC0V -> CC4xC1V -> CC4xC2V -> CC4xC3V -> CC4yC2V -> CC4yC2V (CC4yC3V value is lost)

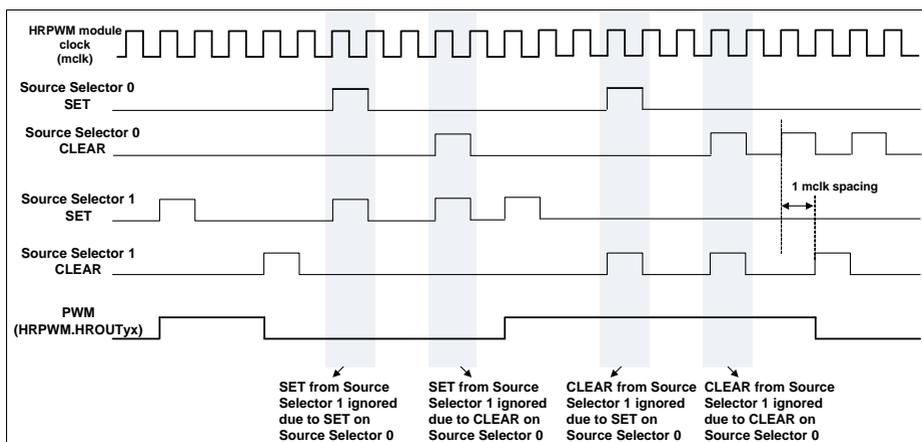
Figure 11 Collision between signals of the two Source Selectors - valid

If the described condition occurs, then the signal generated by Source Selector 1 is lost and the PWM signal is not handled properly - **Figure 11**.

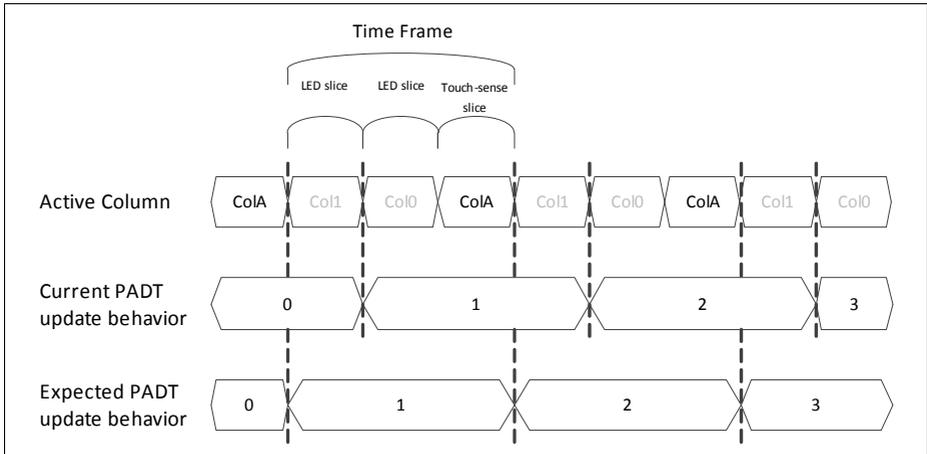
Figure 13 PADT update behavior

The touch-sense pad turn (PADT) value is updated, not at the end of the touch-sense time slice (CoLA), but one time slice later (**Figure 13**).

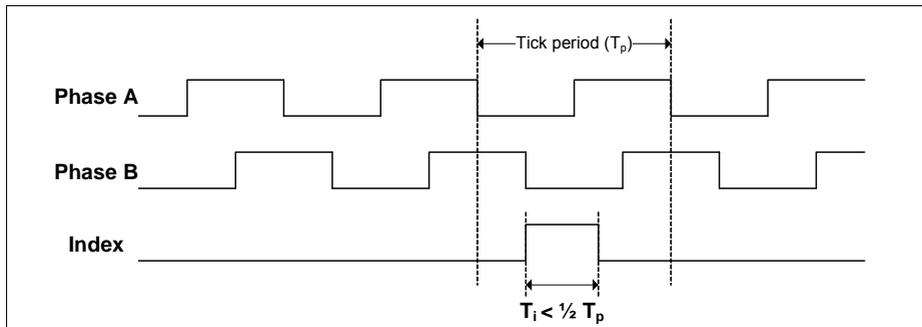
Figure 19 Different index signal types

When the index signal is smaller than 1/2 of the tick period, the POSIF module is not able to decode this signal properly, Figure 2 - notice that the reference edge of the index generation in this figure is the falling of Phase B, nevertheless this is an example and depending on the encoder type, this edge may be one of the other three.

Due to this fact it is not possible to use the POSIF to decode these type of signals (index with duration below 1/2 of the tick period).

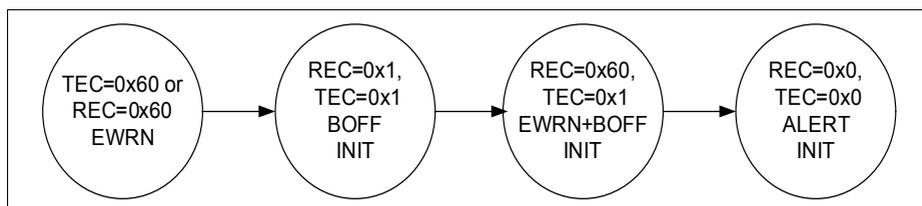
Figure 21 Alert Interrupt Behavior in case of Bus-Off

When the threshold for error warning (EWRN) is reached (default value of Error Warning Level EWRN = 0x60), then the EWRN interrupt is issued. The bus-off (BOFF) status is reached if $TEC > 255$ according to CAN specification, changing the MultiCAN module with REC and TEC to the same value 0x1, setting the INIT bit to 1_B , and issuing the BOFF interrupt. The bus-off recovery phase starts automatically. Every time an idle time is seen, REC is incremented. If REC = 0x60, a combined status EWRN+BOFF is reached. The corresponding interrupt can also be seen as a pre-warning interrupt, that the bus-off recovery phase will be finished soon. When the bus-off recovery phase has finished (128 times idle time have been seen on the bus), EWRN and BOFF are cleared, the ALERT interrupt bit is set and the INIT bit is still set.

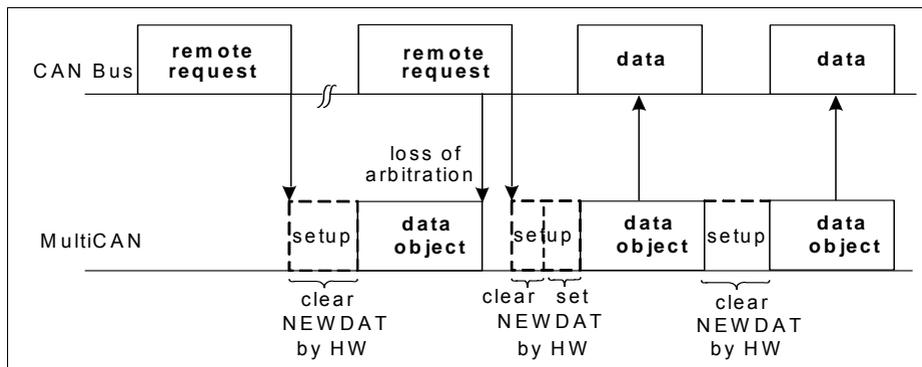
Figure 22 Loss of Arbitration

When the appropriate message object (data frame) triggered by the first remote frame wins the arbitration, it will be sent out and `NEWDAT` is not reset. This leads to an additional data frame, that will be sent by this message object (clearing `NEWDAT`).

There will, however, not be more data frames than there are corresponding remote requests.

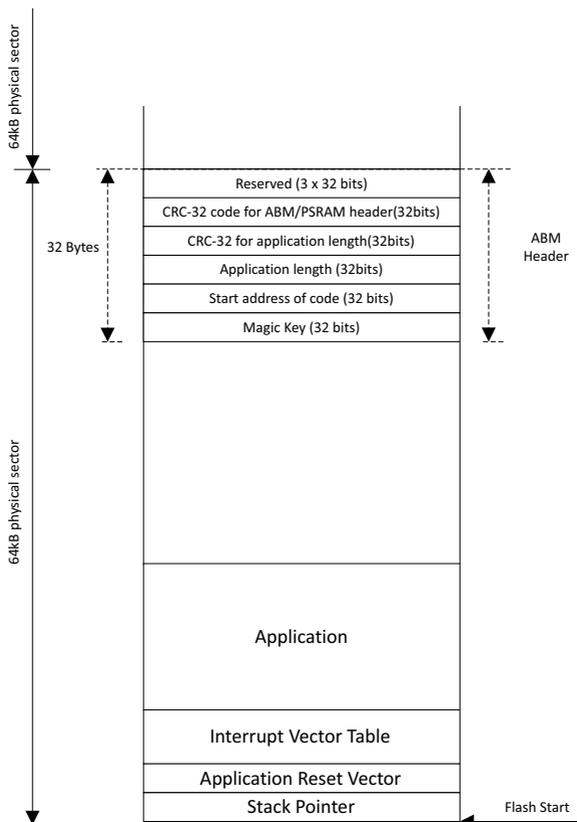
Figure 23 ABM/PSRAM Header - Location of reserved bytes

The reference manual is specifying PSRAM/ABM Header of 32 byte size. Only for 20byte of these 32 bytes the functionality is defined. The remaining 12bytes are reserved. Inside the chapter for Startup modes of the reference manual only the functional bytes are specified but not the location of the reserved bytes.

The following figure provides a detailed view on the location of the reserved bytes:
