Device	XMC4100/XMC4200
Marking/Step	ES-BA, BA
Package	PG-VQFN-48, PG-(LT)QFP-64

Document ID is **086/18**.

This “Errata Sheet” describes product deviations with respect to the user documentation listed below.

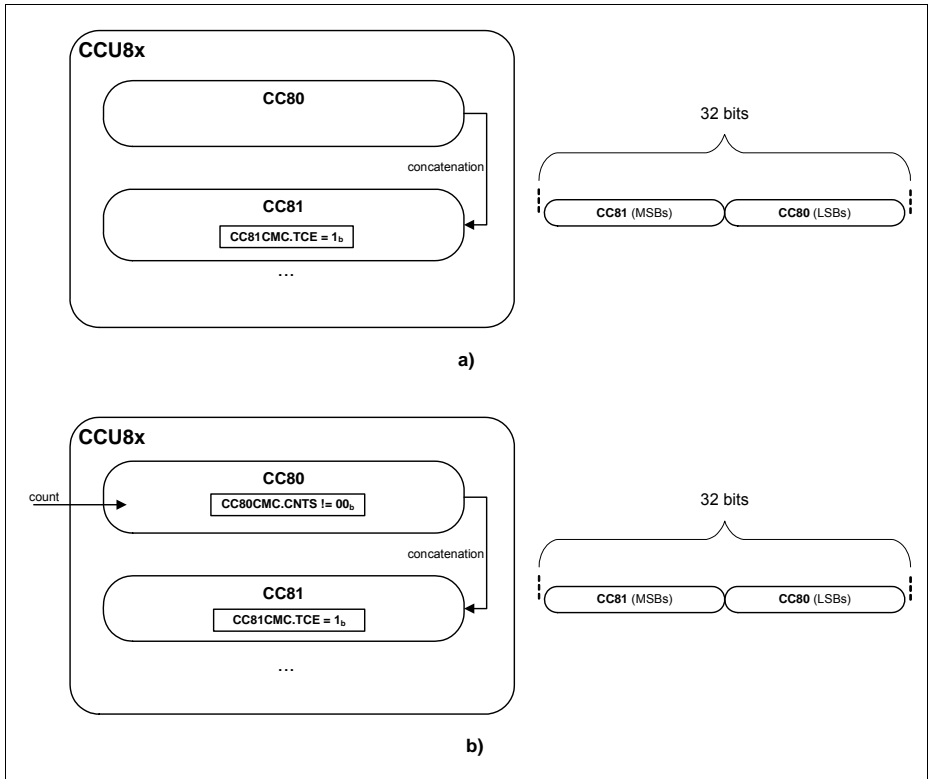
When an external count signal is enabled - by programming the CC8yCMC.CNTS with 01_B, 10_B or 11_B - the concatenation function does not work. One cannot use in parallel the timer concatenation and external count signal features.

Note: On Figure 1, the count signal is used in CCU80 because this timer represents the LSBs. While the count signal could be enabled in the MSB timer (CC81), this does not make sense when the timers are concatenate - because the count should be used to increment the LSB timer. The LSB timer will then in each wrap around, increment the MSB timer.

None

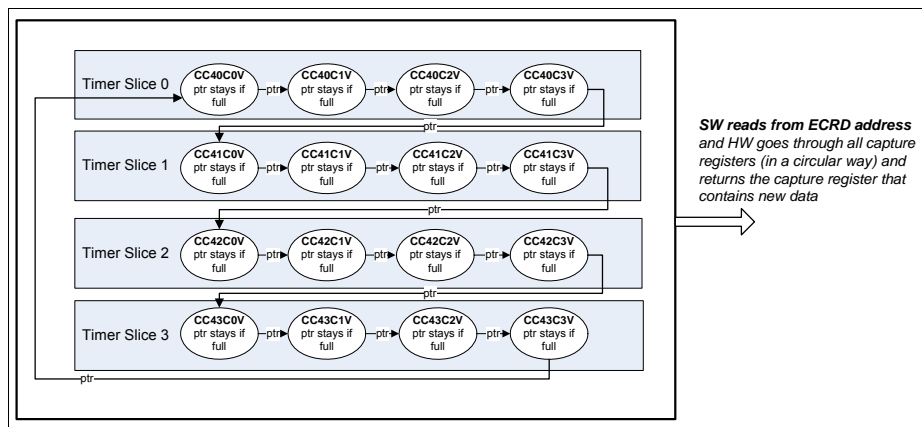
Figure 7 Extended Read Back access - example for CCU4 (CCU8 structure is the same)

- Timer X has 4 capture registers and is the only Timer set with ECM = 1_B. At the moment that the software starts reading the capture registers via the ECRD address, we have already capture two values. The ECRD read back will output CC4xC2V -> CC4xC2V (CC4xC3V value is lost)

- Timer X and Timer Y have 4 capture registers each and they are both configured with ECM = 1_B. At the moment that the software starts reading the capture registers via the ECRD address, we have already capture two values on Timer X and 4 on Timer Y. The ECRD read back will output CC4xC0V -> CC4xC1V -> CC4xC2V -> CC4xC3V -> CC4yC2V -> CC4yC2V (CC4yC3V value is lost)

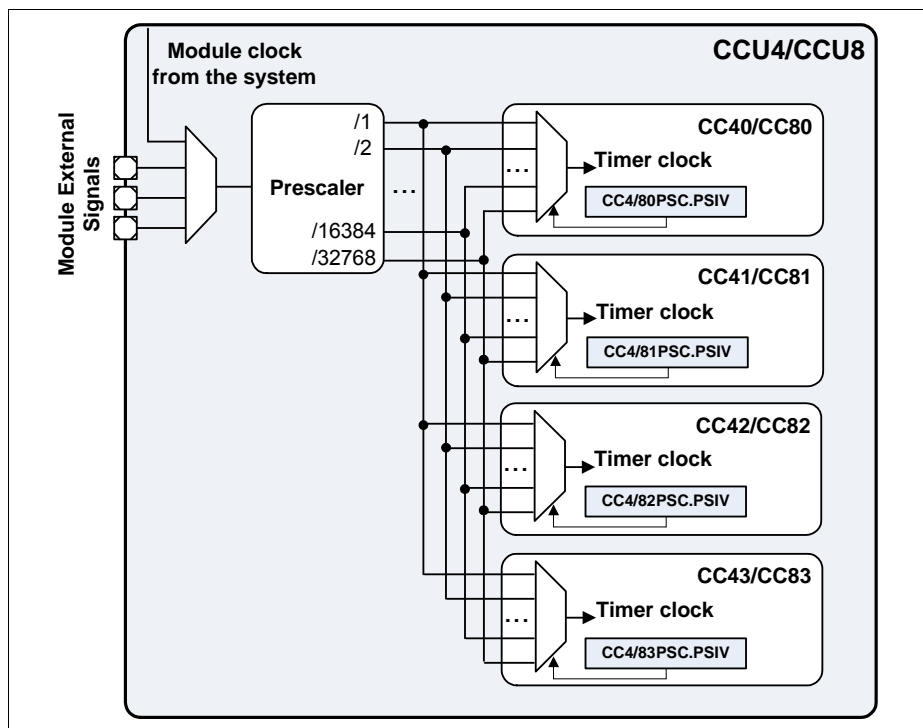
Figure 8 Clock Selection Diagram for CCU4/CCU8

This is only applicable if the Module Clock provided by the system (the normal default configuration and use case scenario) is not being used. In the case that the normal clock configured and programmed at system level is being used, there is not any type of constraints.

One should not also confuse the usage of an external signal as clock for the module with the usage of an external signal for counting. These two features are completely unrelated and there are not any dependencies between both.

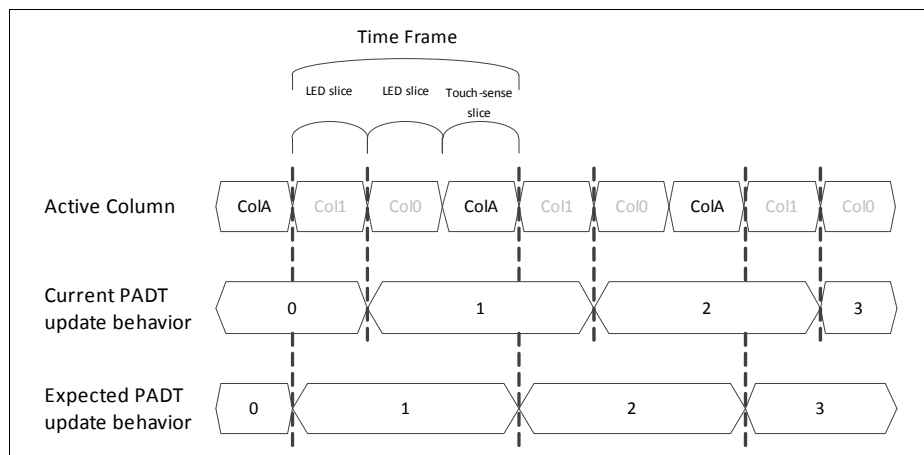
Figure 9 PADT update behavior

The touch-sense pad turn (PADT) value is updated, not at the end of the touch-sense time slice (CoIA), but one time slice later ([Figure 9](#)).

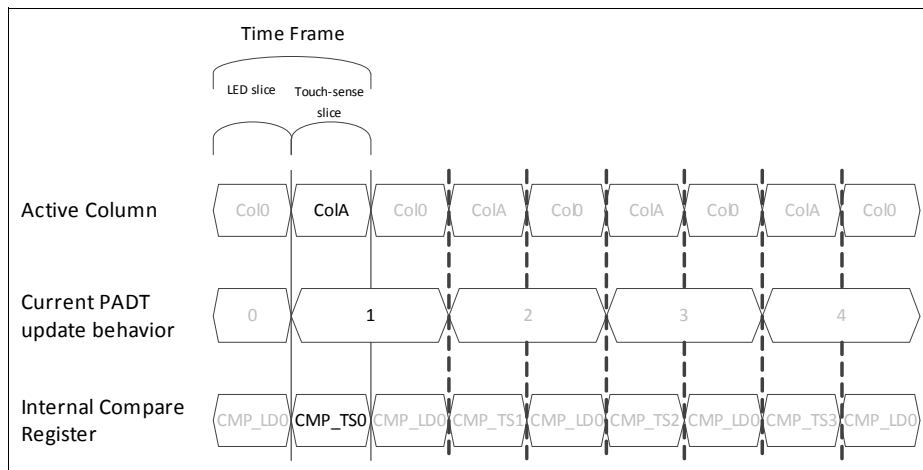
Figure 10 Effect of delay on the update of Internal Compare Register with 1 LED column enabled

If the number of LED columns enabled is smaller than 2, the delay will affect the activation period of the current active pad. At the beginning of every new Col A, the value of the current PADT's compare register is updated to the internal compare register. However, the delay causes the value of the previous PADT's compare register is updated to the internal compare register instead. This means that the current active pad would be activated with the duration of the previous pad's oscillation window ([Figure 10](#)). In addition to this, when no LEDs are enabled, pad turn 0 will prevail for one time slice longer before it gets updated ([Figure 11](#)).

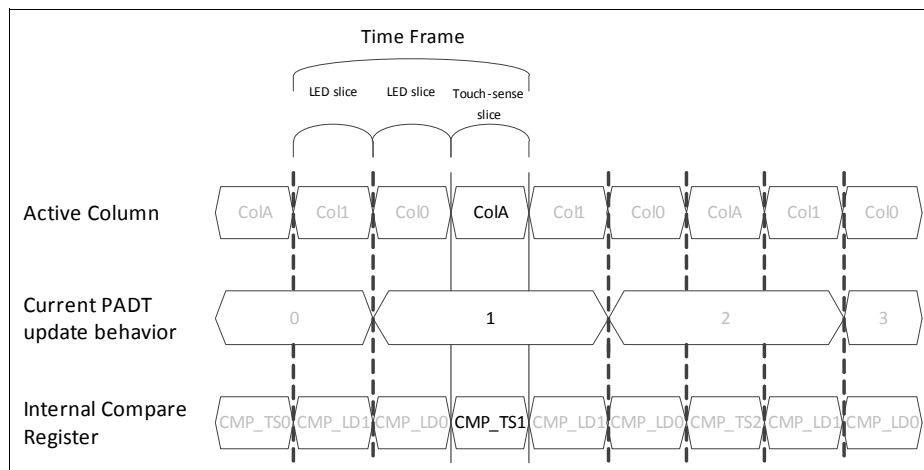
Figure 12 Internal Compare Register updated with correct compare register value with 2 LED columns enabled

If the number of LED columns enabled is 2 or more, the additional LED columns would provide some buffer time for the delay. So, at the start of a new touch-sense time slice, the update of PADT value would have taken place. Hence, the current active PADT compare register value is updated to the internal compare register ([Figure 12](#)).
