Device XMC4300
Marking/Step ES-AA, AA
Package PG-LQFP-100

Document ID is **085/18**

This “Errata Sheet” describes product deviations with respect to the user documentation listed below.

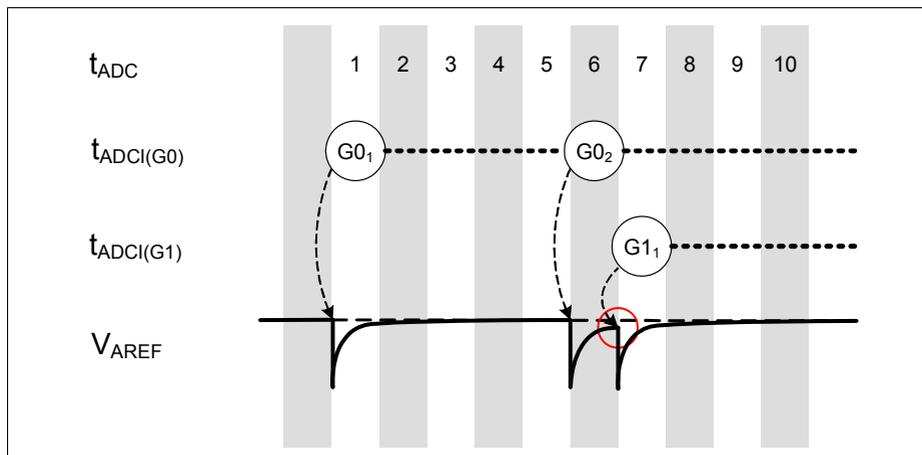
Figure 1 Influence of concurrent conversions on reference voltage

ADC CM.001 Conversion results can be wrong if groups are not synchronized

Due to this architecture, the individual prescalers may be displaced by one module clock as shown in the figure below for G0₂ and G1₁. In this example the division factor is 5 (DIVA=4).

In cycle 1 only the G0 conversion step is started. At start time the reference voltage is strobed and a certain amount of electric charge (see data sheet parameter Q_{CONV}) is consumed. This causes a drop of the reference voltage level V_{AREF} . Quantity of voltage drop depends on analog voltage level to convert.

In cycle 6 another G0 conversion step is starting and in cycle 7 a G1 conversion step. In this case the reference voltage may not yet be fully recovered when the G1 conversion step strobes V_{REF} . Consequently, the G1 conversion step yields an incorrect value.

In repeated measurements using the example setup errors up to 25 LSB have been observed in 10-16 of 4096 conversions. Magnitude of the error however depends on the system configuration and load. The workaround therefore should be applied for all applications.

If two or more converter groups (G0-G3) are started (initialized) asynchronously and multiple conversion steps or sample phases occur in the same time frame then the reference voltage settling time can be violated, which leads to incorrect conversion results.

The workaround makes sure that all ADC group clocks $f_{\text{ADC}(Gx)}$ are started concurrently. Even if your application does not require a master/slave configuration this sequence ensures a synchronized start behaviour.

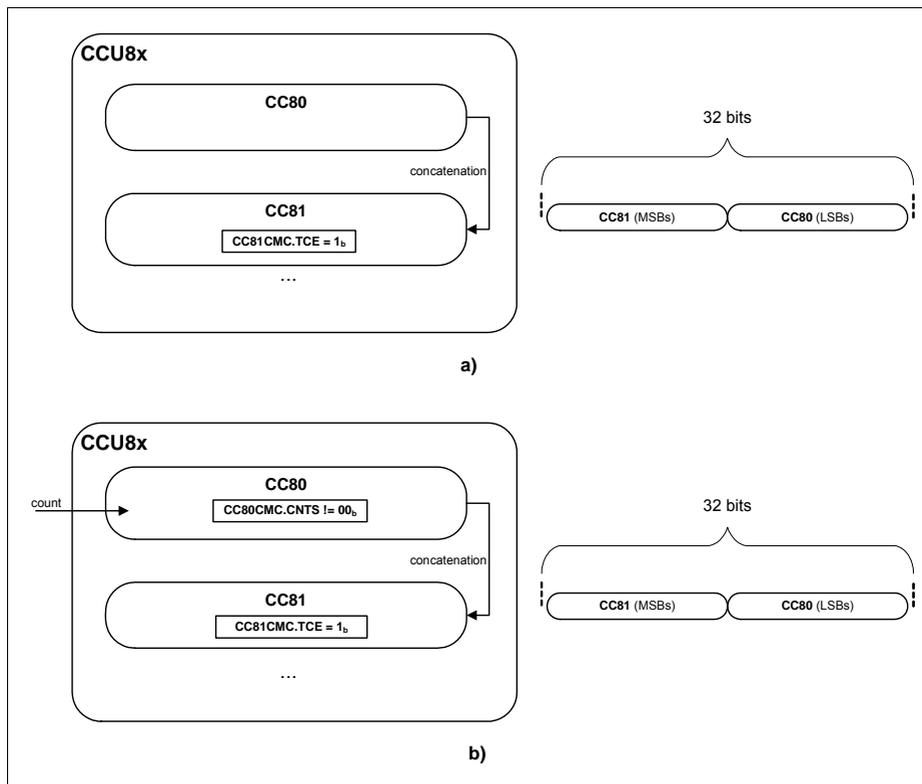
Figure 3 CCU8x concatenation feature resource configuration - a) without external count function; b) with external count function

CCU8 AI.006 Timer concatenation does not work when using external count signal

When an external count signal is enabled - by programming the CC8yCMC.CNTS with 01_B , 10_B or 11_B - the concatenation function does not work. One cannot use in parallel the timer concatenation and external count signal features.

Note: On Figure 1, the count signal is used in CCU80 because this timer represents the LSBs. While the count signal could be enabled in the MSB timer (CC81), this does not make sense when the timers are concatenate - because the count should be used to increment the LSB timer. The LSB timer will then in each wrap around, increment the MSB timer.

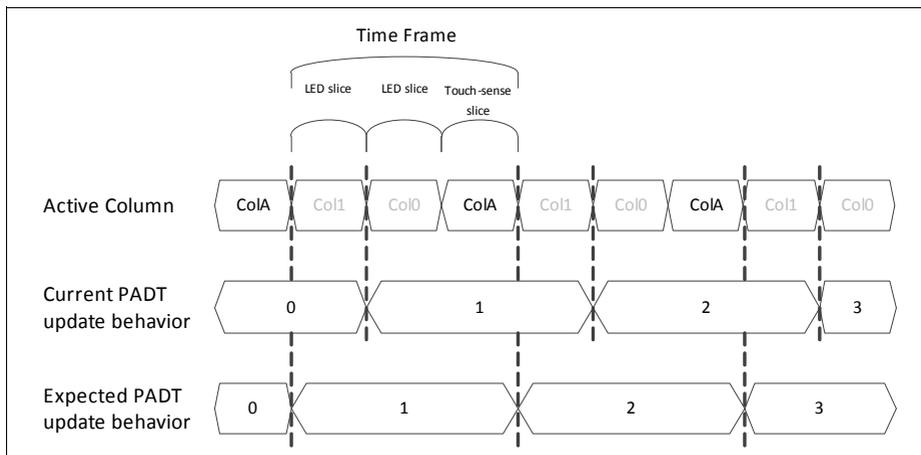
Figure 5 PADT update behavior

LEDTS_AI.001 Delay in the update of FNCTL.PADT bit field

The touch-sense pad turn (PADT) value is updated, not at the end of the touch-sense time slice (CoIA), but one time slice later ([Figure 5](#)).

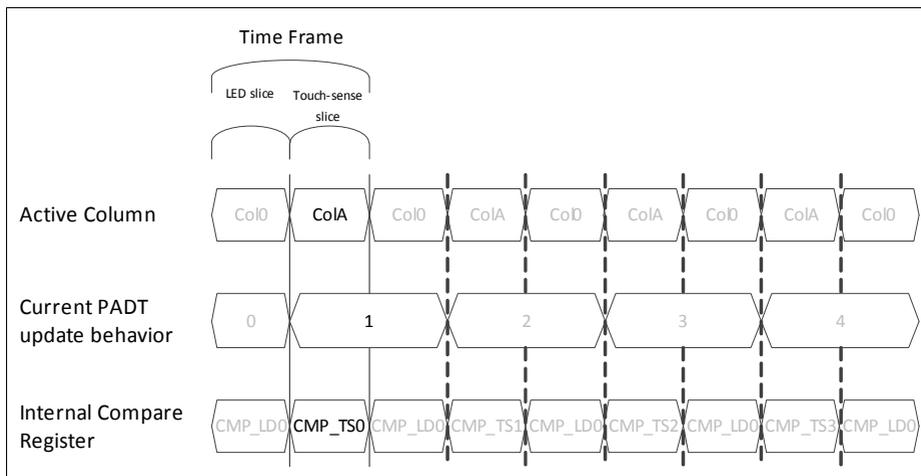
Figure 6 Effect of delay on the update of Internal Compare Register with 1 LED column enabled

If the number of LED columns enabled is smaller than 2, the delay will affect the activation period of the current active pad. At the beginning of every new Col A, the value of the current PADT's compare register is updated to the internal compare register. However, the delay causes the value of the previous PADT's compare register is updated to the internal compare register instead. This means that the current active pad would be activated with the duration of the previous pad's oscillation window (**Figure 6**). In addition to this, when no LEDs are enabled, pad turn 0 will prevail for one time slice longer before it gets updated (**Figure 7**).

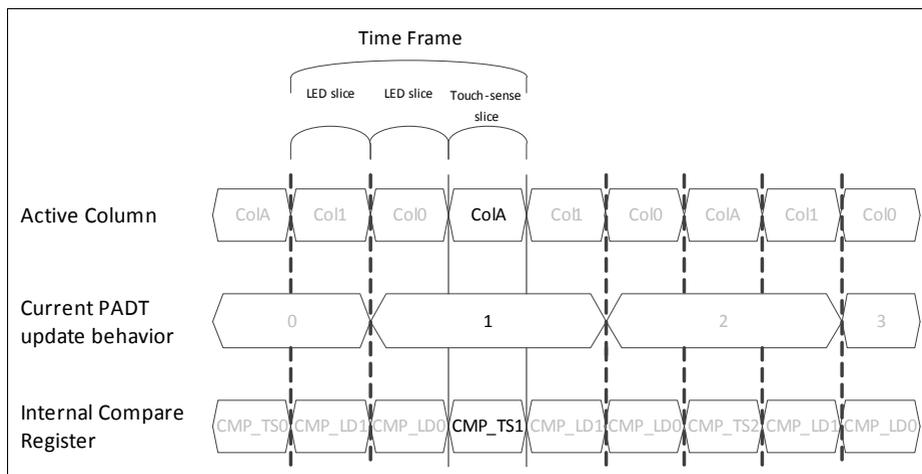
Figure 8 Internal Compare Register updated with correct compare register value with 2 LED columns enabled

If the number of LED columns enabled is 2 or more, the additional LED columns would provide some buffer time for the delay. So, at the start of a new touch-sense time slice, the update of PADT value would have taken place. Hence, the current active PADT compare register value is updated to the internal compare register (**Figure 8**).

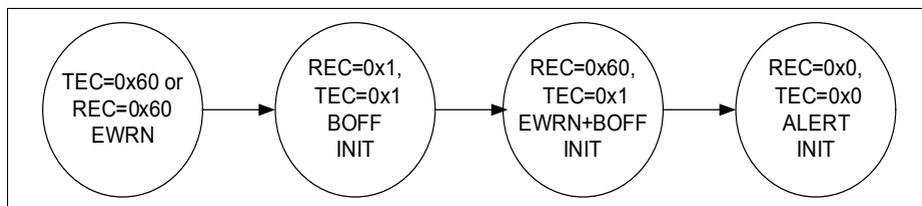
Figure 10 Alert Interrupt Behavior in case of Bus-Off

MultiCAN AI.H007 Alert Interrupt Behavior in case of Bus-Off

When the threshold for error warning (EWRN) is reached (default value of Error Warning Level EWRN = 0x60), then the EWRN interrupt is issued. The bus-off (BOFF) status is reached if $TEC > 255$ according to CAN specification, changing the MultiCAN module with REC and TEC to the same value 0x1, setting the INIT bit to 1_B, and issuing the BOFF interrupt. The bus-off recovery phase starts automatically. Every time an idle time is seen, REC is incremented. If REC = 0x60, a combined status EWRN+BOFF is reached. The corresponding interrupt can also be seen as a pre-warning interrupt, that the bus-off recovery phase will be finished soon. When the bus-off recovery phase has finished (128 times idle time have been seen on the bus), EWRN and BOFF are cleared, the ALERT interrupt bit is set and the INIT bit is still set.

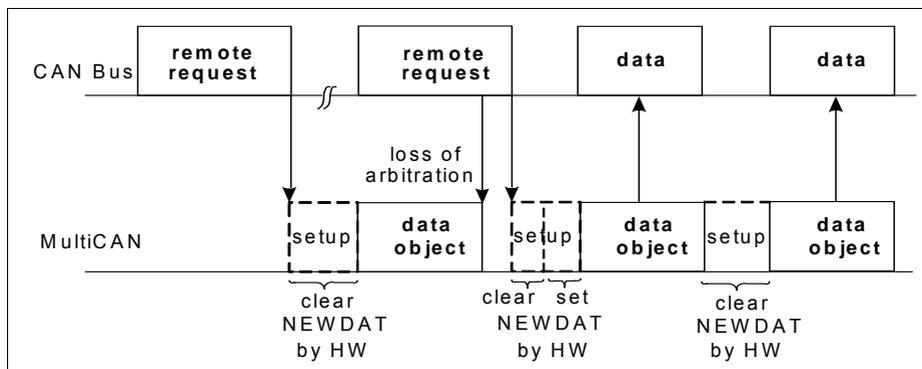
Figure 11 Loss of Arbitration

When the appropriate message object (data frame) triggered by the first remote frame wins the arbitration, it will be sent out and NEWDAT is not reset. This leads to an additional data frame, that will be sent by this message object (clearing NEWDAT).

There will, however, not be more data frames than there are corresponding remote requests.
