Device	XMC4400
Marking/Step	ES-BA, BA
Package	PG-LQFP-64/100

Document ID is **083/18**.

This “Errata Sheet” describes product deviations with respect to the user documentation listed below.

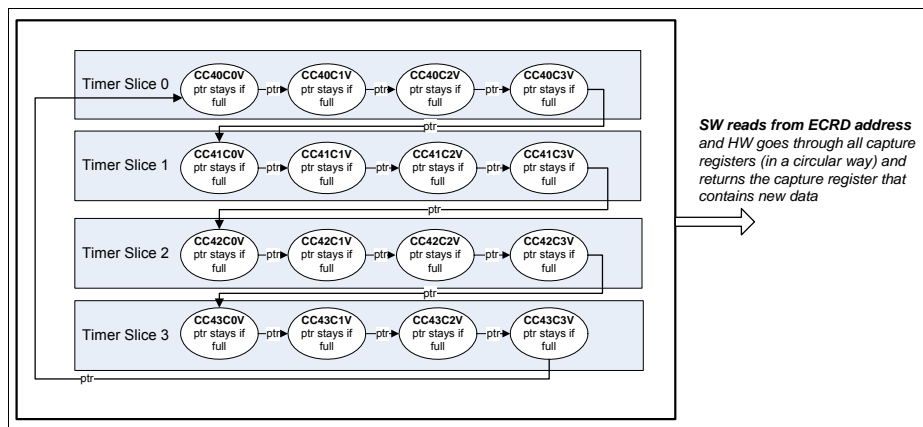
**Figure 7 Extended Read Back access - example for CCU4 (CCU8 structure is the same)**

- Timer X has 4 capture registers and is the only Timer set with  $ECM = 1_B$ . At the moment that the software starts reading the capture registers via the ECRD address, we have already capture two values. The ECRD read back will output  $CC4xC2V \rightarrow CC4xC2V$  ( $CC4xC3V$  value is lost)

- Timer X and Timer Y have 4 capture registers each and they are both configured with  $ECM = 1_B$ . At the moment that the software starts reading the capture registers via the ECRD address, we have already capture two values on Timer X and 4 on Timer Y. The ECRD read back will output  $CC4xC0V \rightarrow CC4xC1V \rightarrow CC4xC2V \rightarrow CC4xC3V \rightarrow CC4yC2V \rightarrow CC4yC2V$  ( $CC4yC3V$  value is lost)

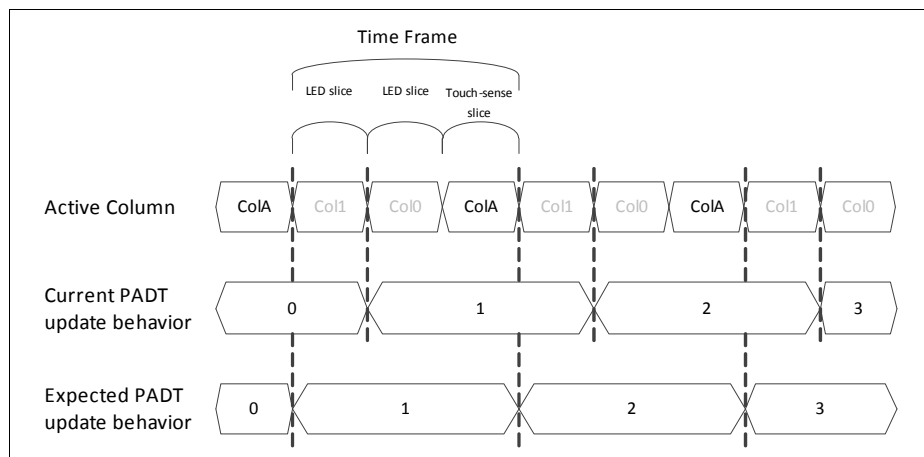
**Figure 9 PADT update behavior**

### **LEDTS AI.001 Delay in the update of FNCTL.PADT bit field**

The touch-sense pad turn (PADT) value is updated, not at the end of the touch-sense time slice (ColA), but one time slice later (**Figure 9**).

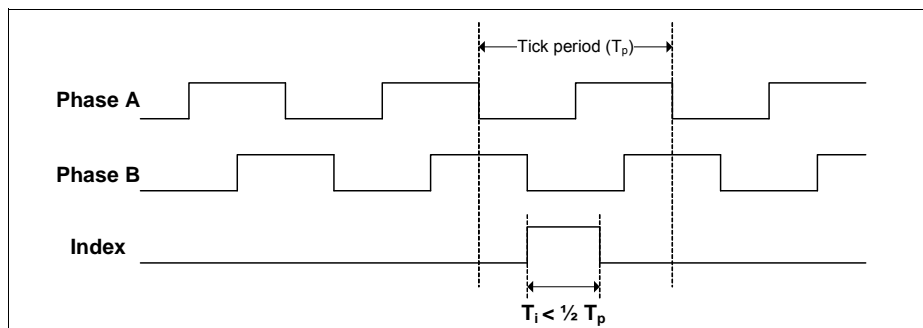
**Figure 15 Different index signal types**

When the index signal is smaller than 1/2 of the tick period, the POSIF module is not able to decode this signal properly, Figure 2 - notice that the reference edge of the index generation in this figure is the falling of Phase B, nevertheless this is an example and depending on the encoder type, this edge may be one of the other three.

Due to this fact it is not possible to use the POSIF to decode these type of signals (index with duration below 1/2 of the tick period).

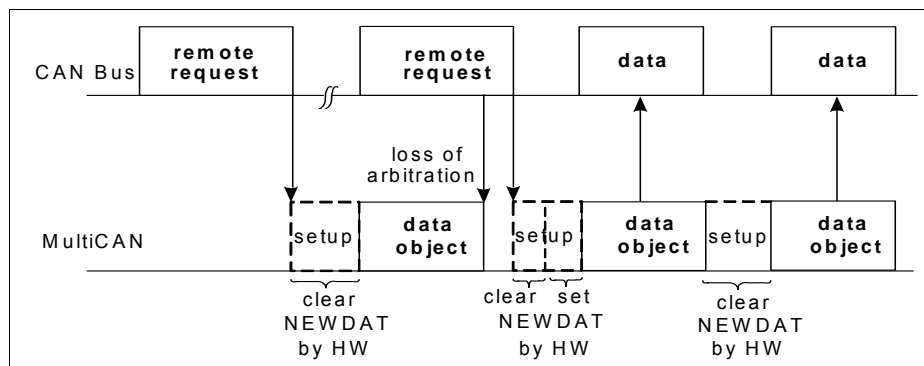
**Figure 18 Loss of Arbitration**

When the appropriate message object (data frame) triggered by the first remote frame wins the arbitration, it will be sent out and `NEWDAT` is not reset. This leads to an additional data frame, that will be sent by this message object (clearing `NEWDAT`).

There will, however, not be more data frames than there are corresponding remote requests.
