Device	XMC4500
Marking/Step	ES-AC, AC
Package	PG-LQFP-100/144, PG-LFBGA-144

Document ID is **081/18**.

This “Errata Sheet” describes product deviations with respect to the user documentation listed below.

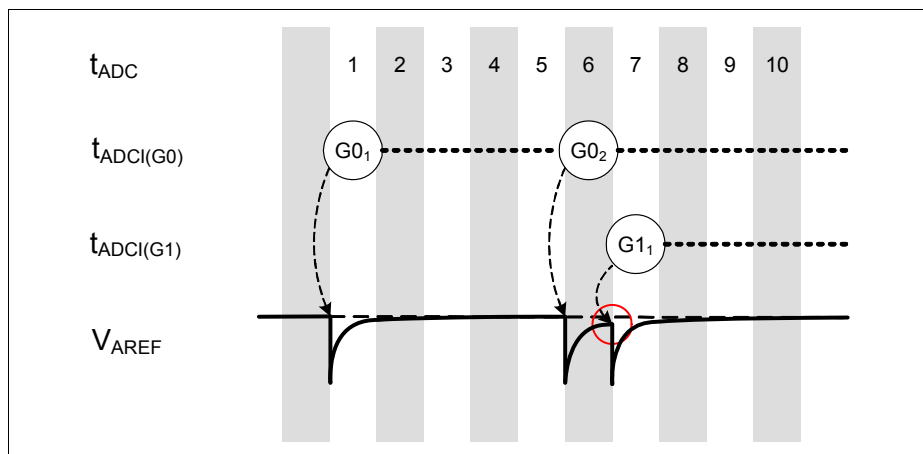
**Figure 1 Influence of concurrent conversions on reference voltage**

Due to this architecture, the individual prescalers may be displaced by one module clock as shown in the figure below for G0<sub>2</sub> and G1<sub>1</sub>. In this example the division factor is 5 (DIVA=4).

In cycle 1 only the G0 conversion step is started. At start time the reference voltage is strobed and a certain amount of electric charge (see data sheet parameter  $Q_{CONV}$ ) is consumed. This causes a drop of the reference voltage level  $V_{AREF}$ . Quantity of voltage drop depends on analog voltage level to convert.

In repeated measurements using the example setup errors up to 25 LSB have been observed in 10-16 of 4096 conversions. Magnitude of the error however depends on the system configuration and load. The workaround therefore should be applied for all applications.

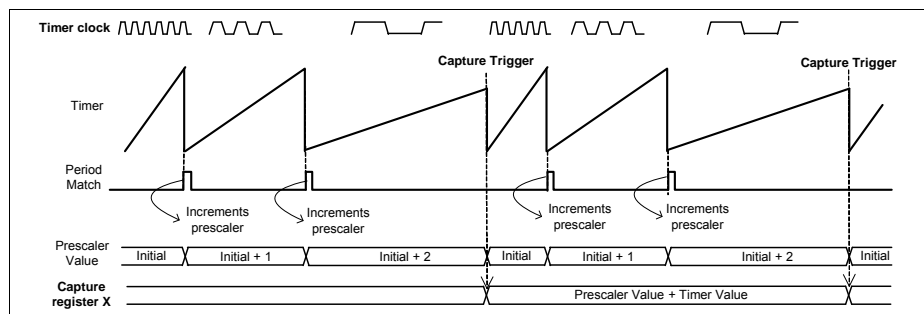
**Figure 3 Floating Prescaler for Capturing**

The usage of Capture Register 2 and Capture Register 3 is not possible when the Floating Prescaler function is enabled,  $CC8yTC.FPE = 1_B$ . This only happens when the Capture Trigger 1 is being used,  $CC8yCMD.CAP1S \neq 00_B$ . Therefore is not possible to use the Floating Prescaler feature with the capture trigger 1. The usage of the capture trigger 0 is not affected, which means that capture register 0 and capture register 1 can be used with the floating prescaler feature.

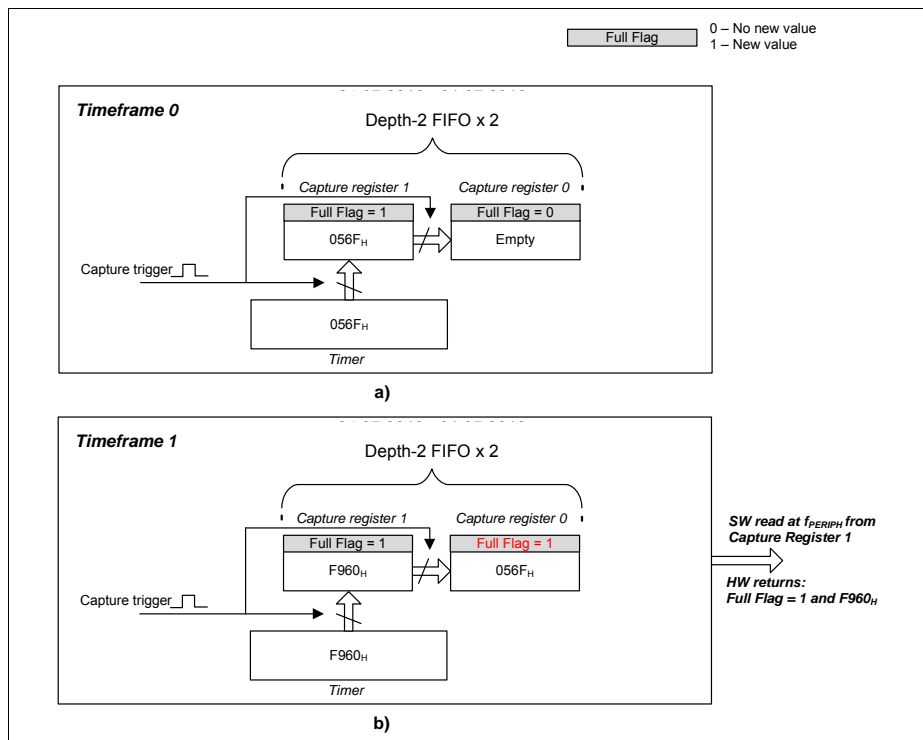
**Figure 11 Capture shift during read back phase - a) Capture trigger without collision with read back; b) Capture trigger collision with read back**

Referring to [Figure 11](#), it can be understood that the proper data is sent to the software when it reads back the capture register 1, nevertheless this same data is shifted to the next capture register (capture register 0) and the full flag of this register is set.

After this if the software reads back capture register 0, a value is going to be returned with a full flag set (indicating that this is a new value - that has not yet been read, which is not true).

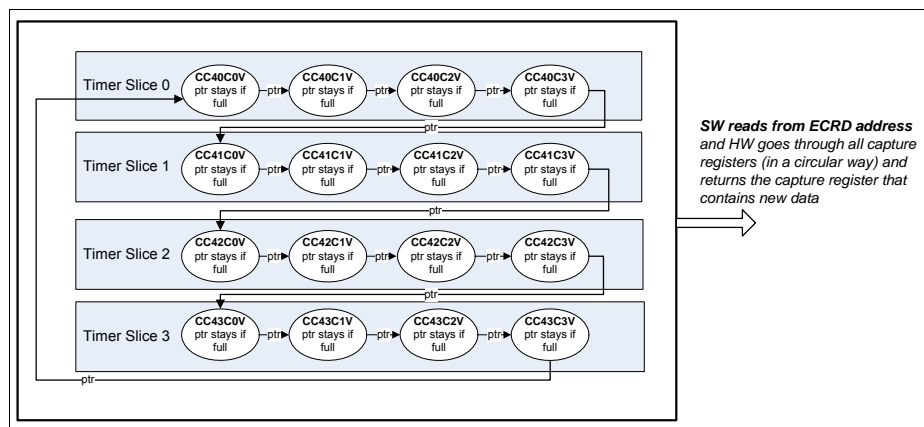
**Figure 12 Extended Read Back access - example for CCU4 (CCU8 structure is the same)**

- Timer X has 4 capture registers and is the only Timer set with  $ECM = 1_B$ . At the moment that the software starts reading the capture registers via the ECRD address, we have already captured two values. The ECRD read back will output CC4xC2V -> CC4xC2V (CC4xC3V value is lost)

- Timer X and Timer Y have 4 capture registers each and they are both configured with  $ECM = 1_B$ . At the moment that the software starts reading the capture registers via the ECRD address, we have already captured two values on Timer X and 4 on Timer Y. The ECRD read back will output CC4xC0V -> CC4xC1V -> CC4xC2V -> CC4xC3V -> CC4yC2V -> CC4yC2V (CC4yC3V value is lost)

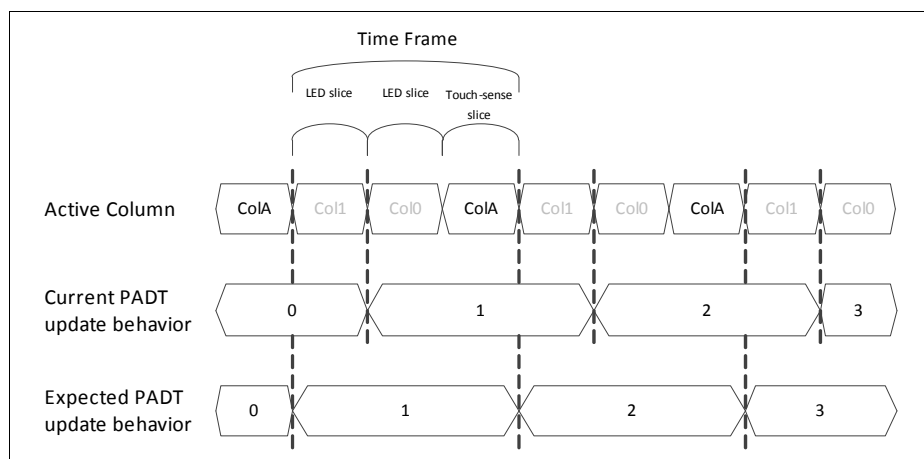
**Figure 14 PADT update behavior**

The touch-sense pad turn (PADT) value is updated, not at the end of the touch-sense time slice (ColA), but one time slice later (**Figure 14**).

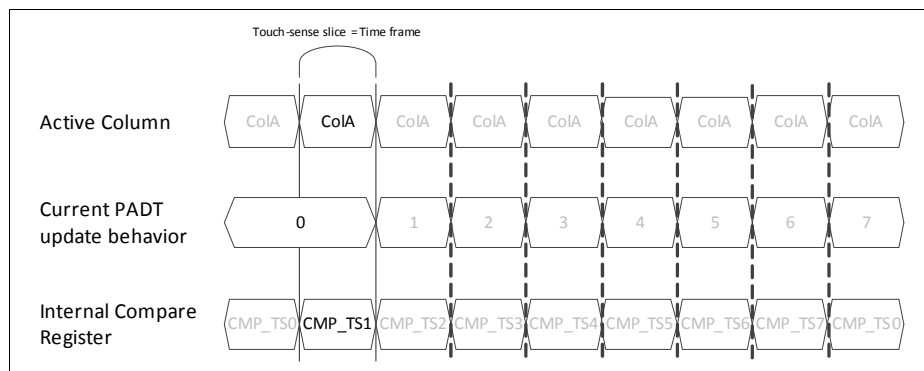
**Figure 16 Pad turn 0 prevails for one time slice longer when no LEDs are enabled**

If the number of LED columns enabled is smaller than 2, the delay will affect the activation period of the current active pad. At the beginning of every new Col A, the value of the current PADT's compare register is updated to the internal compare register. However, the delay causes the value of the previous PADT's compare register is updated to the internal compare register instead. This means that the current active pad would be activated with the duration of the previous pad's oscillation window (**Figure 15**). In addition to this, when no LEDs are enabled, pad turn 0 will prevail for one time slice longer before it gets updated (**Figure 16**).

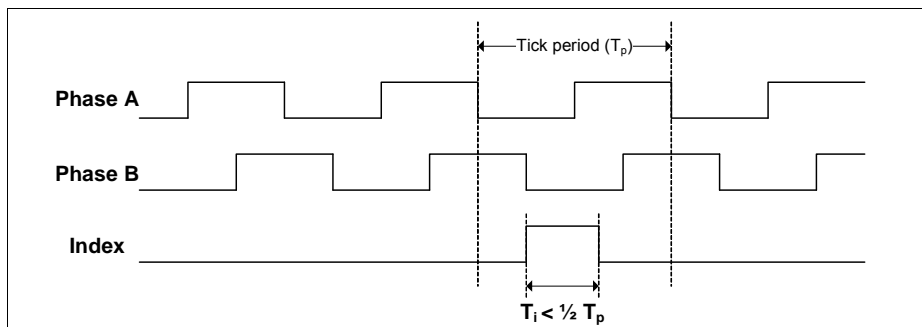
**Figure 20 Different index signal types**

When the index signal is smaller than 1/2 of the tick period, the POSIF module is not able to decode this signal properly, Figure 2 - notice that the reference edge of the index generation in this figure is the falling of Phase B, nevertheless this is an example and depending on the encoder type, this edge may be one of the other three.

Due to this fact it is not possible to use the POSIF to decode these type of signals (index with duration below 1/2 of the tick period).

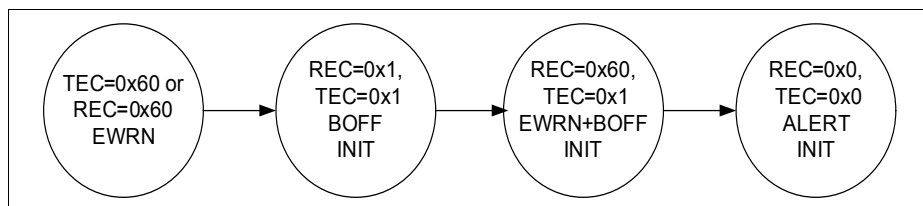
**Figure 22 Alert Interrupt Behavior in case of Bus-Off**

When the threshold for error warning (EWRN) is reached (default value of Error Warning Level EWRN = 0x60), then the EWRN interrupt is issued. The bus-off (BOFF) status is reached if  $TEC > 255$  according to CAN specification, changing the MultiCAN module with REC and TEC to the same value 0x1, setting the INIT bit to 1<sub>B</sub>, and issuing the BOFF interrupt. The bus-off recovery phase starts automatically. Every time an idle time is seen, REC is incremented. If REC = 0x60, a combined status EWRN+BOFF is reached. The corresponding interrupt can also be seen as a pre-warning interrupt, that the bus-off recovery phase will be finished soon. When the bus-off recovery phase has finished (128 times idle time have been seen on the bus), EWRN and BOFF are cleared, the ALERT interrupt bit is set and the INIT bit is still set.

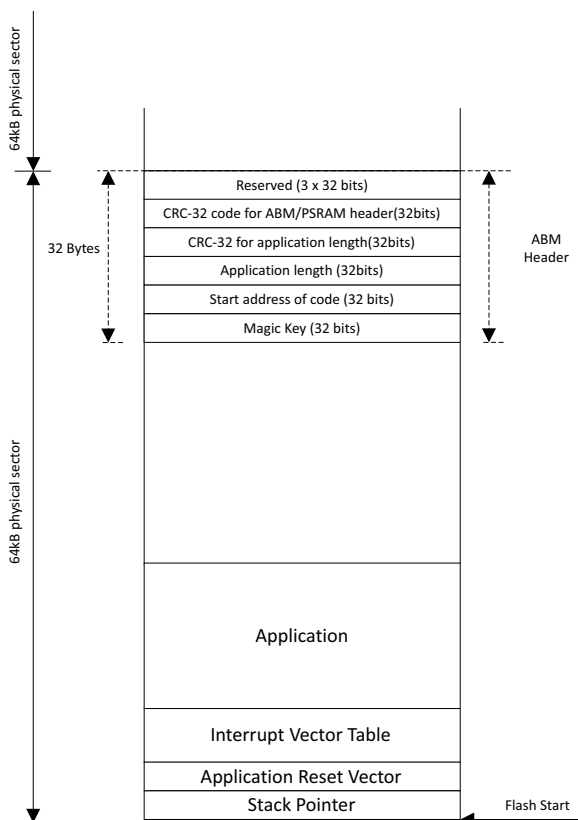
**Figure 24 ABM/PSRAM Header - Location of reserved bytes**

The reference manual is specifying PSRAM/ABM Header of 32 byte size. Only for 20byte of these 32 bytes the functionality is defined. The remaining 12bytes are reserved. Inside the chapter for Startup modes of the reference manual only the functional bytes are specified but not the location of the reserved bytes.
