<b>Device</b>	<b>XMC4500</b>
<b>Marking/Step</b>	<b>ES-AC, AC</b>
<b>Package</b>	<b>PG-LQFP-100/144, PG-LFBGA-144</b>

Document ID is **116/17**.

This “Errata Sheet” describes product deviations with respect to the user documentation listed below.

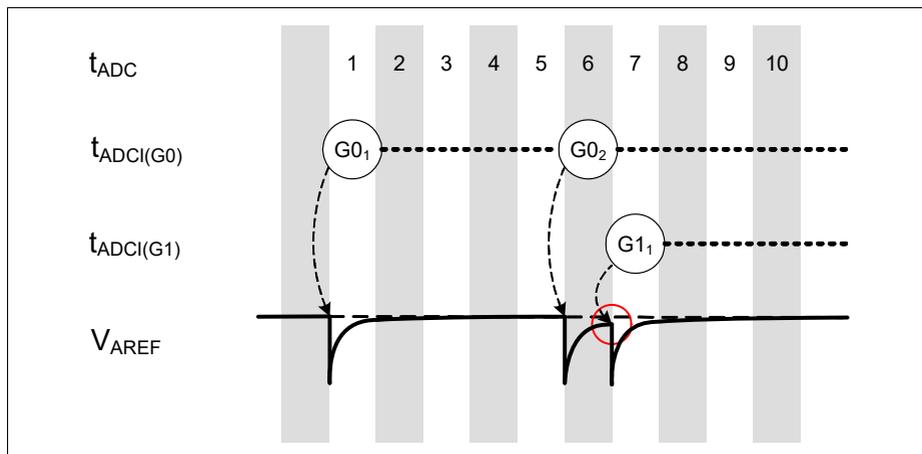
**Figure 1 Influence of concurrent conversions on reference voltage**

Due to this architecture, the individual prescalers may be displaced by one module clock as shown in the figure below for G0<sub>2</sub> and G1<sub>1</sub>. In this example the division factor is 5 (DIVA=4).

In cycle 1 only the G0 conversion step is started. At start time the reference voltage is strobed and a certain amount of electric charge (see data sheet parameter  $Q_{CONV}$ ) is consumed. This causes a drop of the reference voltage level  $V_{AREF}$ . Quantity of voltage drop depends on analog voltage level to convert.

In repeated measurements using the example setup errors up to 25 LSB have been observed in 10-16 of 4096 conversions. Magnitude of the error however depends on the system configuration and load. The workaround therefore should be applied for all applications.

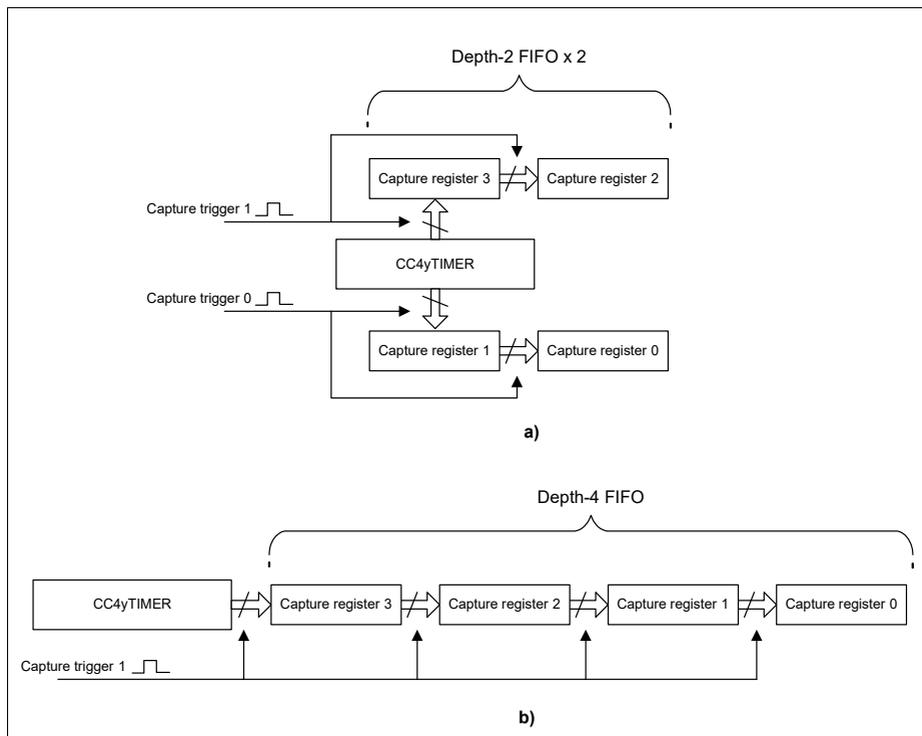
**Figure 2 CCU4 capture modes - a) Depth-2 x2 Capture; b) Depth-4 Capture**

These situations occur whenever capture trigger 1 is being used (when the CC4yCMC.CAP1S field is programmed with a value different from 00<sub>B</sub>).

Note that the period interrupt is only necessary if the capture trigger periodicity is bigger than the timer period itself.

By using the floating prescaler function present in each timer slice, the capture routine can ignore the missing period interrupt, for a capture trigger frequency as low as 0.25 Hz (for  $f_{CCU}$  equal to 120 MHz).

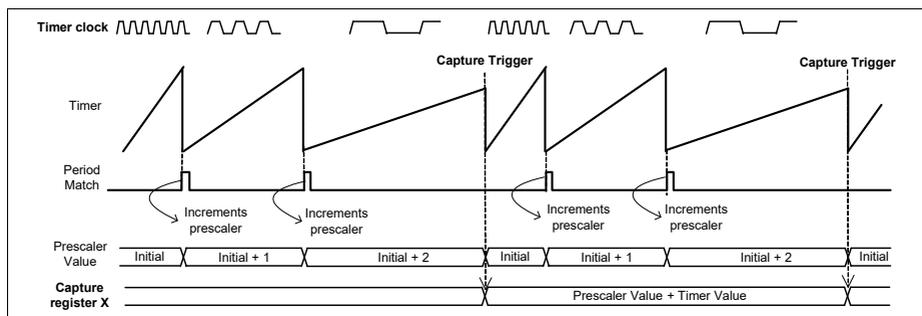
**Figure 3 Floating Prescaler for Capturing**

The usage of Capture Register 2 and Capture Register 3 is not possible when the Floating Prescaler function is enabled,  $CC8yTC.FPE = 1_B$ . This only happens when the Capture Trigger 1 is being used,  $CC8yCMD.CAP1S \neq 00_B$ . Therefore is not possible to use the Floating Prescaler feature with the capture trigger 1. The usage of the capture trigger 0 is not affected, which means that capture register 0 and capture register 1 can be used with the floating prescaler feature.

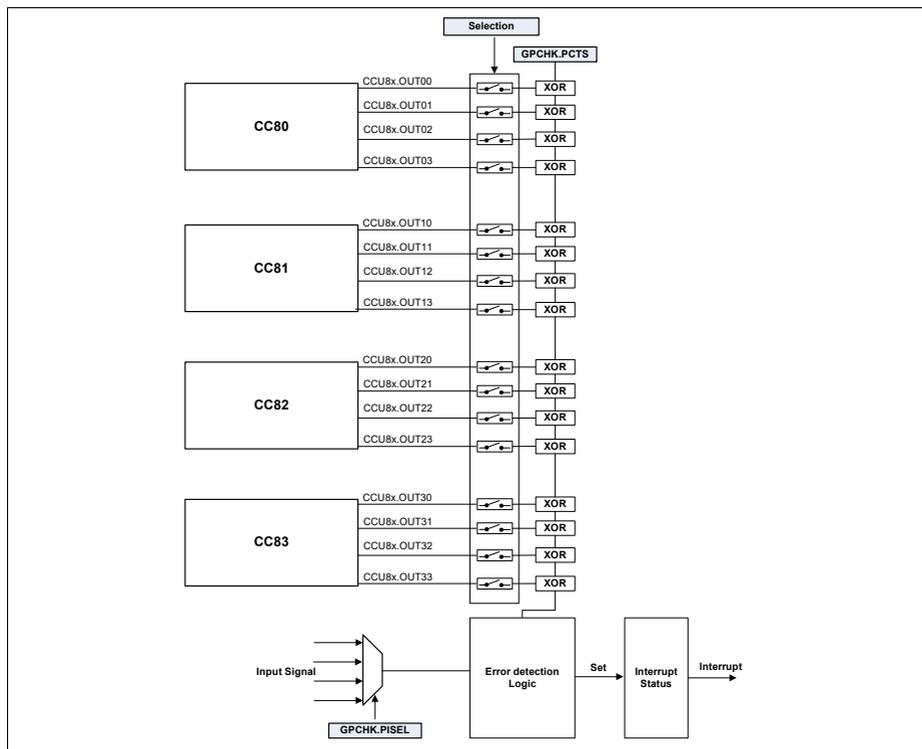
Figure 4 Parity Checker diagram

This means that if in the previous PWM cycle an error was detected and one interrupt was triggered, the software needs to read back the status register before the end of the immediately next PWM cycle.

This is indeed only necessary if multiple interrupt sources are ORed together in the same interrupt line. If this is not the case and the parity checker error source is the only one associated with an interrupt line, then there is no need to read back the status information. This is due to the fact, that only one action can be triggered in the software routine, the one linked with the parity checker error.

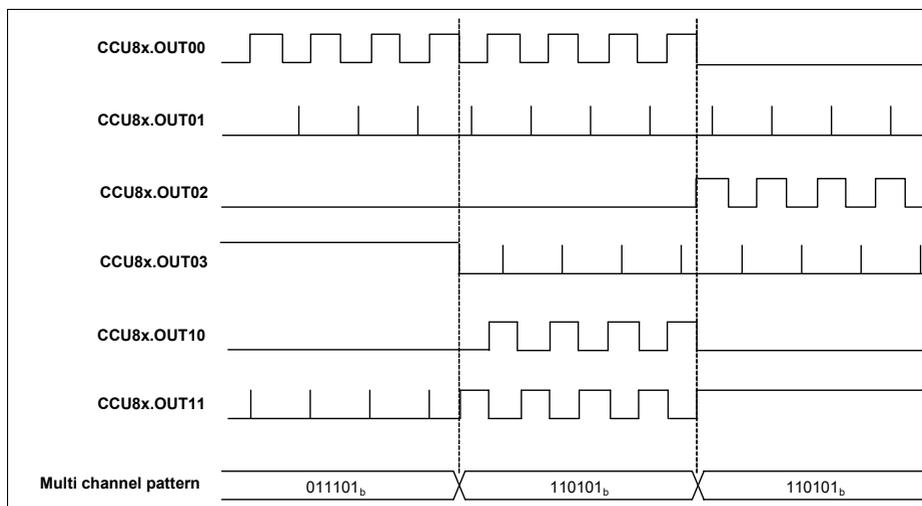
**Figure 7 PWM output glitch**

A glitch is present at the PWM outputs whenever the dead time of the specific compare channel is enabled - CC8yDTC.DTE1 and/or CC8yDTC.DTE2 set to 1<sub>B</sub> (each compare channel has a separate dead time function) - and the specific multi channel pattern for the channel is 01<sub>B</sub> or 10<sub>B</sub>.

This glitch only affects the PWM output that is linked to the inverting ST path of each compare channel (non inverting outputs are not affected).

The effect of this glitch can be seen in Figure 3. The duration of the PWM glitch has the same length has the dead time value programmed into the CC8yDC1R.DT1F field (for compare channel 1) or into the CC8yDC1R.DT2F.

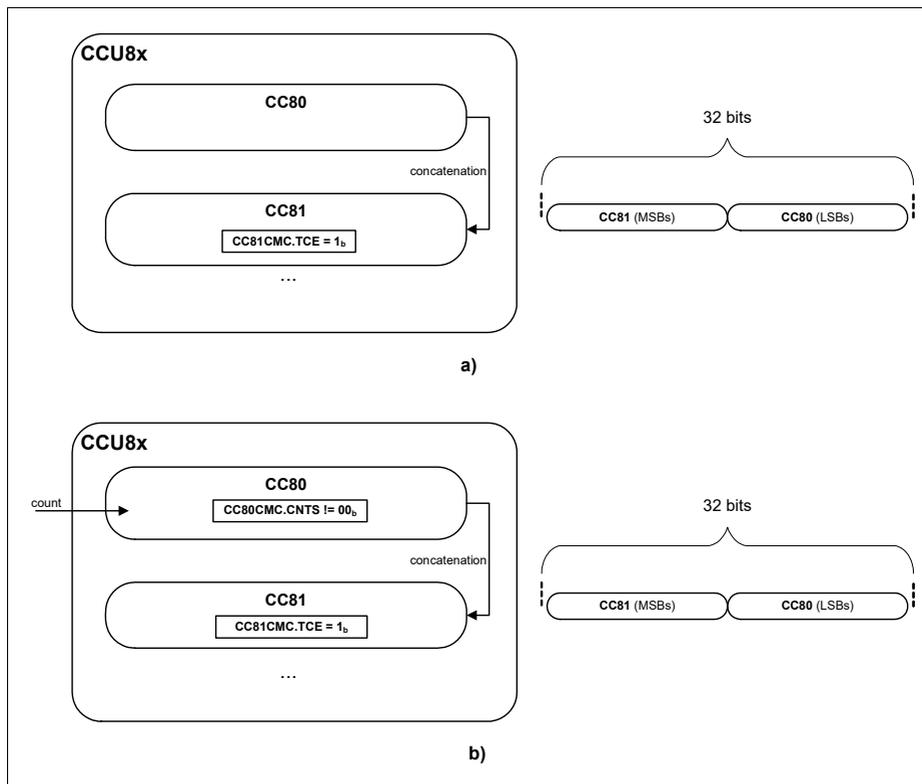
**Figure 8** CCU8x concatenation feature resource configuration - a) without external count function; b) with external count function

When an external count signal is enabled - by programming the CC8yCMC.CNTS with  $01_B$ ,  $10_B$  or  $11_B$  - the concatenation function does not work. One cannot use in parallel the timer concatenation and external count signal features.

*Note: On Figure 1, the count signal is used in CCU80 because this timer represents the LSBs. While the count signal could be enabled in the MSB timer (CC81), this does not make sense when the timers are concatenate - because the count should be used to increment the LSB timer. The LSB timer will then in each wrap around, increment the MSB timer.*

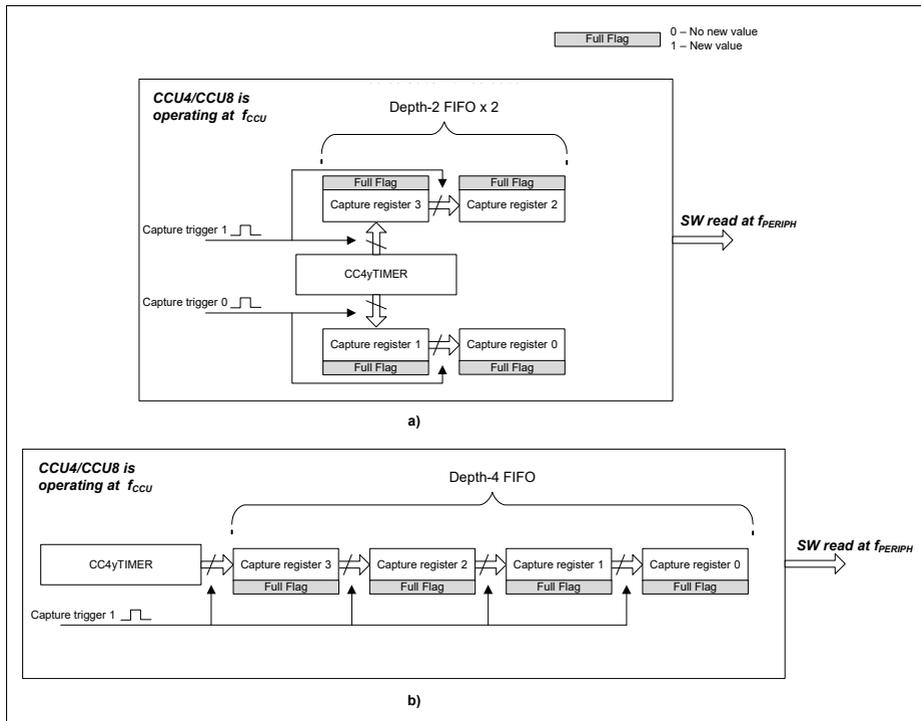
**Figure 9 Capture Modes Structure - a) Depth-2 x2 Capture; b) Depth-4 Capture**

When the peripheral bus clock frequency is smaller than the CCU4/CCU8 module clock frequency,  $f_{\text{periph}} < f_{\text{CCU}}$ , the read back of the full flag is inconsistent. Sometimes it returns the information that a new value has been captured and sometimes it does not.

*Note: The capture interrupt is generated correctly.*

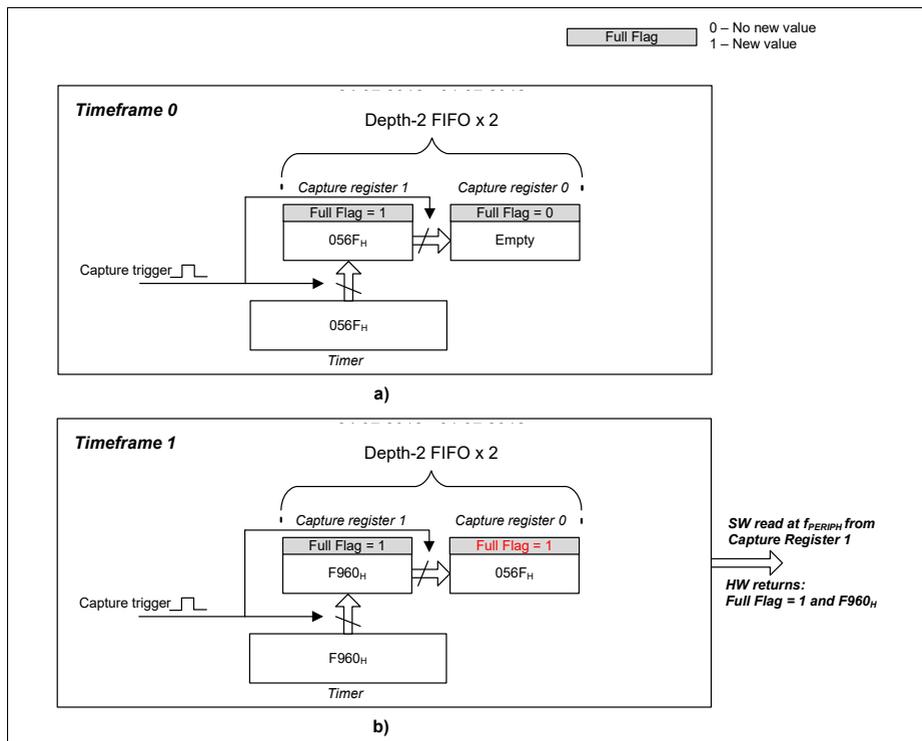
**Figure 11 Capture shift during read back phase - a) Capture trigger without collision with read back; b) Capture trigger collision with read back**

Referring to [Figure 11](#), it can be understood that the proper data is sent to the software when it reads back the capture register 1, nevertheless this same data is shifted to the next capture register (capture register 0) and the full flag of this register is set.

After this if the software reads back capture register 0, a value is going to be returned with a full flag set (indicating that this is a new value - that has not yet been read, which is not true).

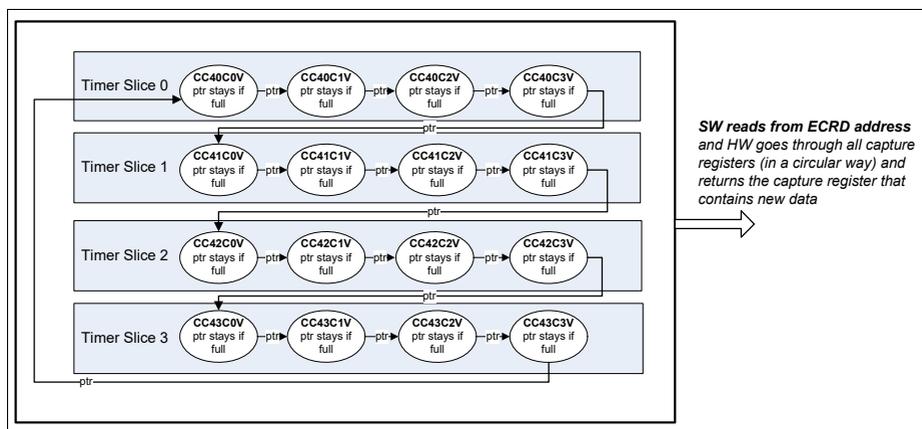
**Figure 12 Extended Read Back access - example for CCU4 (CCU8 structure is the same)**

- Timer X has 4 capture registers and is the only Timer set with  $ECM = 1_B$ . At the moment that the software starts reading the capture registers via the ECRD address, we have already capture two values. The ECRD read back will output CC4xC2V -> CC4xC2V (CC4xC3V value is lost)

- Timer X and Timer Y have 4 capture registers each and they are both configured with  $ECM = 1_B$ . At the moment that the software starts reading the capture registers via the ECRD address, we have already capture two values on Timer X and 4 on Timer Y. The ECRD read back will output CC4xC0V -> CC4xC1V -> CC4xC2V -> CC4xC3V -> CC4yC2V -> CC4yC2V (CC4yC3V value is lost)

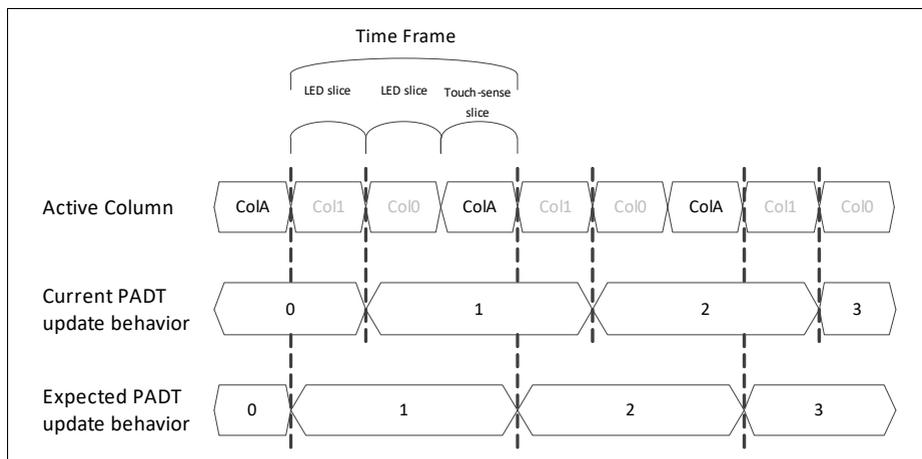
**Figure 14 PADT update behavior**

The touch-sense pad turn (PADT) value is updated, not at the end of the touch-sense time slice (ColA), but one time slice later (**Figure 14**).

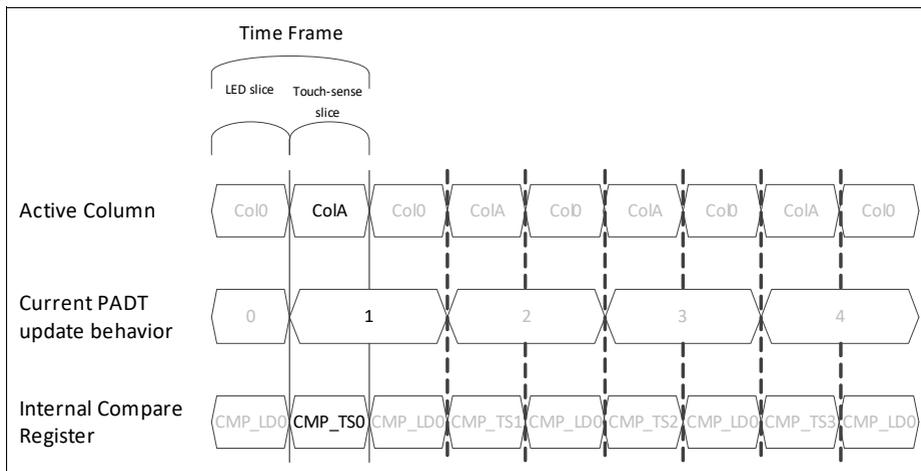
**Figure 15 Effect of delay on the update of Internal Compare Register with 1 LED column enabled**

If the number of LED columns enabled is smaller than 2, the delay will affect the activation period of the current active pad. At the beginning of every new Col A, the value of the current PADT's compare register is updated to the internal compare register. However, the delay causes the value of the previous PADT's compare register is updated to the internal compare register instead. This means that the current active pad would be activated with the duration of the previous pad's oscillation window (**Figure 15**). In addition to this, when no LEDs are enabled, pad turn 0 will prevail for one time slice longer before it gets updated (**Figure 16**).

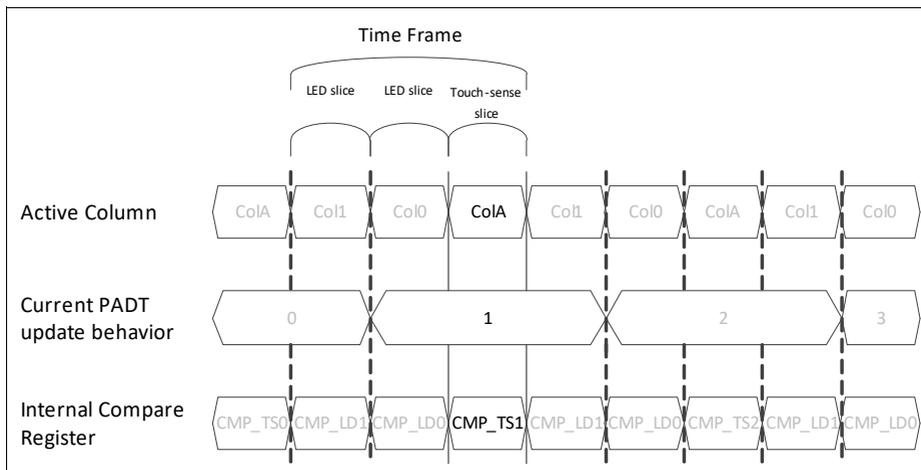
**Figure 17 Internal Compare Register updated with correct compare register value with 2 LED columns enabled**

If the number of LED columns enabled is 2 or more, the additional LED columns would provide some buffer time for the delay. So, at the start of a new touch-sense time slice, the update of PADT value would have taken place. Hence, the current active PADT compare register value is updated to the internal compare register (**Figure 17**).

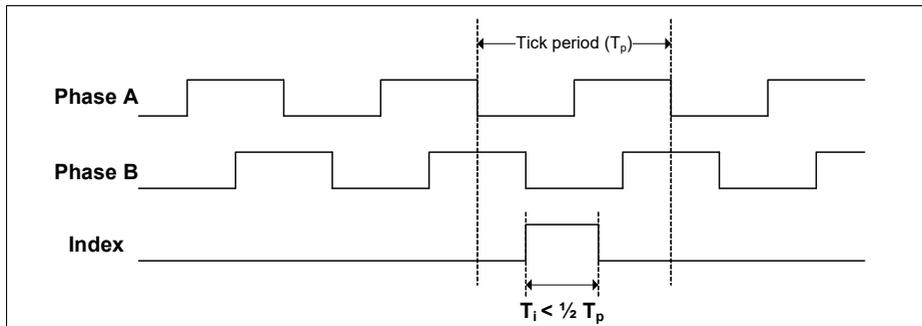
**Figure 20** Different index signal types

When the index signal is smaller than 1/2 of the tick period, the POSIF module is not able to decode this signal properly, Figure 2 - notice that the reference edge of the index generation in this figure is the falling of Phase B, nevertheless this is an example and depending on the encoder type, this edge may be one of the other three.

Due to this fact it is not possible to use the POSIF to decode these type of signals (index with duration below 1/2 of the tick period).

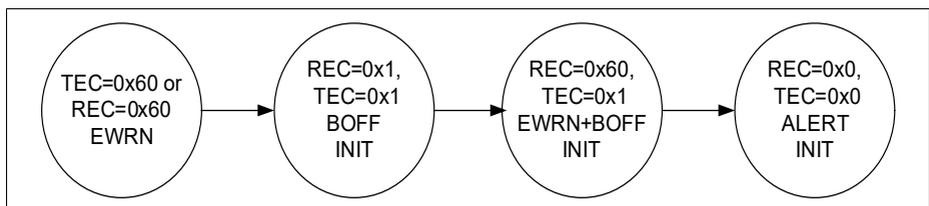
**Figure 22 Alert Interrupt Behavior in case of Bus-Off**

The MultiCAN module shows the following behavior in case of a bus-off status:

When the threshold for error warning (EWRN) is reached (default value of Error Warning Level EWRN = 0x60), then the EWRN interrupt is issued. The bus-off (BOFF) status is reached if TEC > 255 according to CAN specification, changing the MultiCAN module with REC and TEC to the same value 0x1, setting the INIT bit to 1<sub>B</sub>, and issuing the BOFF interrupt. The bus-off recovery phase starts automatically. Every time an idle time is seen, REC is incremented. If REC = 0x60, a combined status EWRN+BOFF is reached. The corresponding interrupt can also be seen as a pre-warning interrupt, that the bus-off recovery phase will be finished soon. When the bus-off recovery phase has finished (128 times idle time have been seen on the bus), EWRN and BOFF are cleared, the ALERT interrupt bit is set and the INIT bit is still set.

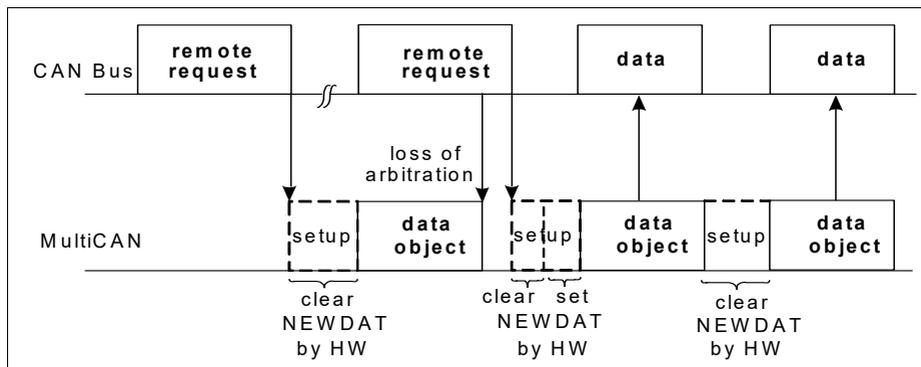
**Figure 23 Loss of Arbitration**

When the appropriate message object (data frame) triggered by the first remote frame wins the arbitration, it will be sent out and `NEWDAT` is not reset. This leads to an additional data frame, that will be sent by this message object (clearing `NEWDAT`).

There will, however, not be more data frames than there are corresponding remote requests.

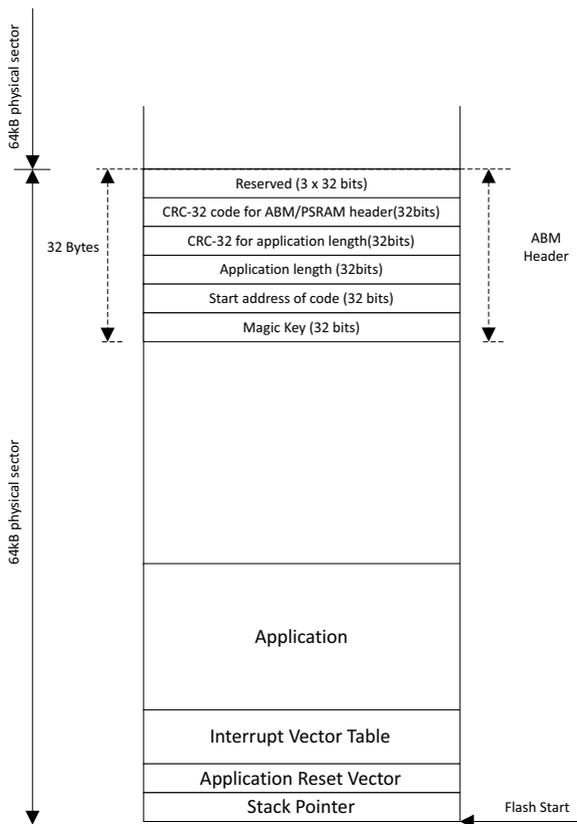
**Figure 24 ABM/PSRAM Header - Location of reserved bytes**

The reference manual is specifying PSRAM/ABM Header of 32 byte size. Only for 20byte of these 32 bytes the functionality is defined. The remaining 12bytes are reserved. Inside the chapter for Startup modes of the reference manual only the functional bytes are specified but not the location of the reserved bytes.

The following figure provides a detailed view on the location of the reserved bytes:
