XC2700 Derivatives

16/32-Bit Single-Chip Microcontroller
with 32-Bit Performance

Errata Sheet

V1.7 2014-10

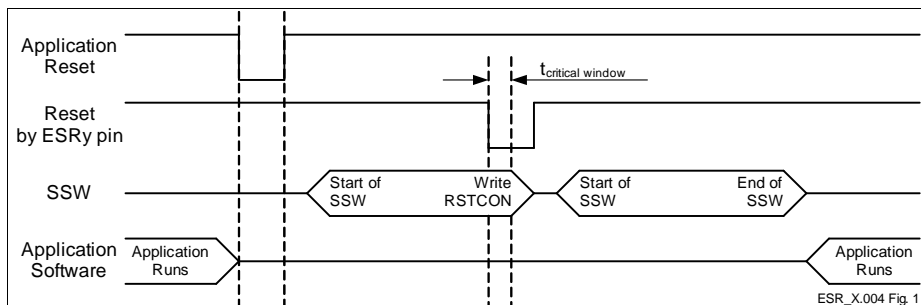
Figure 1 Critical application reset sequence

SCU_RSTCONx registers are reset only by Power-On, but they may be wrongly affected after a second application reset requested by an ESRy pin. This may lead to the SCU_RSTCONx register values being set to zero, which could unexpectedly disable reset sources within the user application. The conditions which lead to this behavior are:

1. First, an application reset by SW (software), CPU (Central Processing Unit), MP (Memory), WDT (Watchdog Timer) or ESRy (External Service Request y) occurs.
2. Following this, an application reset on an ESRy pin occurs.
3. If the above mentioned ESRy reset occurs during a critical time window of the SSW (startup software), then it's possible that the application will operate with the wrong SCU_RSTCONx register value. The critical time window occurs when the SSW is writing the SCU_RSTCONx registers, and at the same time, the ESRy reset request is processed by the reset circuitry. The width of this critical window $f_{critical\ window}$ is less than 13 cycles.

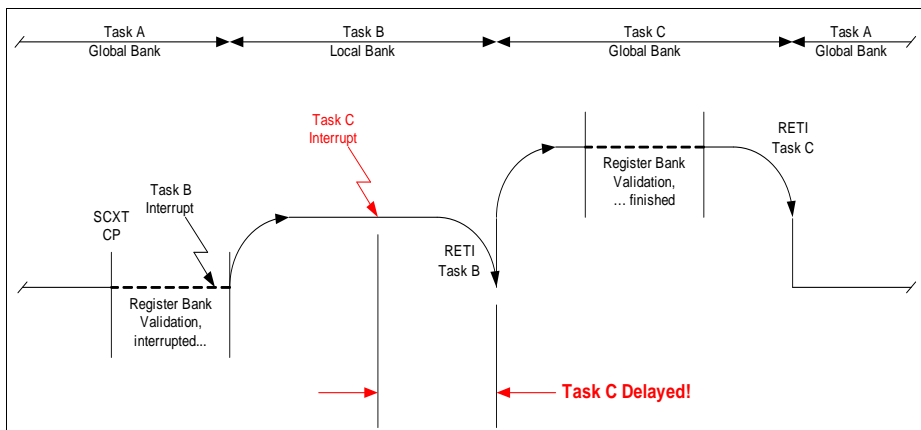
Figure 2 Example for Case 2: Interrupt Service for Task C delayed

- The Context Pointer CP is written to (e.g. by POP, MOV, SCXT ... instructions) within a routine (Task A) that uses a **global** register bank (bit field PSW.BANK = 00_B), i.e. the context for this routine will be modified,
- This context switch procedure (19 cycles) is interrupted by an interrupt request (Task B) which is programmed (with GPRSELx = 1X_B) to automatically use one of the **local** banks via the bank selection registers BNKSEL0...3 (i.e. the interrupting routine has a priority level ≥ 12),
- Before the corresponding interrupt service routine is finished, another interrupt request (Task C) occurs which is programmed (with GPRSELx = 00_B) to automatically use the **global** bank via the bank selection registers BNKSEL0...3 (i.e. the interrupting routine has a priority level ≥ 13).

In this case service of this interrupt request (for Task C) is delayed until bit field PSW.BANK becomes 00_B after executing the RETI instruction at the end of the routine (Task B) using the local bank.
