Device	XMC1100
Marking/Step	EES-AB, ES-AB, AB
Package	PG-TSSOP-16/38, PG-VQFN-24/40

Overview

This “Errata Sheet” describes product deviations with respect to the user documentation listed below.

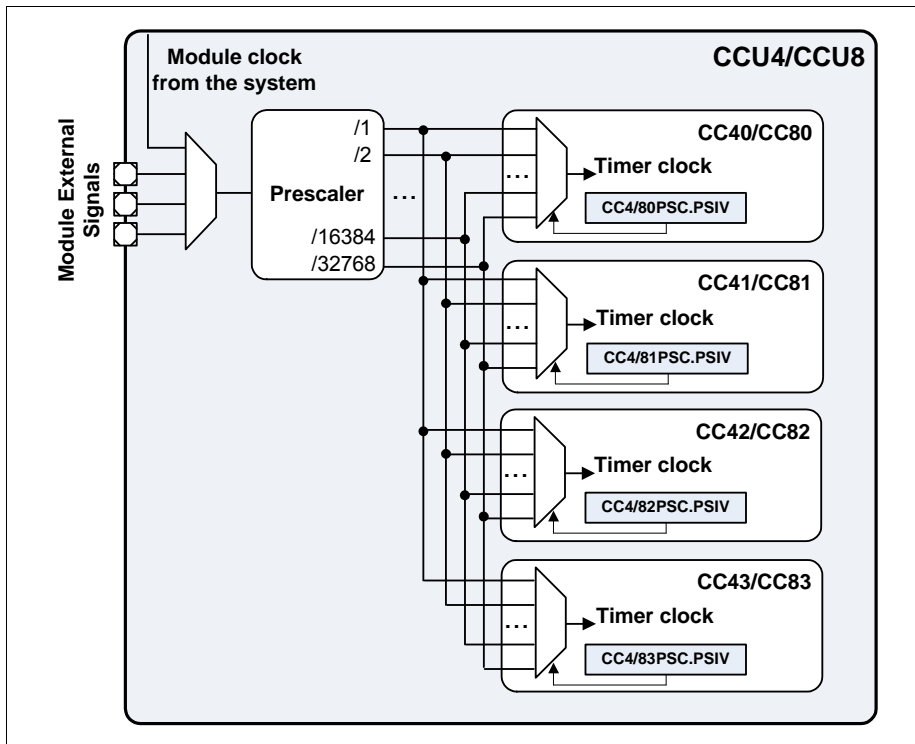
Figure 1 Clock Selection Diagram for CCU4/CCU8

Currently is only possible to use an external signal as Timer Clock when a division ratio of 2 or higher is selected. When no division is selected (divided by 1), the external signal cannot be used.

The user must program the PSIV field of each Timer Slice with a value different from 0000_B - minimum division value is /2.

This is only applicable if the Module Clock provided by the system (the normal default configuration and use case scenario) is not being used. In the case that the normal clock configured and programmed at system level is being used, there is not any type of constraints.

None.
